# MONITORING AND RESEARCH DEPARTMENT

REPORT NO. 13-49

PERFORMANCE OF PERMEABLE PAVEMENTS INSTALLED AT

THE EMPLOYEE PARKING LOT AT THE STICKNEY WATER

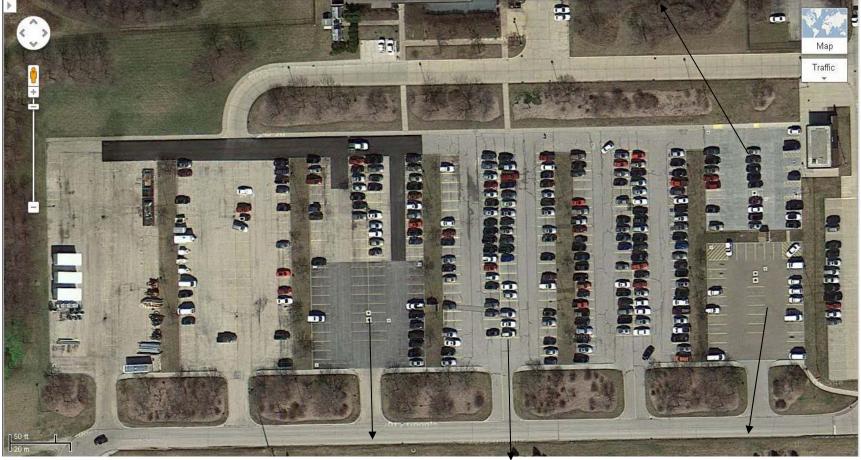
## PHOTOGRAPH 1: PHOTOGRAPH OF THE EMPLOYEE PARKING FACILITY OF THE METROPOLITAN WATER RECLAMATION DISTRICT OF GREATER CHICAGO'S STICKNEY WATER RECLAMATION PLANT AND LOCATIONS OF THE PERMEABLE AND CONTROL LOTS

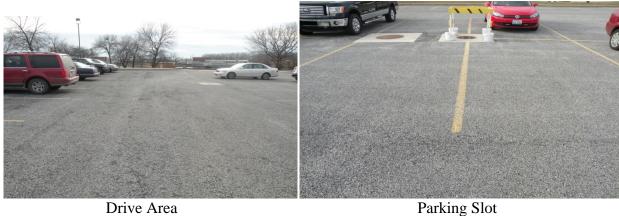
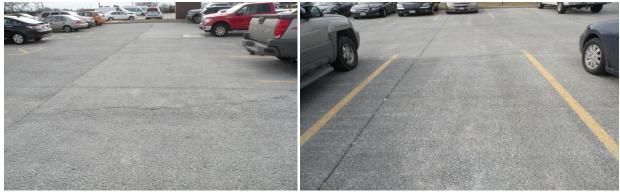
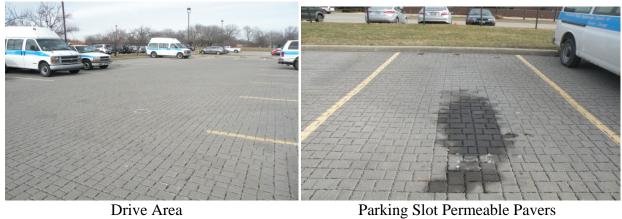
# PHOTOGRAPH 3: PHOTOGRAPHS OF PERMEABLE PAVEMENT LOTS (a) ASPHALT, (b) CONCRETE, AND (c) PAVERS TAKEN IN DECEMBER 2012 SHOWING DETERIORATION OF SURFACE IN DRIVE AREAS AS COMPARED TO PARKING SLOTS

(a) Permeable Asphalt

(b) Permeable Concrete

(c) Permeable Pavers

**Permeable Asphalt**. A few longitudinal cracks were observed at the end of 2009. The end of the 2010 evaluation indicated that this lot was in relatively good condition. There was no vegetation growth on the surface, but there was some surficial sediment buildup in small areas along the eastern border and northwest corner of the lot. Additionally, cuts and scours caused by snow plowing were observed. Minor raveling, i.e. progressive disintegration of the pavement causing large particles to dislodge, was also observed. The 2011 evaluation revealed no vegetative growth but that raveling had increased, especially in the driving lanes and southern entrance. The raveling increased significantly in the drive areas in 2012 as compared to previous years, and some raveling was also observed in the parking slots.

**Permeable Concrete**. At the end of 2009, a crack appeared near the monitoring well area, and also small spalled areas were observed near Northeastern corner of the lot. At the end of 2010, this lot was in relatively good condition with only very little vegetative growth along the edges of the lot. Minor raveling and some cracking were also observed. In 2011, there was vegetative growth along the borders of the lot, necessitating weeding, major raveling around the control joints along the perimeter of the lot, and two large cracks in the center of the lot. By the end of 2012, increased raveling was observed in the drive areas as compared to previous years, and the area between the parking slots had only minor raveling (Photograph 3).

**Permeable Pavers**. At the end of 2009, a few chipped and cracked pavers were observed and loose CA-16 Paver fill gathered at a few locations. At the end of 2010, this lot was the most degraded among the three permeable pavement lots. Multiple locations of chipped pavers and vegetation were observed. Pronounced depressions were noted throughout the lot. Additionally, fill between the pavers was missing in a number of locations. The 2011 evaluation revealed weeds in the corners of the lot, necessitating weeding, and an increased number of chipped, spalled, and cracked pavers. The 2012 evaluation showed more degradation than was observed in 2011. Also an oil leak patch in a parking slot was observed as well as a little vegetation that needed weeding (Photograph 3).
