In-situ infiltration performance of different permeable pavements in a employee used parking lot – A four-year study

Monitoring and Research Department, Metropolitan Water Reclamation District of Greater Chicago, 6001 West Pershing Road, Cicero, IL, 60804, USA

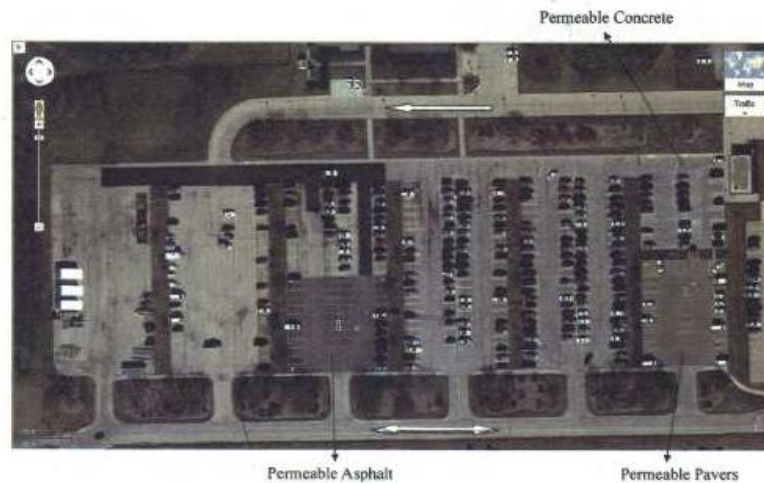
Picture 1. A picture showing relative location of permeable parking lots in an employee parking lot at the Stickney Water Reclamation Plant.

The permeable parking surfaces that were constructed on the existing employee parking facility measure approximately 245.8 m × 82.1 m in total (Picture 1). The existing parking facility had six sections. The easternmost section was divided into two with a ~6 m grassed median separating the two sections with a permeable pavers lot on the south side and a permeable concrete lot on the north side. The permeable asphalt lot was located on the southern half of the 3rd from the westernmost parking section. Each parking section is separated by a 6 m wide grassed median, with through traffic moving east-west between different sections at the north side of the parking sections. The actual sizes of the permeable parking lots and number of parking stalls in each lot are given in Table 1. There are 43, 38, and 23 parking slots in permeable pavers, permeable concrete, and permeable asphalt lots, respectively (Table 1). The permeable pavers' lot receives minimum traffic, as it is used to park the MWRDGC's pollution control full-size vans and small utility vehicles with, on average, only less than 40% of the

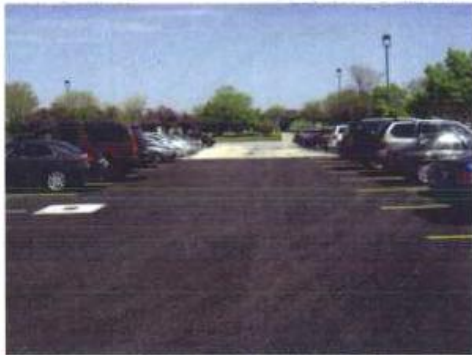
(a) Permeable Asphalt

Picture 2. Pictures of permeable pavement sections (a) asphalt, (b) concrete, and (c) pavers in an employee parking lot at the Stickney Water Reclamation Plant when opened for use in May, 2009.

The porous asphalt used looks similar to conventional asphalt; it consists of open-graded asphalt (10-cm layer) over an open-graded fill base 30 cm deep, consisting of CA-7 aggregates above native soil (Fig. 1 and Picture 2a). The aggregate base was separated from subgrade native soil by LINQ 180 EX separation geotextile.

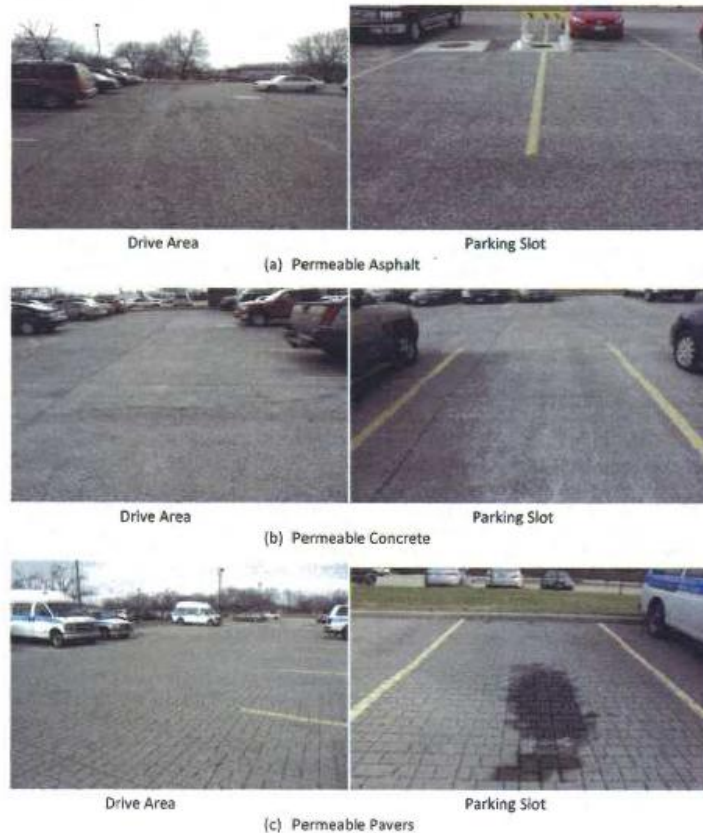
The end of the 2010 evaluation indicated that this lot was in relatively good condition. There was no vegetation identified, but some surficial sediment buildup in small areas along the eastern border and northwest corner of the lot was observed. Additionally, cuts and scours caused by snowplowing were observed. Minor raveling, i.e. progressive disintegration of the pavement causing large particles to dislodge, was also observed. The 2011 evaluation revealed no vegetative growth but that raveling had increased, especially in the driving lanes and southern entrance. The raveling increased significantly in the driving areas in 2012, as compared to previous years, and some raveling was also observed in parking slots (Picture 3). Once raveling occurred at the surface, it worsened with time due to daily traffic and also winter snowplowing.

The 2010 evaluation indicated that this lot was in relatively good condition with only minor vegetative growth along the edges of the lot. Minor raveling and some cracking was also observed. The 2011 evaluation revealed vegetation along the borders of the lot necessitating weeding, major raveling around the control joints along the perimeter of the lot, and two large cracks in the center of the lot. By the end of 2012, increased raveling was observed in driving areas as compared to previous years; the area between parking slots had only minor raveling (Picture 3).

The 2010 evaluation indicated that this lot was in the worst condition of the three permeable pavement lots. Multiple locations of chipped pavers and vegetation growing between the pavers were observed. Pronounced depressions were noted throughout the lot. Additionally, the fill between the pavers was noticeably missing in a number of locations. The 2011 evaluation revealed weeds in the corners of the lot necessitating weeding and an increased number of chipped, spalled, and cracked pavers. The 2012 evaluation

showed more degradation than was observed in 2011 and little vegetation that needed weeding (Picture 3). In addition, an oil leak patch of approximately 1 m² area was also observed in one slot.

Picture 3. Pictures of permeable parking sections (a) asphalt, (b) concrete, and (c) pavers taken in December, 2012 showing deterioration of surface in driving areas as compared to parking slots.

In fact, we measured the infiltration rate in a parking slot in the permeable paver lot in 2012 where oil leaked (see Picture 3c) and observed the infiltration rate of only 0.38 mm s⁻¹, which was ten times lower than the mean infiltration rate in pavers measured at the same time in 2012. For this particular site, dry deposition is considered the most significant cause for clogging. The urban areas in Chicago, Illinois, are reported to have much higher mass fluxes of dry deposition compared to smaller cities. Franz et al. (1998) reported mass flux of dry deposition in the area of the study site varied from 34 to 200 mg m⁻² d⁻¹, which is significantly higher as compared to 1.2–28 mg m⁻² d⁻¹ in smaller cities. Additionally, shear stress caused by vehicle operation may have also played a role. This latter cause is the suspected reason that infiltration rates from the third year (2011) onwards declined at a much higher rate in driving areas as compared to parking slots (Table 3 and Fig. 2).

It is clear that with time, infiltration rates of permeable pavements decline, and declines are greater in places with greater traffic, as shown in comparison of parking slots and driving area in the present study, which may be related to higher wear and tear and greater degree of clogging of pores. Clearly, use intensity increases the rate of wear and clogging of pores, which may be much higher in commercial parking lots where traffic intensity may be much higher. Thus, as pointed out by Bean et al. (2004) and Dierkes et al. (2015), maintenance programs to prevent clogging may be very important in maintaining the high surface infiltration rates. In an interesting study using gamma rays, Baladès et al. (1995) showed that the clogged area was limited to the upper two cm of permeable surfaces tested. In general, four methods of maintenance are available for maintaining permeable pavements: (1) gentle water spray of the surface followed by sweeping; (2) sweeping followed by suction; (3) suction alone; and (4) high pressure water jet washing and suction together. The maintenance program we have adopted until now has been a gentle water spray followed by rotary brush sweeping twice a year. In a comprehensive review of what kind of maintenance practices work better, it may be concluded that clogging can be countered by suction cleaning as a preventive maintenance and by high pressure water jet washing followed by suction as a remedial maintenance (Baladès et al., 1995; Bean et al., 2004; Dierkes et al., 2015).
