New Castle County's Clearwater Disconnection Pilot Program

Katherine R. Mechler^{1*}, James W. Shelton¹, Anthony J. Dill¹, Bryan P. Lennon¹, David A Hofer²

¹ Malcolm Pirnie the Water Division of Arcadis, Wilmington, Delaware.

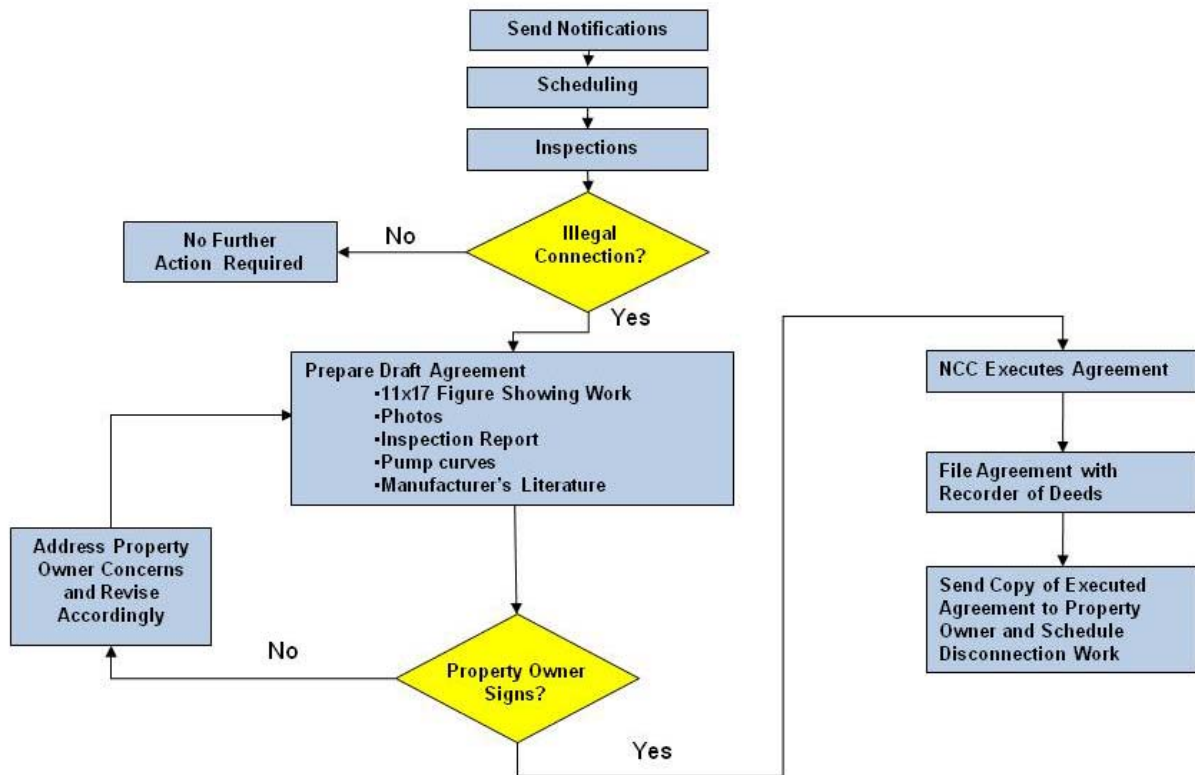
Figure 1. Private Property Approach.

work. Before any work was scheduled at a property, the agreement was reviewed, approved, executed by both the property owner and NCC, and recorded at the County’s Recorder of Deeds office. The agreements were recorded to assure that future property owners would not be eligible for any future financial assistance to disconnect Clearwater connections that had been re-connected following the Pilot Program. Figure 1, on the following page, includes a flow chart that shows the steps for routing and executing the agreements.

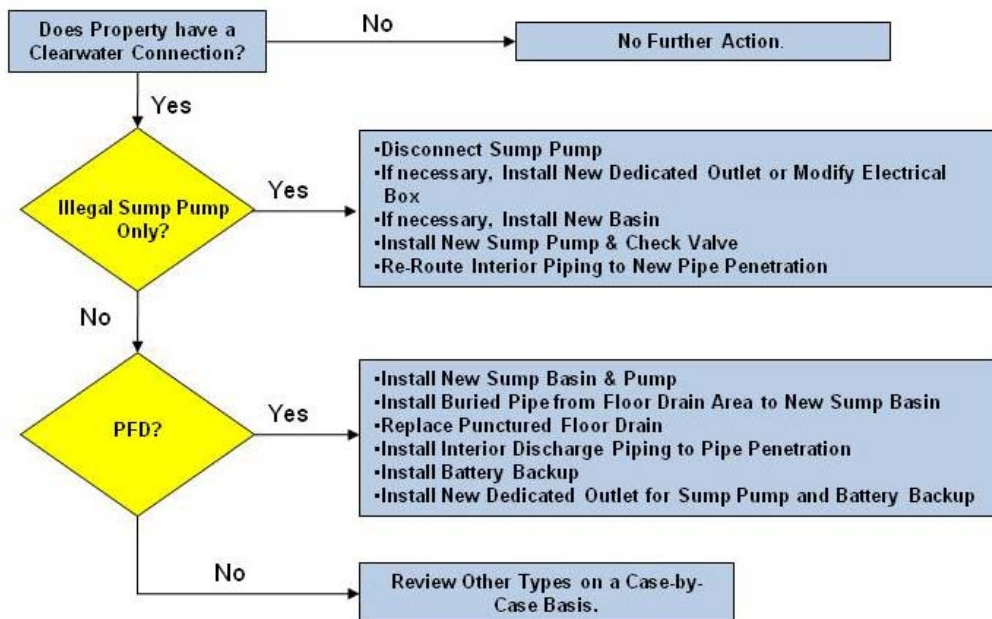
Figure 2. Interior Work.

The design process for Clearwater disconnections was broken down into two distinct aspects of the work: interior design work and exterior design work. Although these two aspects of the design process interrelate in terms of selecting the ideal location for new penetrations for discharge piping, they were considered largely independent. Figure 2 describes the basic steps in determining the appropriate scope of work for the interior of the basement. Figure 3 describes the basic steps for determining the appropriate scope of work for the exterior of the property. Effort was made to reasonably accommodate property owner requests and limitations as long as they were feasible and did not add excessive cost.
