STICKNEY WATER RECLAMATION PLANT PERMEABLE PAVEMENT DEMONSTRATION INTERIM REPORT 2010 AND 2011

Monitoring and Research Department Thomas C. Granato, Director

June 2012

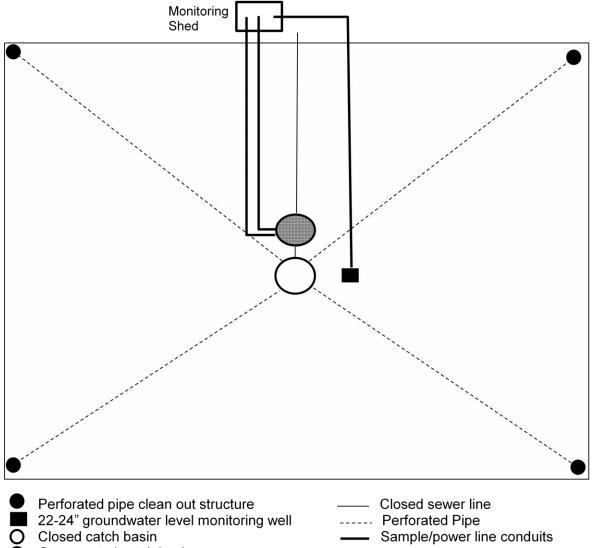
FIGURE 1: TYPICAL PERMEABLE LOT LAYOUT

The lots receive different contributions of run-on from permeable and impermeable surfaces during rainfall events and are allowed to drain freely towards the local groundwater. A system of four-inch perforated pipe rests on the bottom of the CA-7 fill in each permeable lot. These pipes collect flow migrating through the fill which drains into a closed catch basin. All four lots have an open-grated catch basin to accept runoff (RO) in the center of the lot as well. In the permeable lots, the infiltration catch basin is connected to the open-grated catch basin via a 12-inch closed pipe. Thus, water collected by the perforated pipes will flow into the open-grated catch basin. A second 12-inch closed pipe leads away from the open-grated catch basin and conveys water off-site. The typical permeable lot layout is shown in Figure 1.

Open-grated catch basin

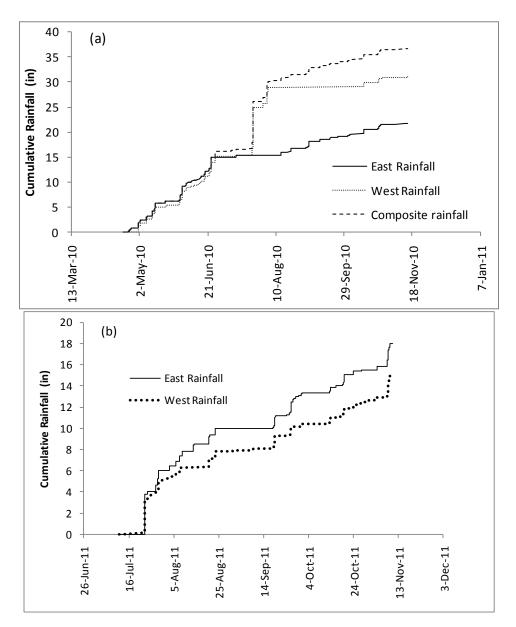
FIGURE 2: (a) 2010 CUMULATIVE RAINFALL FOR THE EASTERN AND WESTERN STICKNEY WATER RECLAMATION PLANT LOTS, AND (b) 2011 CUMULATIVE RAINFALL FOR THE EASTERN AND WESTERN STICKNEY WATER RECLAMATION PLANT LOTS

Plots of the cumulative rainfall for the eastern and western rain gauges are shown in <u>Figure 2a</u> and <u>2b</u> for 2010 and 2011, respectively. Due to the electrical problems in 2010 cited above, an off-site rain gauge located at the intersection of South Western Avenue and Blue Island Avenue in Chicago, Illinois (approximately five miles from the site) was used to supplement the missing data providing a composite rainfall used in the analysis below. For 2010, a total of 36.7 inches of rainfall was estimated over the course of the entire monitoring season; for 2011, a total of 15–18 inches of rainfall was estimated over the course of the shortened monitoring season. Periodic site visits during periods of rainfall indicated no visible standing water or RO on any of the permeable lots during both monitoring seasons. RO and standing water were observed in the impermeable control lot.

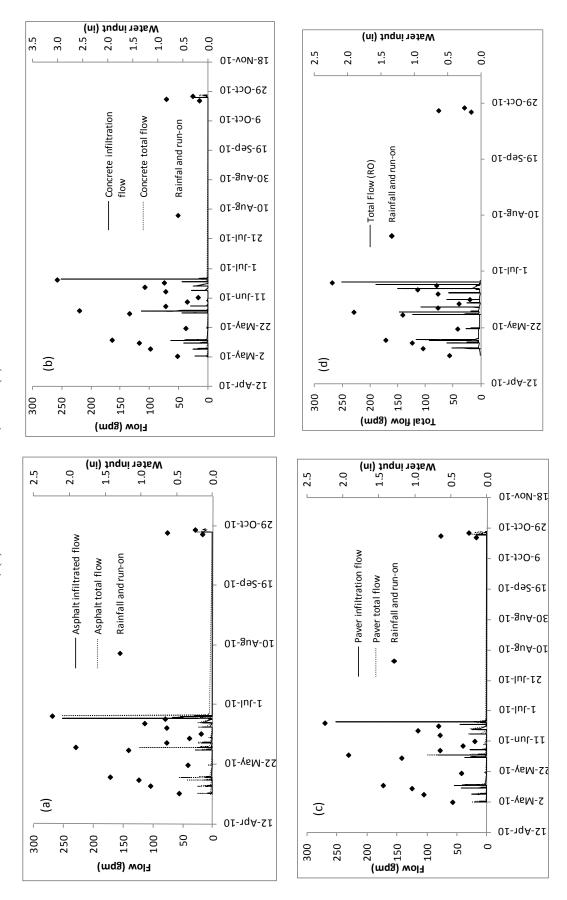
FIGURE 4: 2010 TOTAL FLOWS, INFILTRATED FLOWS, AND RAINFALL FOR THE (a) POROUS ASPHALT, (b) POROUS CONCRETE, (c) POROUS PAVER, AND (d) CONTROL LOTS

The infiltrated and total flow response for the three permeable lots showed a similar pattern whereby flow increase was observed during rainfall and run-on events. Upon conclusion of the rainfall event, flows decreased to a baseline level for all permeable lots as shown in Figures 4a-4d. (Please note that cumulative daily rainfalls were plotted at the beginning of the day and therefore may not correlate exactly with the peaks shown in the figures.) Unfortunately, problems with flow measurements were encountered. For example, recorded infiltrated flows were often higher than the recorded total flows, and RO estimations (total flow minus infiltrated flow) were often higher than the water input for the lot even though no RO was ever observed; this would produce a negative calculation for RO, which is impossible.
