***MONITORING AND RESEARCH  
DEPARTMENT***

*REPORT NO. 17-32*

*MONITORING THE EFFECTIVENESS OF URBAN STORMWATER  
BEST MANAGEMENT PRACTICES IN THE CERMAK-BLUE ISLAND  
STREETSCAPES CORRIDOR IN CHICAGO, ILLINOIS*

*July 2017*

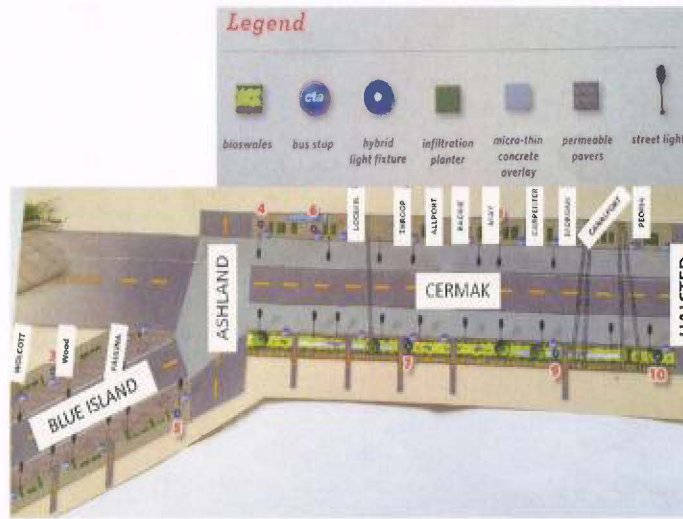
FIGURE 3: GENERAL LAYOUT GRAPHICS SHOWING SALIENT FEATURES OF THE PROJECT SITE

Three types of BMPs were installed at the project site during Phase 1 (Figure 3, from Wolcott/Blue Island Avenue to Halsted/Cermak Road). Features of the landscape before, during, and after construction are shown in Figure 4. The following is a brief description of green infrastructure BMPs installed at the project corridor:

- i. **Permeable Pavers:** Permeable pavers that covered the parking and biking lanes were installed on both sides of the road on Blue Island Avenue (Figure 3). Rainwater falling directly on these areas and the runoff from the road and adjoining impervious areas soak through the spaces in between these pavers and are stored temporarily in the stone storage area below the pavers before the water infiltrates into the native soil below. The stone layer underneath the pavers, infiltration boxes, and the sidewalks were connected to provide large storage volumes for infiltrated water. The permeable pavers were also installed in the nearby Juarez Academy High School plaza and the sidewalks along the school up to Loomis Avenue. The overflow from the pavers at the school plaza and sidewalks was directed to bioswales through a water feature. This water feature also delivered the runoff from the school's roof in the form of channeled fountains to the bioswale. The water feature directed the water to aesthetically enhanced stone formations on the west side of the bioswale (Figure 5).

- iii. **Bioswales:** There was a continuous bioswale on the south side of Cermak Road between Ashland Avenue and Halsted Avenue (Figure 3 and 5). The bioswale received the runoff water from the road surface and some surrounding impervious areas. The bioswale was landscaped to maximize the benefits of the micro-environments – with most drought-resistant plants on the drier upper edges of the bioswale and water-loving plants at the bottom of bioswale. Another bioswale was located on the west side of Loomis Avenue in front of the high-school plaza (see Figure 5).

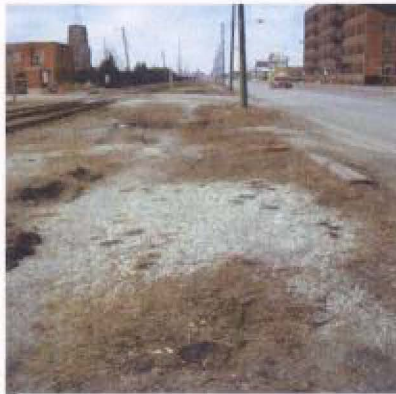
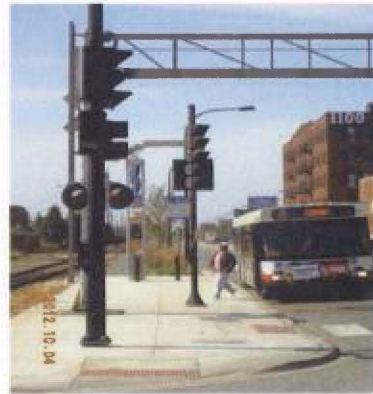
FIGURE 4: PHOTOGRAPHS OF THE SITE BEFORE, DURING, AND AFTER CONSTRUCTION

South side of Cermak Road at Racine Road, looking west, before (left) and after (right) construction

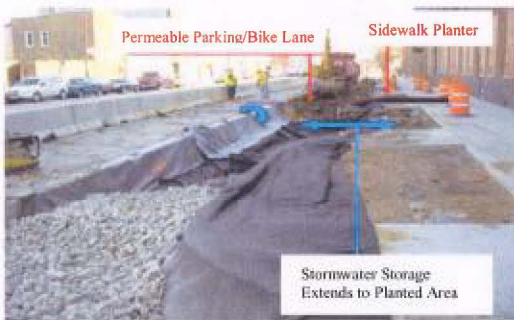
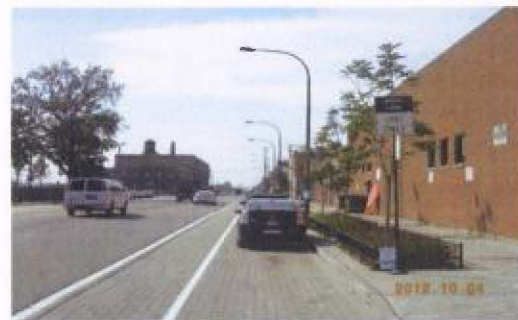
North side of Blue Island Ave., looking west, during (left) and after (right) construction.

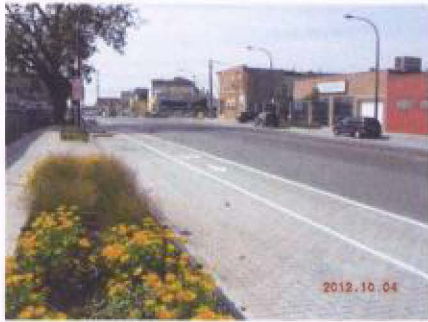
**Planter Box Alongside Permeable Pavers in Bike and Parking Lane on Blue Island Ave.**

- ii. **Infiltration Boxes:** A total of 43 infiltration planter boxes were installed on both sides of Blue Island Avenue which received the runoff from road surface and sidewalks. Infiltration planter boxes had mixed vegetation, which included native grasses, perennial shrubs, and forbes. The stone sub-layer below the planter boxes, sidewalks, and below permeable pavers were connected to provide large storage volumes for infiltrating water. On the north side of Cermak Road, there were 19 infiltration boxes and 41 tree boxes. The typical infiltration planter box and tree box installed in this corridor are shown in Figure 5.

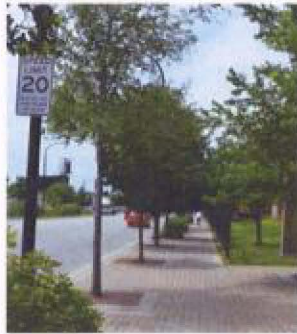
**Tree Box on Cermak Rd.**

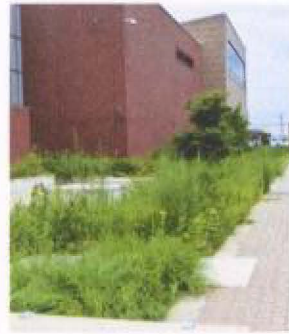
**Bioswale - School**

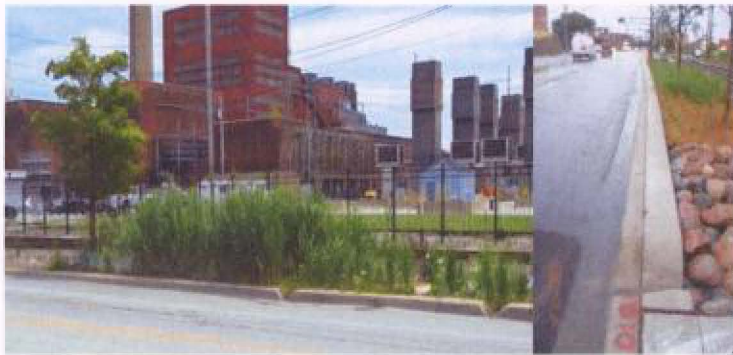
**Bioswale on Cermak – Roadside view**

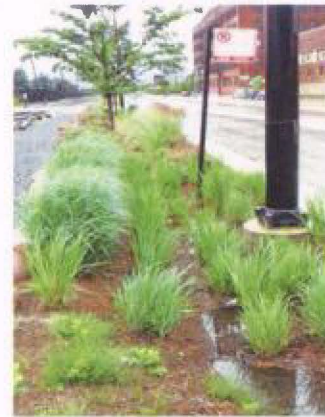
**Bioswale on Cermak – Railroad Side View**

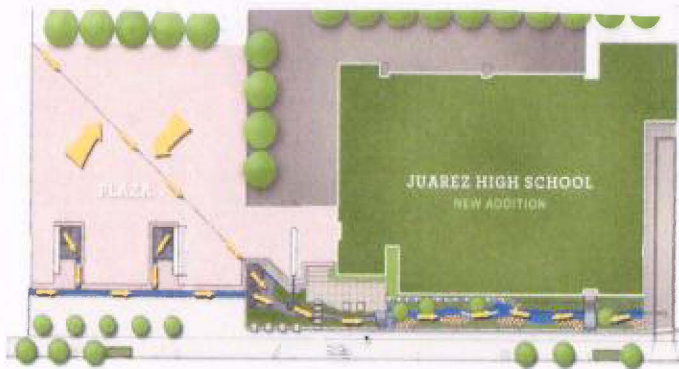
**Water Feature: Arrows Indicating Overflow from Permeable Pavers in School Plaza to Bioswale**

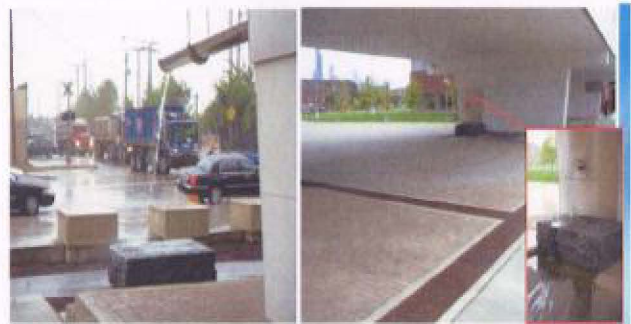
**Water Feature: Runoff From School Roof Entering Bioswale After Falling on Aesthetic Rocks**

This bioswale received the overflow water from the permeable pavers installed on the school plaza but also runoff water from the school's roof via a water feature (see [Figure 5](#)).

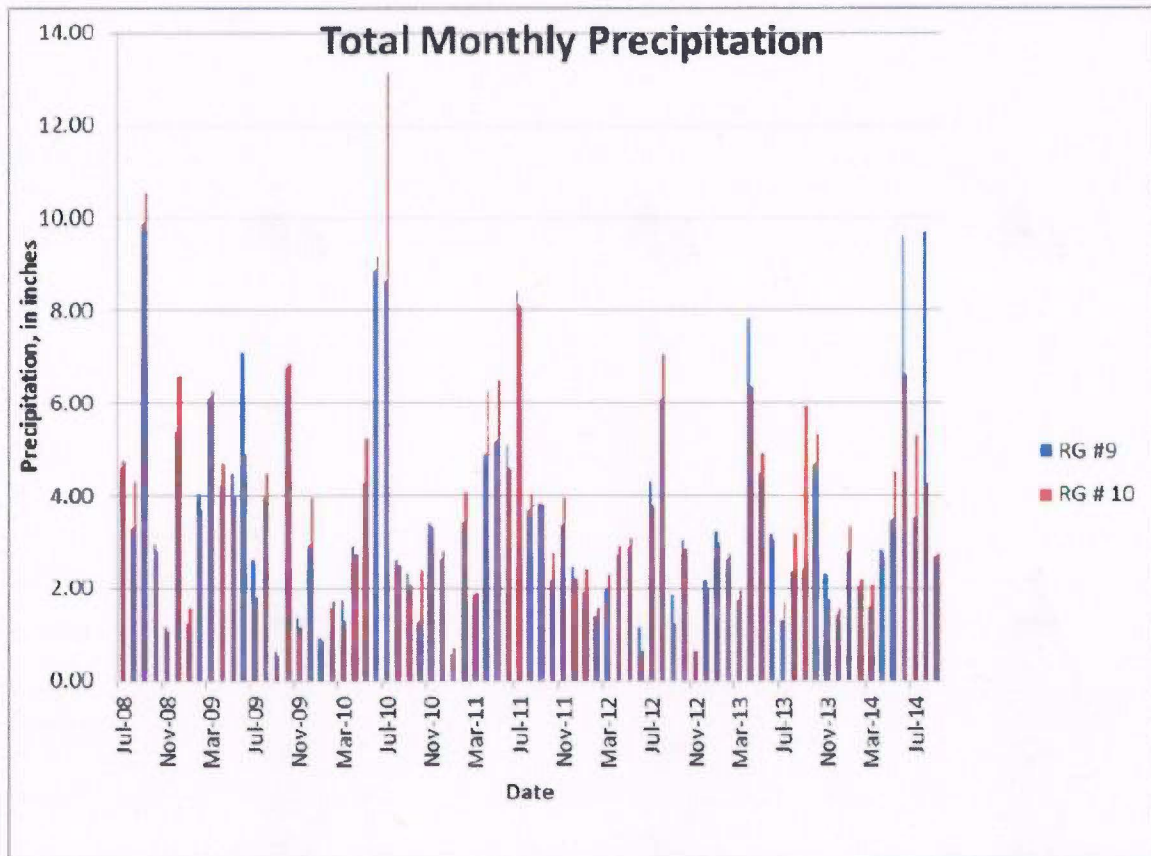
FIGURE 9: MONTHLY PRECIPITATION HYETOGRAPH FROM THE ILLINOIS STATE WATER SURVEY COOK COUNTY PRECIPITATION NETWORK GAGE, GAGE NUMBERS 9 AND 10, DURING THE STUDY PERIOD

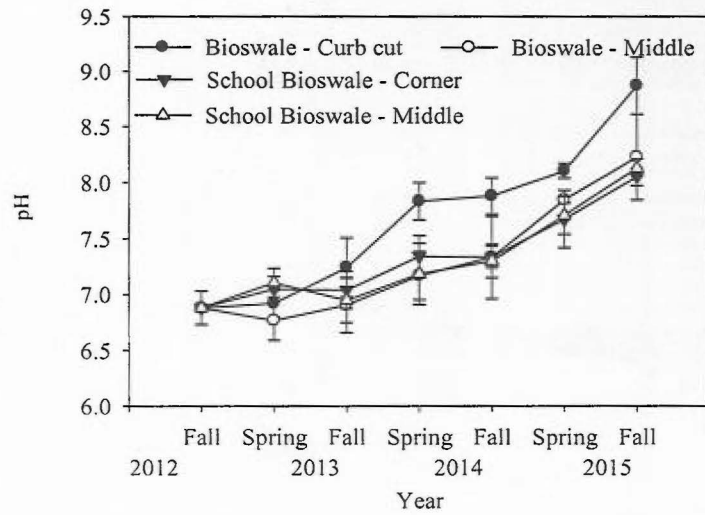
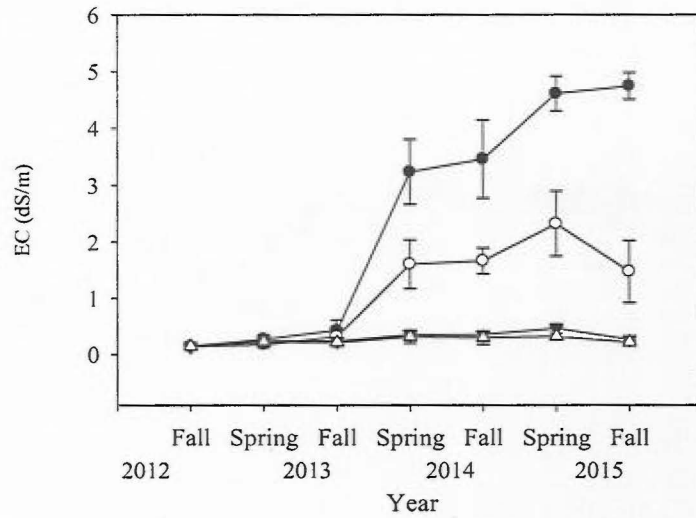
FIGURE 10: CHANGES IN SOIL pH AND ELECTRICAL CONDUCTIVITY OF SURFACE 0 TO 30 cm LAYER IN BIOSWALES AND PLANTER BOXES WITH TIME

Figures 10 and 11 show the results of biannual measurements of pH and EC of bioswale and planter soils. Consistent trends of increasing soil pH and EC for the bioswale and planter soils between fall 2012 and fall 2015 were observed. Similar trends were observed in both the surface-to-5 cm and the surface-to-30 cm layers of soil. In general, increases in soil pH and EC were of a higher magnitude in the bioswale on Cermak Road, as compared to the school bioswale, and also in infiltration planter boxes with a curb cut than without a curb cut. These trends are due to changes in the bioswale and planter soils as stormwater runoff is routed into the BMPs and infiltrated through the soils but also the source of that runoff water. For example, the school bioswale received runoff from the school roof top and overflow from the permeable pavement plaza, but the bioswale on Cermak Road received the runoff from the Cermak Road catchment area, which is expected to carry more sediments and pollutants than the school roof or plaza. Similarly, the infiltration planter boxes with curb cut showed a greater increase in pH and EC as compared to planter boxes without-curb cut. Infiltration planter boxes with curb cut received runoff from both the road pavement and also the sidewalks and without curb cut received runoff only from sidewalks. The soil pH and EC were significantly higher near the curb cut of Cermak Road bioswale as compared to the middle of the bioswale, likely due to the greater deposition of sediments and the infiltration of concentrated first flush runoff closer to the curb cut. These results indicate that soil in the infiltration planter boxes and bioswales not only retain sediments and pollutants from runoff, which would otherwise end up in combined sewers, but also retard their transport to the surface or ground water.

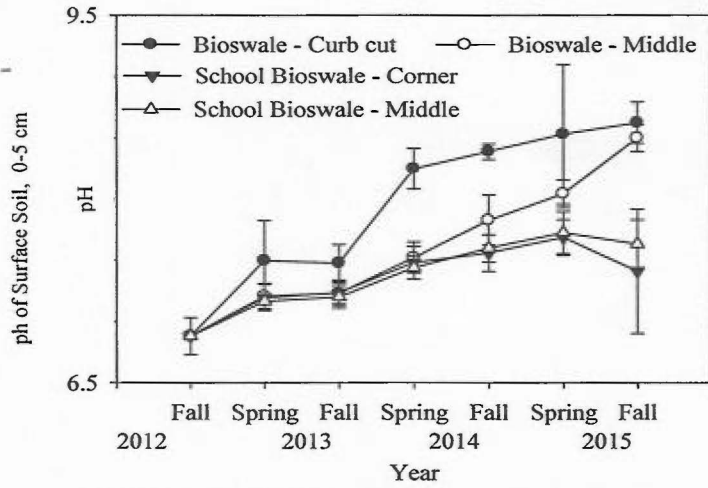
FIGURE 11: CHANGES IN SOIL pH AND ELECTRICAL CONDUCTIVITY OF SURFACE 0 TO 5 cm LAYER IN BIOSWALES AND PLANTER BOXES WITH TIME

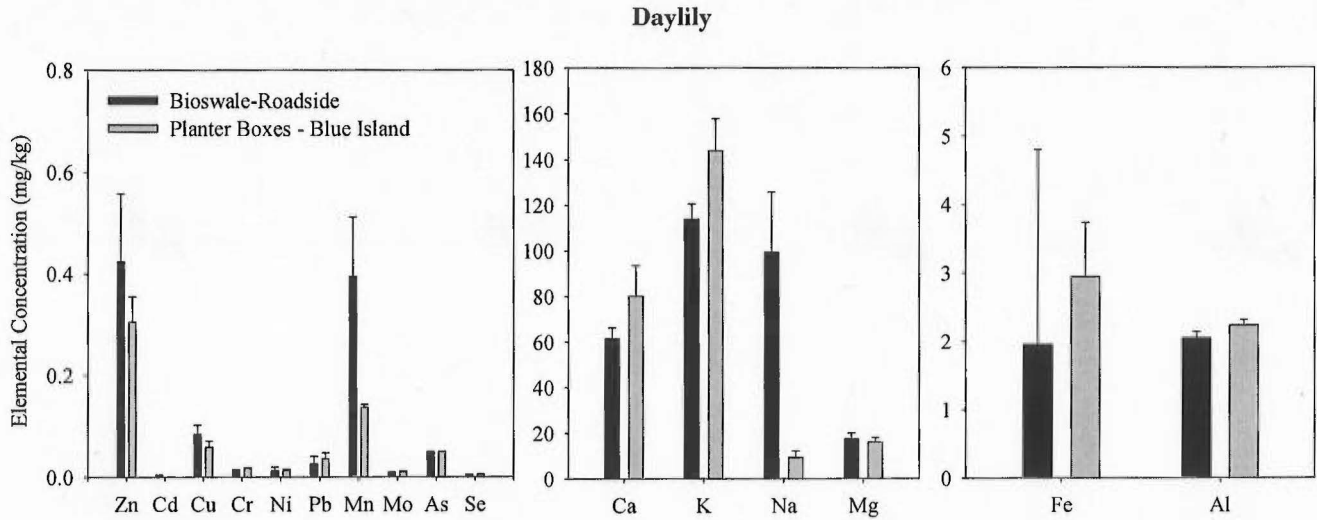
FIGURE 15: ELEMENTAL CONCENTRATION IN DAYLILY PLANT TISSUE GROWN IN ROADSIDE BIOSWALE AND PLANTER BOXES ON BLUE ISLAND ROAD IN THE STREETSCAPE CORRIDOR

Avenue showed only significantly higher accumulation of Mn when grown in roadside bioswale. The reason for higher Mn in roadside bioswale may be linked to industrial activity, as a metal recycling facility was located in the vicinity of this bioswale (Figure 15). On Blue Island Avenue, Pennsylvania sedge growing in the infiltration planter boxes on the north side of the roadway had significantly higher concentrations of Zn and Mn as compared to those plants growing in the infiltration boxes on the south side of the roadway, while the results for Fe and Al were the opposite (Figure 16).

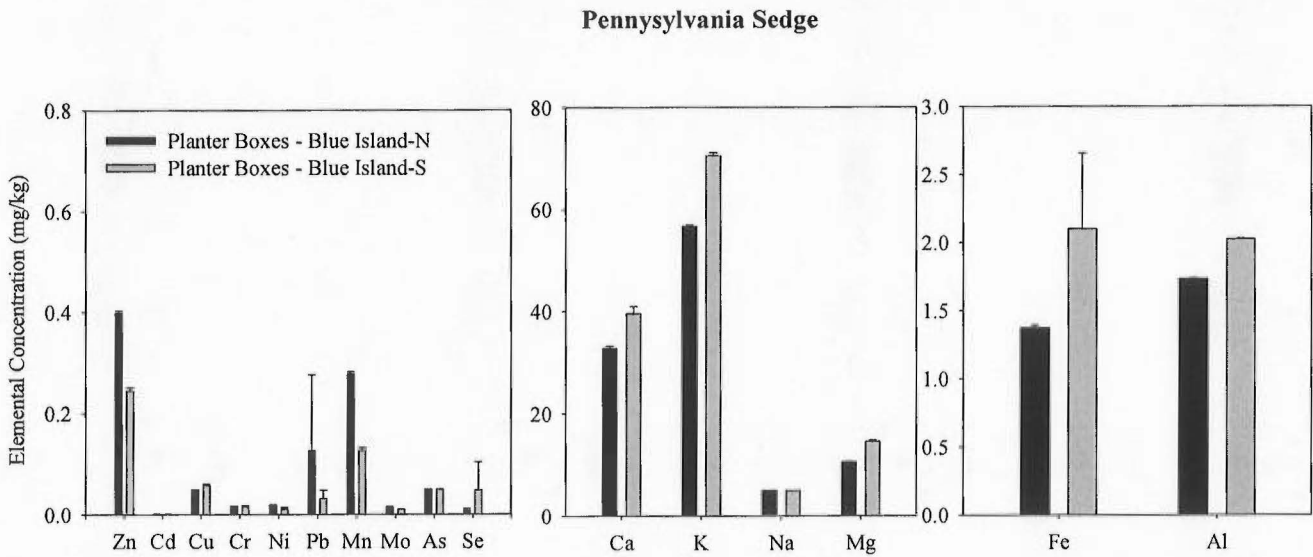
FIGURE 16: ELEMENTAL CONCENTRATION IN PENNSYLVANIA SEDGE PLANT TISSUE GROWN IN PLANTER BOXES ON NORTH AND SOUTH SIDE OF BLUE ISLAND ROAD IN THE STREETSCAPE CORRIDOR

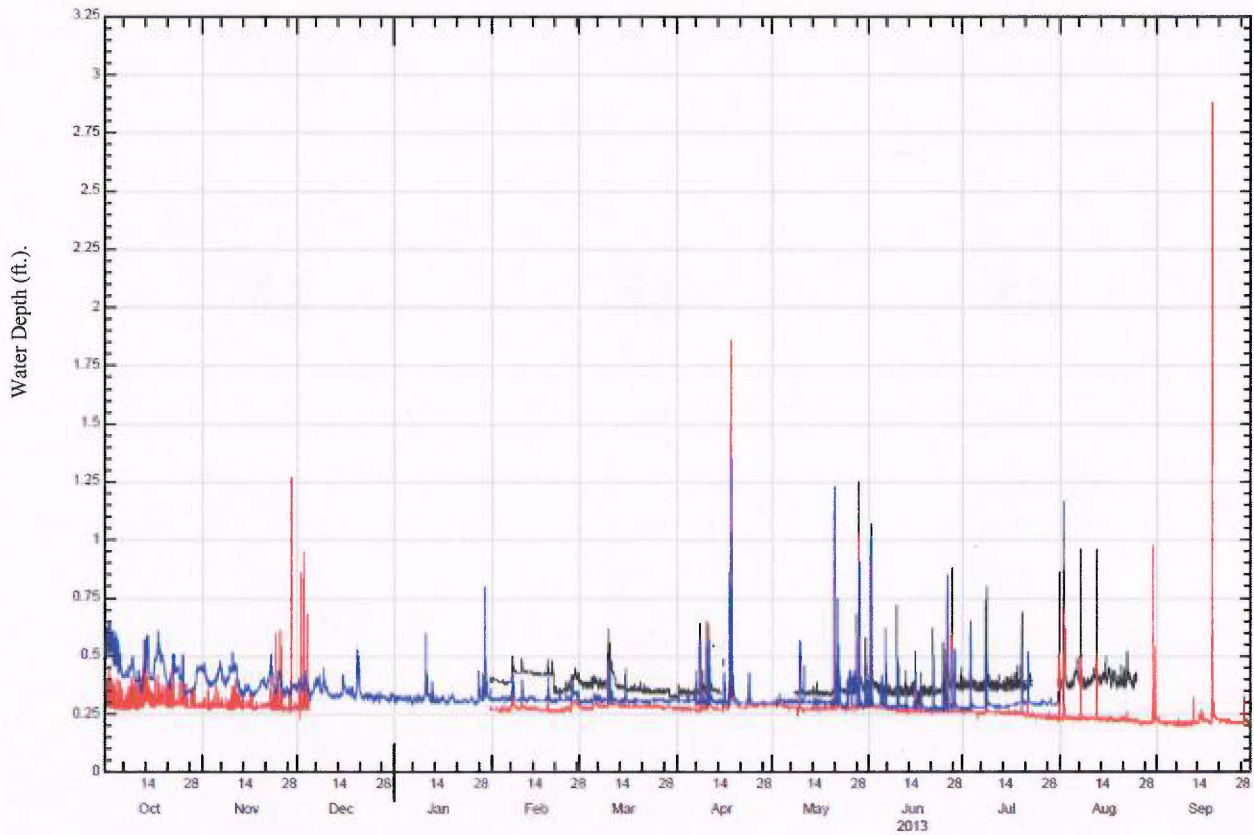
FIGURE 17: WATER LEVEL HYDROGRAPH FROM THE SEWER FLOW MONITORING STATION NEAR PAULINA STREET

Black Line = SMH-1-Blue Island Avenue near Leavitt Street  
Red Line = SMH-2-Blue Island Avenue near Paulina Street  
Blue Line = SMH3-Cermak Road near Throop Street

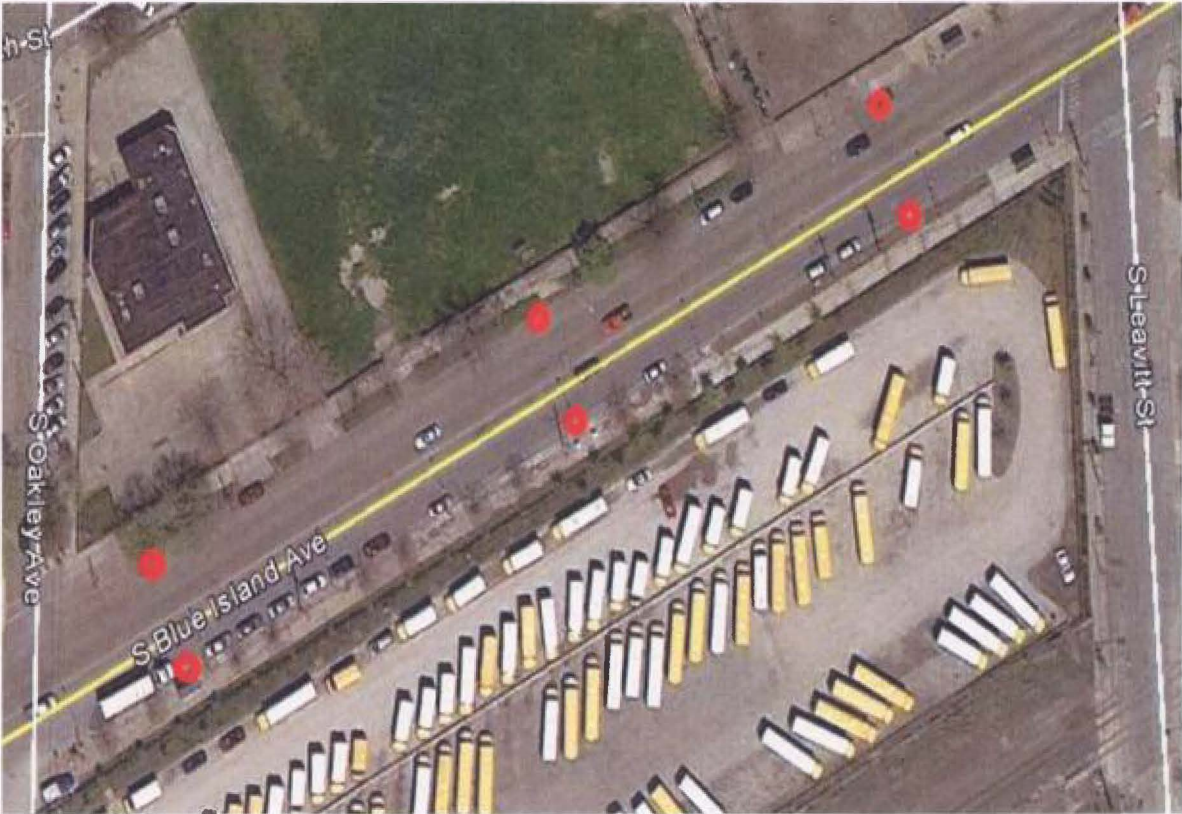
FIGURE 18: LOCATION OF CATCH BASINS IN THE SECTION OF BLUE ISLAND AVENUE BETWEEN OAKLEY AVENUE AND LEAVITT STREET

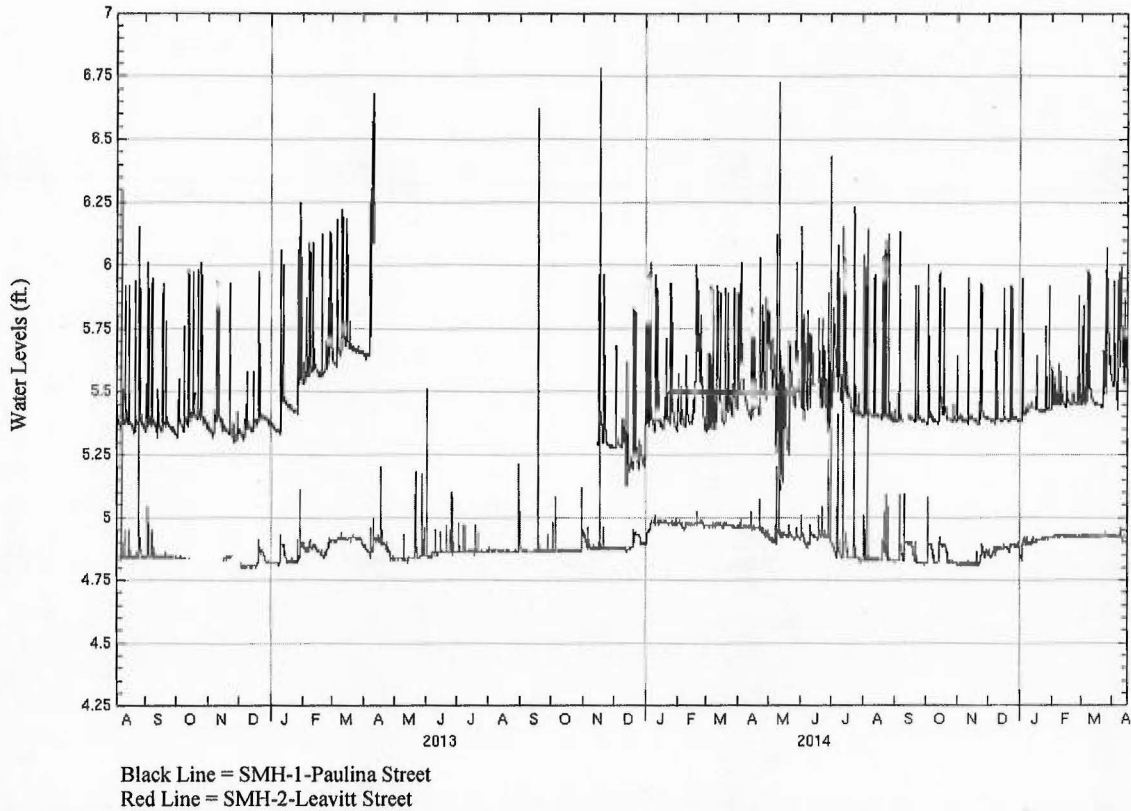
FIGURE 20: HYDROGRAPH OF CATCH BASIN WATER LEVELS AT THE LEAVITT STREET, WITHOUT PERMEABLE PAVERS, AND PAULINA STREET, WITH PERMEABLE PAVERS, LOCATIONS FOR THE PERIOD AUGUST 2012 - APRIL 2015

[Figure 20](#) shows catch basin water levels at the Leavitt Street and Paulina Street locations for a 32-month period (August 2012 – April 2015). Changes in the catch basin water level hydrograph were used to calculate the volume of outflow from the catch basin to the local combined sewer for selected storm events. The catch basins in the study corridor were relatively consistent in dimension. The catch basin dimensions (diameter and area) and recorded catch basin water level data were used to compute the volume of stormwater that drained from the roadway to the catch basin ([Table 7](#)). The general differences in the recorded catch basin water level hydrographs between the Leavitt Street and Paulina Street locations are the result of the permeable pavers infiltrating stormwater runoff before it reached the curb at the Paulina Street location.

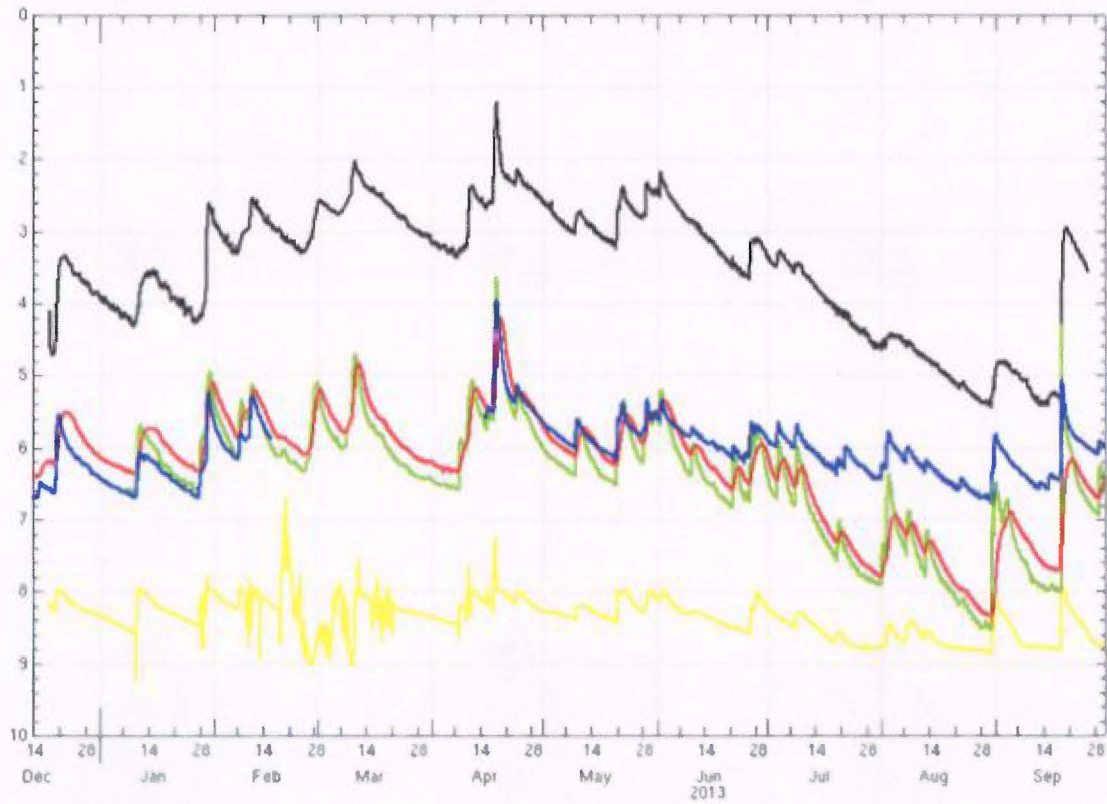
FIGURE 21: GROUNDWATER HYDROGRAPHS FOR THE PERIOD  
DECEMBER 2012 - SEPTEMBER 2013 FROM THE FIVE MONITORING  
WELLS IN THE STUDY

Black Line = Bioswale  
Yellow Line = Leavitt  
Green Line = Juarez High School, Shallow  
Red Line = Juarez High School, Deep  
Blue Line = Canalport

Groundwater levels were analyzed to determine the role of shallow groundwater on the hydrology of the study area and the effectiveness of BMPs in infiltrating stormwater runoff to shallow groundwater. The five monitoring wells were all completed/screened in the “native” soil/fill material at depths of 8.7 - 19.5 ft below land surface. Figure 21 shows the groundwater hydrographs for a ten-month period (December 2012 - September 2013) from the five monitoring locations in the study corridor. Each of the shallow monitoring wells shows the same general trends and fluctuations of shallow groundwater levels.

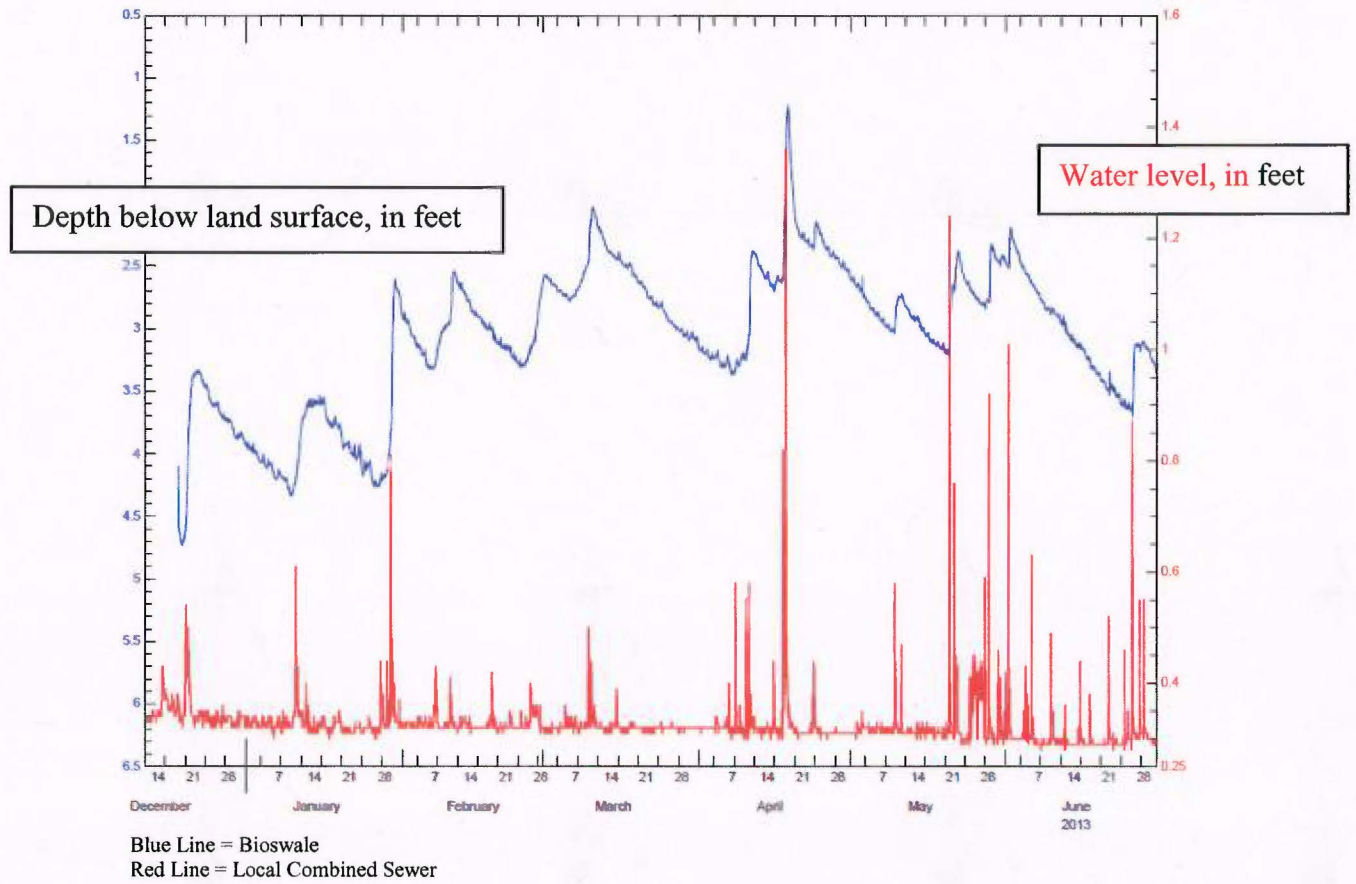
FIGURE 23: GROUNDWATER HYDROGRAPH FROM THE BIOSWALE MONITORING WELL AND WATER LEVEL IN THE LOCAL COMBINED SEWER SHOWING FLUCTUATIONS IN THE LEVEL OF SHALLOW GROUNDWATER IN RESPONSE TO STORM EVENTS

The slug test results show an average hydraulic conductivity of the native soil/fill material of 0.20 ft/day. The hydraulic conductivity value and the water level data from the bioswale monitoring well show that the bioswale functions are designed to infiltrate stormwater runoff from the roadway to shallow groundwater (Figure 23). Fluctuation in the level of shallow groundwater in response to storm events shows the bioswale filling with stormwater, but only on one occasion, reaching the level of the land surface in the vicinity of the monitoring well.

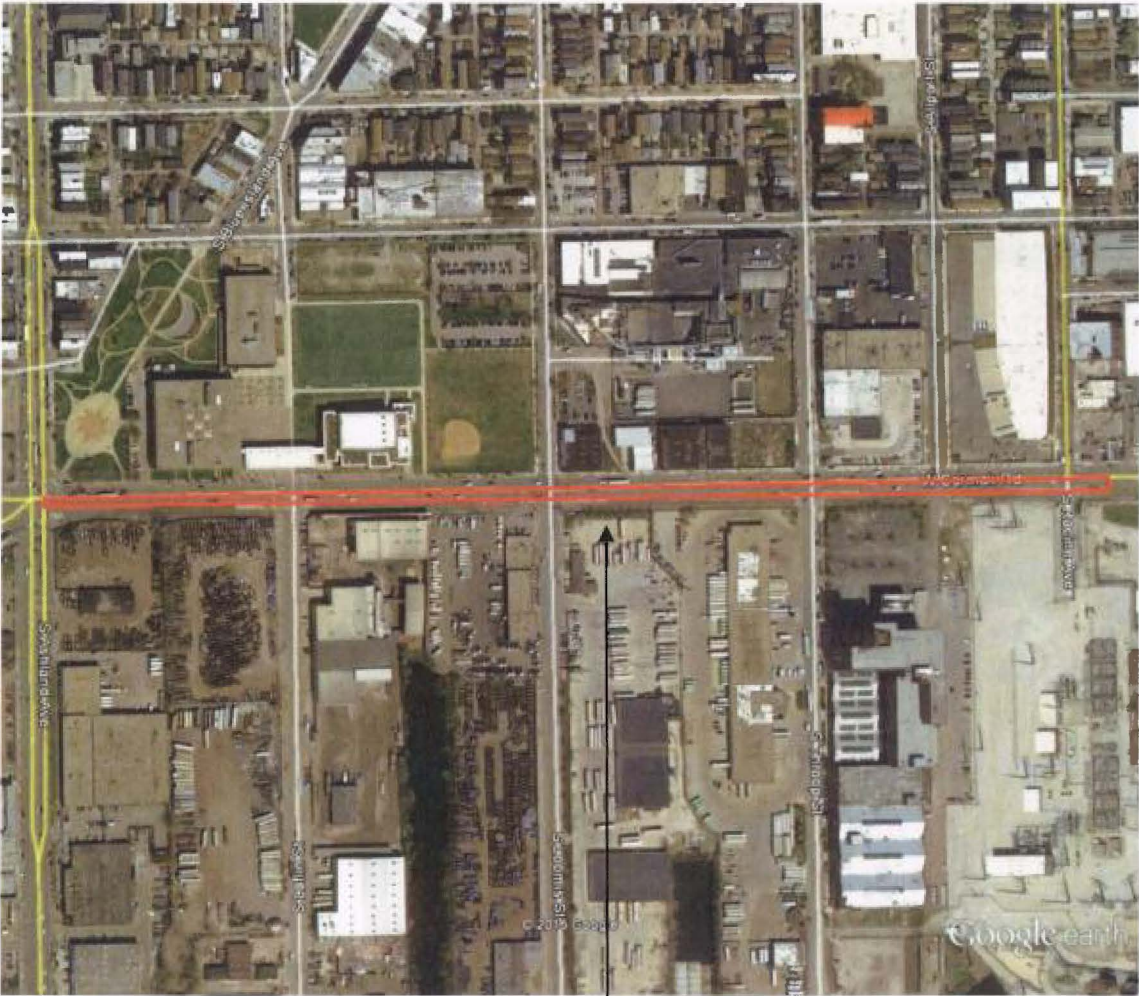
FIGURE 28: APPROXIMATE CATCHMENT AREA FOR THE BIOSWALE

2,670 ft Catchment Area of Bioswale

The catchment area for the bioswale runs approximately 2,670 ft along Cermak Road, from the intersection with Ashland Avenue east to approximately Racine Avenue, where the width of the bioswale pinches out next to railroad tracks ([Figure 28](#)).

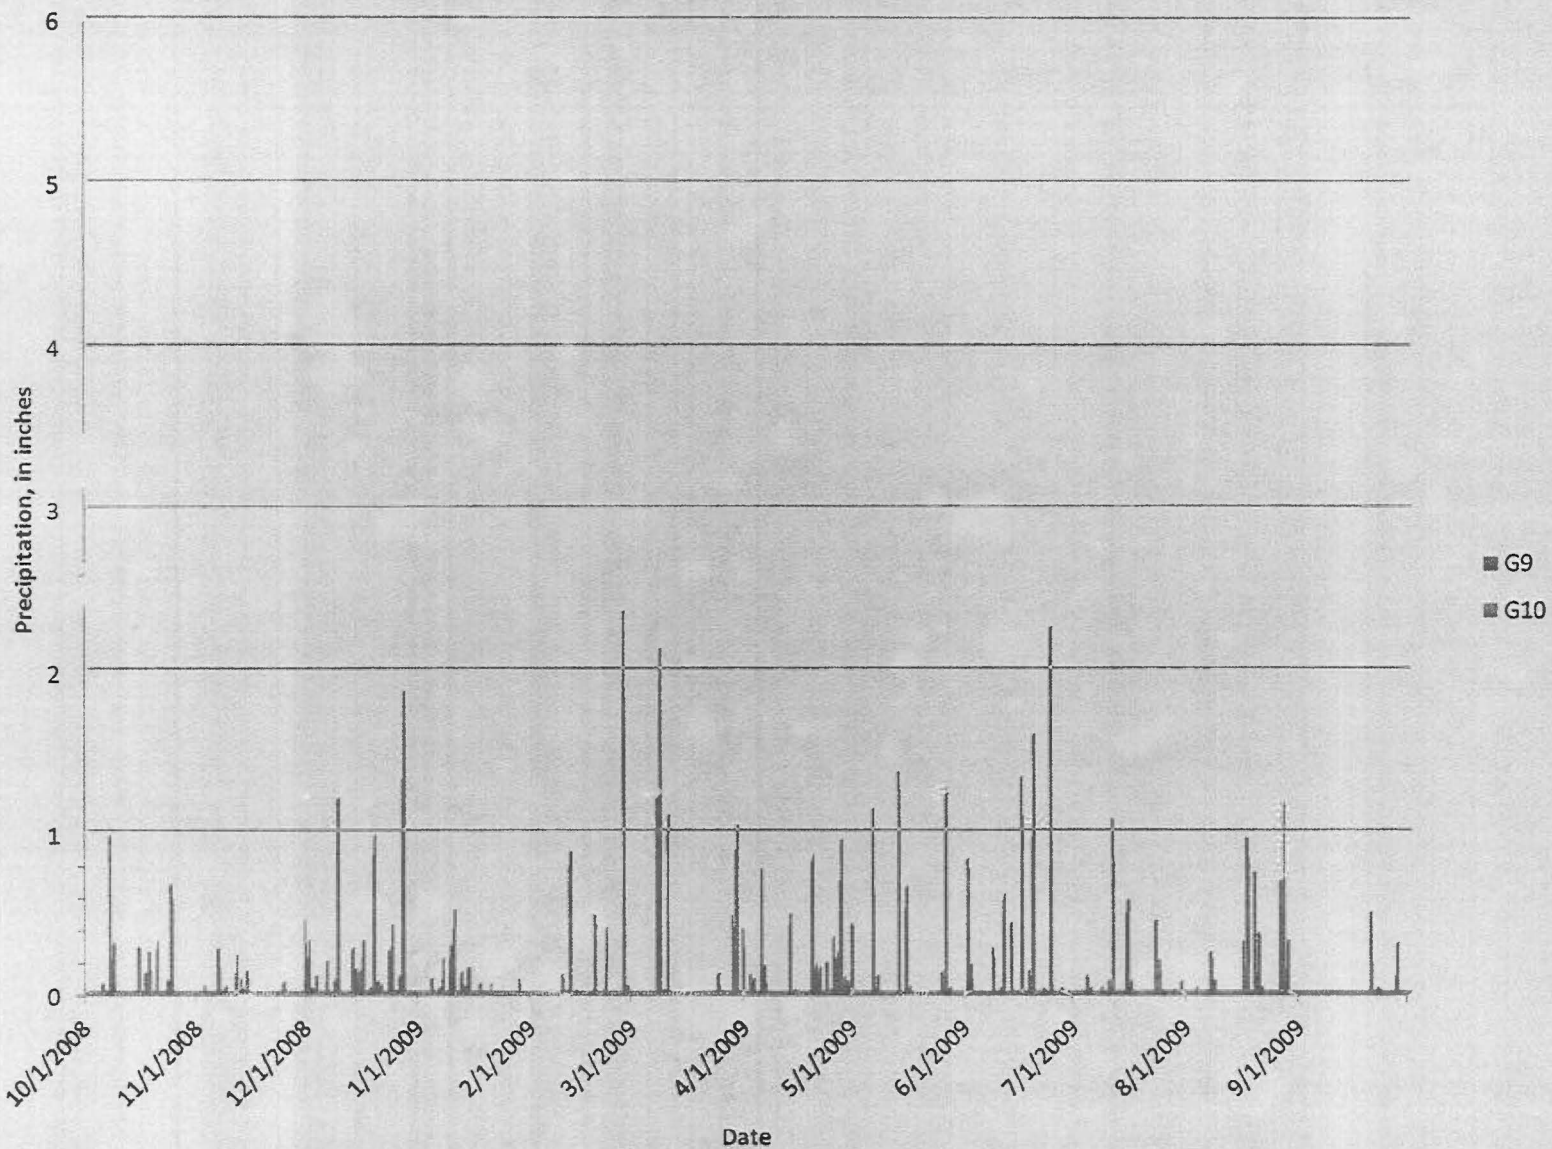
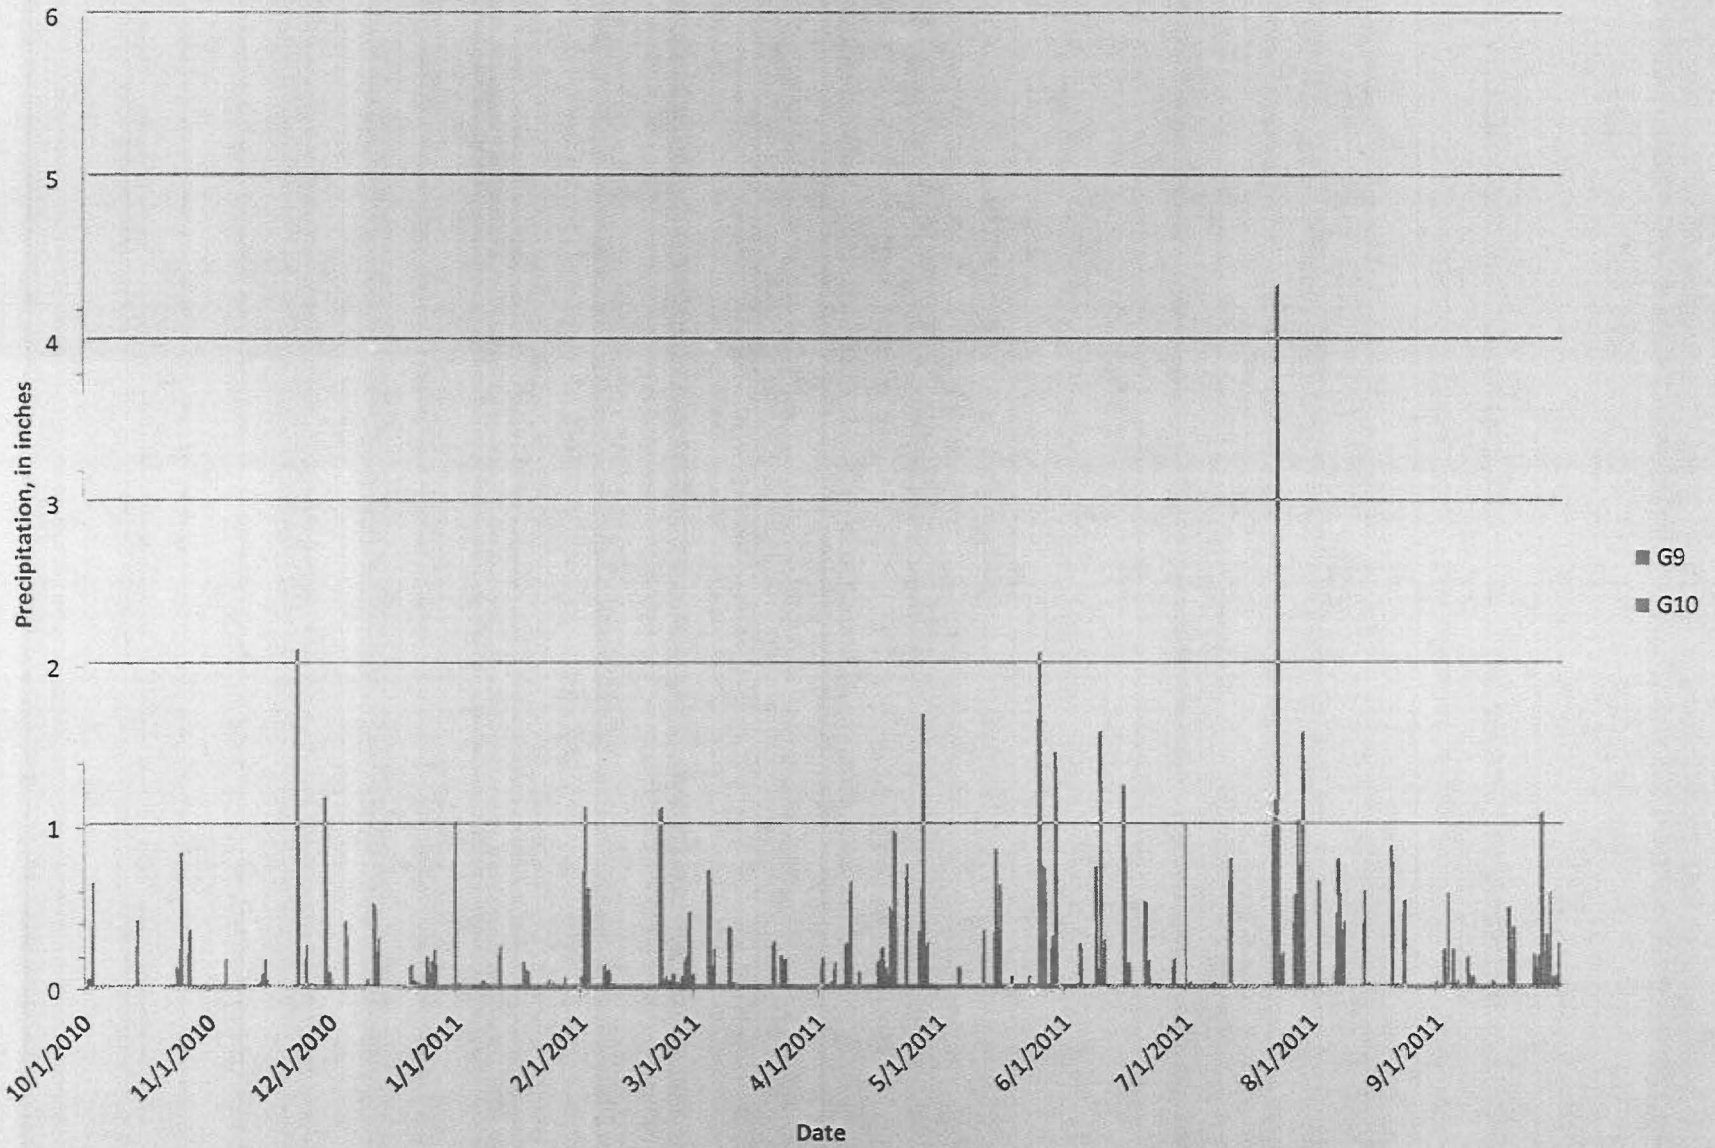
**APPENDIX A: DAILY TOTAL PRECIPITATION FROM THE ILLINOIS STATE WATER  
SURVEY COOK COUNTY PRECIPITATION NETWORK GAGES G9 AND G10 LOCATED  
IN THE VICINITY OF STREETScape PROJECT CORRIDOR FROM 2008 TO 2015.**

# Daily Total Precipitation
