Water Environment Research Foundation
Collaboration. Innovation. Results.

Methods for Cost-Effective Rehabilitation of Private Lateral Sewers

02-CTS-5

2006

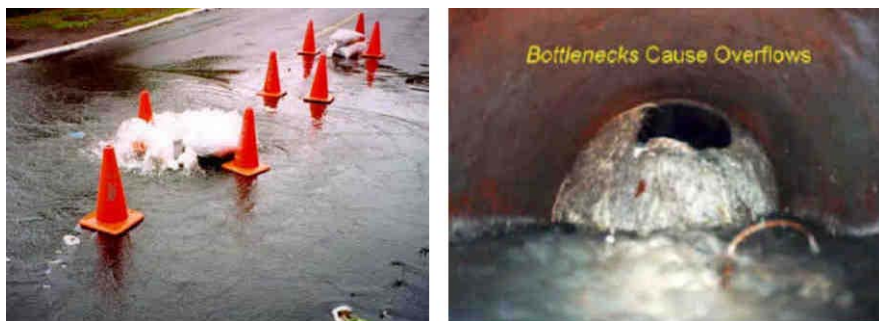
Figure 1-1. Left: SSO at the Manhole. Right: Partial Pipe Blockage (ADS Services).

A sanitary sewer overflow (SSO) is a wastewater discharge from a sanitary sewer on land or public area before the WWTP. It occurs through manholes (Figure 1-1, Left) and lift stations, and deteriorated pipes throughout the system. Sewer basement backups and flooding of homes with sewage are also SSOs, as is an emergency sewer bypass used at a WWTP.

Occasional SSOs occur in almost every system and the U.S. EPA estimates between 23,000 and 75,000 events occur annually. SSO events can be related to either bringing too much water into the collection system through I/I or to “bottlenecks” in the system (partial or complete pipe blockages caused by tree roots, sediments and debris, grease buildup, foreign objects, pipe structural failure and collapse) that can cause overflows during both dry and wet weather (Figure 1-1, Right).

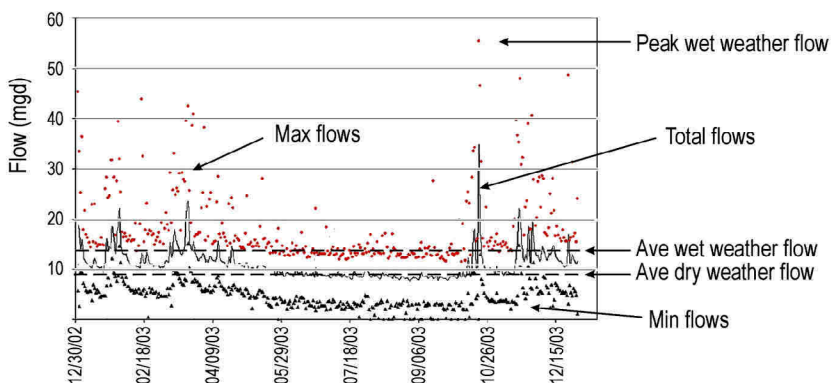
Figure 1-3. Treatment Plant Flow Example.

An example of hydraulic overloading of a WWTP is shown in Figure 1-3. The plant in question is a regional plant that treats the flow from a collection system that is not fully separated. One portion of the system, the combined sewer in the downtown area, brings excessive inflow during rainfall storms and is accountable for the large spikes in the graph. However, the remainder of the collection system, which is a nominally separated sanitary sewer system, also exhibits significant RDI/I (Lu, 2005).

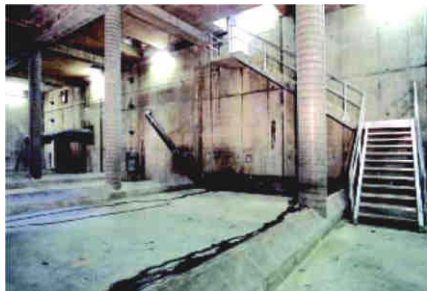
Figure 1-4. Peak Flow Storage Facility (Victoria, B.C., Canada).

An example of facility for storing peak flows is a reservoir under construction at the Marigold Pump Station in Victoria, B.C., Canada (Figure 1-4). This below-grade, reinforced concrete storage facility will provide off-line storage during peak wet-weather events. The capacity of the facility is 5,000 m³ (1.3 mg).

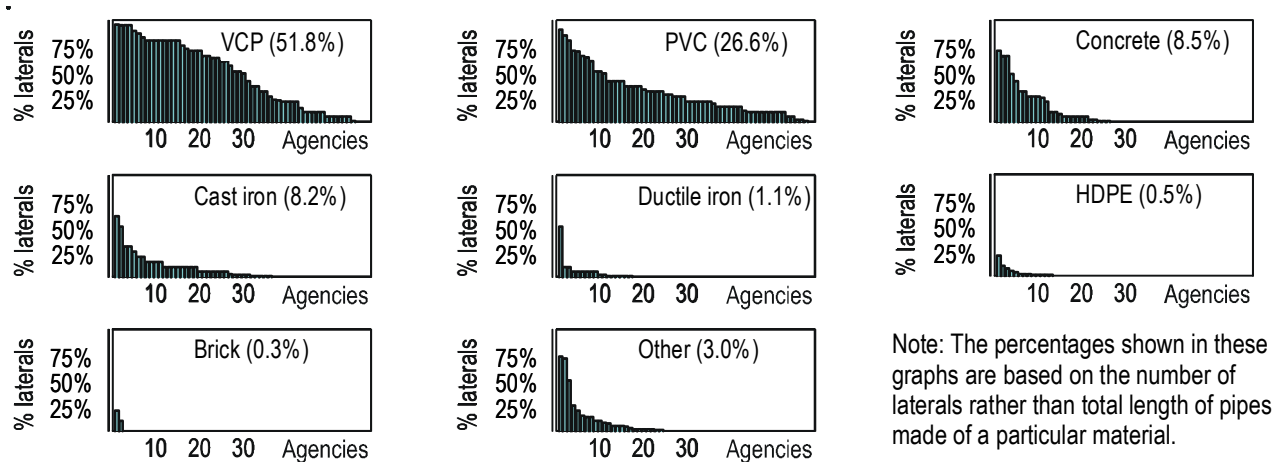
Figure 2-7. Allocation of Different Pipe Types within the Participating Agencies.

The participating agencies reported the pipe types used for sewer laterals in their systems (Figure 2-6 and Figure 2-7). Most private sewer laterals were reported to be VCP pipes (51.8%),

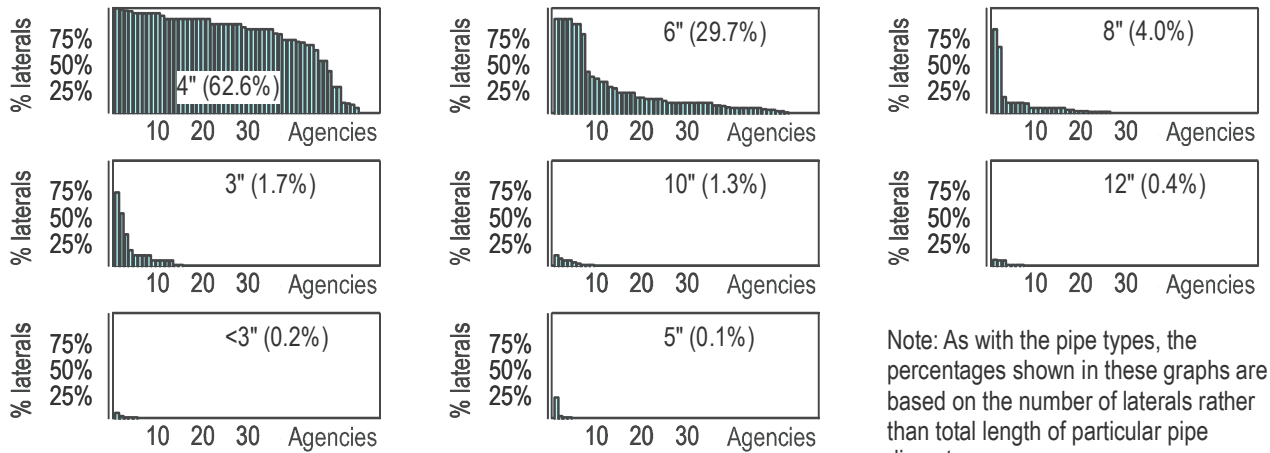
Figure 2-9. Allocation of Different Pipe Sizes within the Participating Agencies.

The participating agencies reported the pipe sizes used for sewer laterals in their systems (Figure 2-8 and Figure 2-9). Most private sewer laterals were reported to be 4” pipes (62.6%) and 6” pipes (29.7%). Smaller diameters (3” or less) and larger diameters (up to 12”) were reported in smaller quantities.

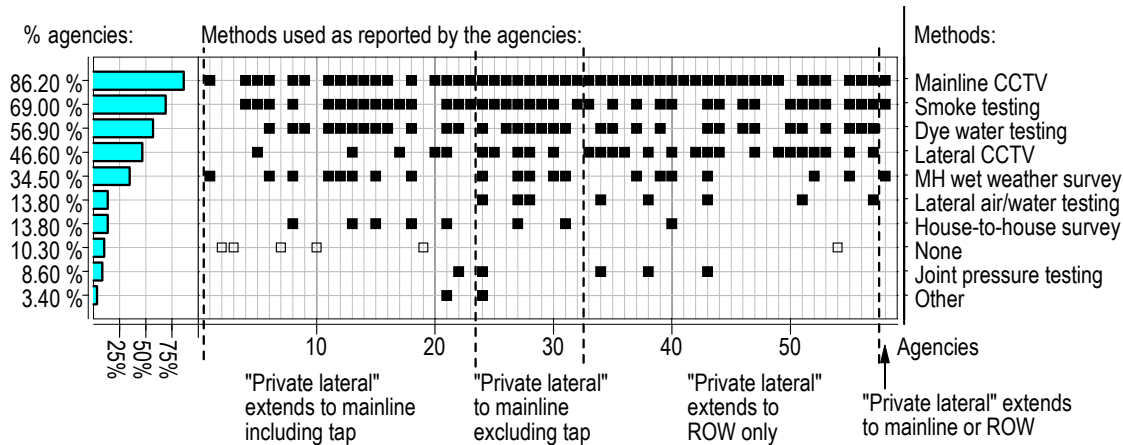
Figure 2-19. Methods for Identification of I/I Sources.

The agencies reported using various methods to identify sources of I/I on private property (Figure 2-19). The most popular method is mainline CCTV inspection, which identifies leaking lateral-to-mainline connections (86.2% of agencies), followed by smoke testing and dye water testing (69.0% and 56.9% of participating agencies respectively). “Other” reported methods include visual inspection of the basements on sale of property (one agency) and questionnaires filled in by homeowners (one agency).

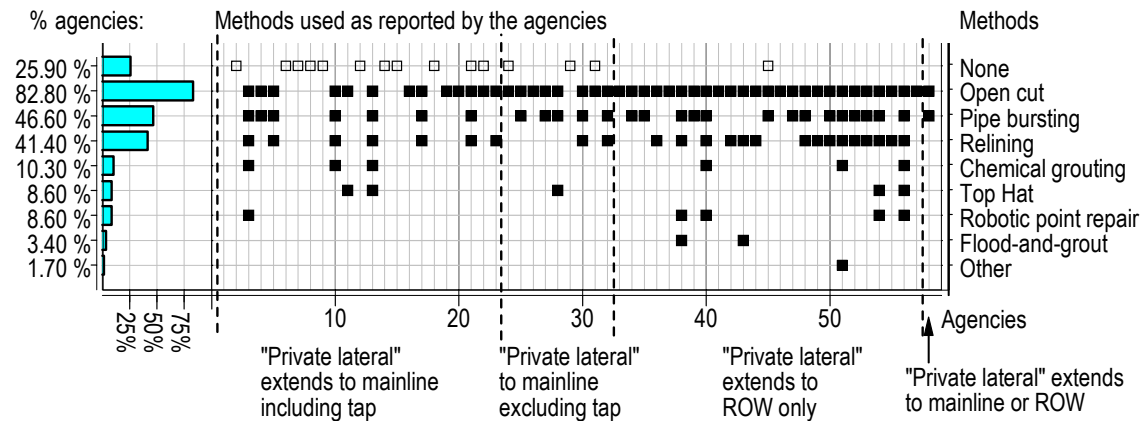
Figure 2-28. Methods for Rehabilitation of (Private/Public) Sewer Laterals.

The participating agencies reported utilizing various repair methods on sewer laterals aimed at removal of infiltration (Figure 2-28), however, their responses were not completely consistent:

A total of 82.8% of participating agencies reported using open cut replacement or open cut point repair for repairing the laterals. Pipe bursting and pipe relining were reported as the most frequently used trenchless repair methods by 46.6% and 41.4% of participating agencies

respectively. Chemical grouting was reported as used by 10.3% of participating agencies, however, this reflects the fact that this method is usually used on the publicly owned part of laterals (lateral-to-mainline connections and the first few feet up the lateral from the mainline).

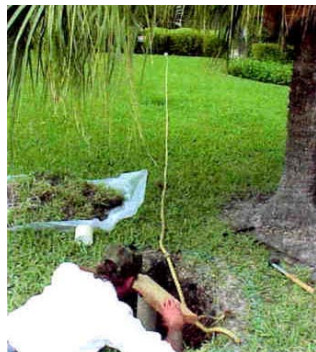
Figure 3-3. Rope Laid over the Lateral (City of Sarasota).

For the purpose of recording the location, the procedure may include laying a rope on the ground marking the path of the lateral. The rope is digitally photographed and the exact measurements relative to the property corners, trees and other objects on the property entered into the agency’s records (Figure 3-3).

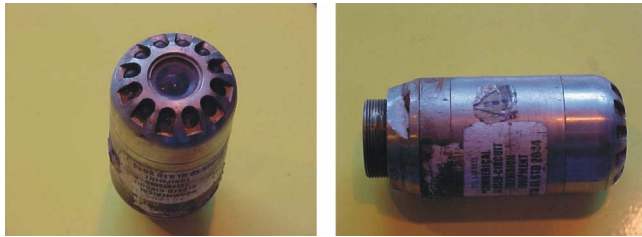
Figure 3-5. Sonde Added to a Lateral CCTV Camera (Miami-Dade County, FL).

Sonde on a Lateral Mini-CCTV Camera. A sonde can be built into a mini-CCTV camera (Figure 3-5), which is an option offered by most manufacturers of this equipment (see Table 3-4 on p.3-19). The camera can either be inserted into the lateral through the cleanout and pushed through the lateral (Figure 3-6), or launched from the mainline if the mini-CCTV camera is designed for such application.

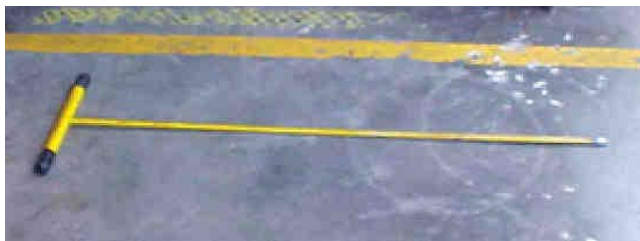
Figure 3-8. Rod Probe (Miami-Dade County, FL).

For locating of cleanouts covered with soil, a rod probe can be used (Figure 3-8). The probe shown is a 4' fiberglass probe, which is non-conductive and therefore safe for use even if an electrical wire is accidentally hit under ground.

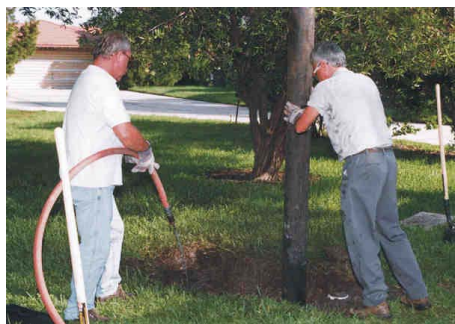
Figure 3-9. Hydro Excavating of a Cleanout Pit (City of Sarasota, FL).

In vacuum excavating (Figure 3-9), the lateral pipe can be physically exposed and its depth confirmed. If the general location of the lateral is known in advance (for example, the beginning and end point of the lateral are known from the CCTV inspection or the cleanouts are

visible and thus known), vacuum excavation can confirm the location of the lateral at some mid-points. However, vacuum excavating is most often used to install new cleanouts when needed.

This method was used, for example, with great success in Sarasota, FL, where 764 cleanouts (4" Inserta Tee) were installed as a part of a lateral pipe bursting project in 2000/01 as described in the case study in Appendix A. The soil was cut with a water jet and vacuumed out with a 6" tube connected to the vacuum truck. The pit size was about 2'×3'. It took on average 60 minutes to complete each pit. (Ray, 2005)

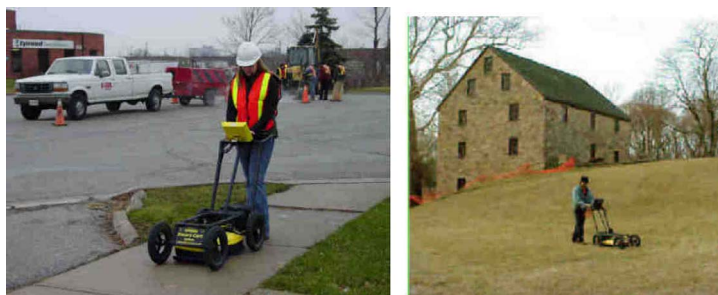
Figure 3-10. Lightweight and Compact GPR Unit (Sensors & Software Inc.).

Ground penetrating radar uses the transmission and reflection properties of an electromagnetic wave passing through the soil to accurately determine the depth and location of subsurface objects. This principle can be used to locate sewer laterals. For locating a lateral, a GPR device is moved over the surface where the lateral is expected to be located (Figure 3-10). There is no need to access the inside of the lateral and the method is therefore suitable in situations where the CCTV cannot be used because there are no accessible cleanouts or any other points of entry into the lateral.

The GPR systems (such as the Noggin SmartCart by Sensors & Software Inc. shown in Figure 3-10) start around \$19,000 for purchase. A Florida based contractor reported using GPR for the past 12 years in several Florida agencies (Orange County, Seminole Lake County, Orlando Utilities Commission, etc.) and that locating of utilities is contracted on an hourly base for approximately \$170/hr (DeMarsh, 2005). The locating is typically contracted for all subsurface utilities prior to a design project rather than for locating of sewer laterals exclusively. In one eight-hour working day, roughly 3,500-4,500' of utilities can be located on average¹⁶.

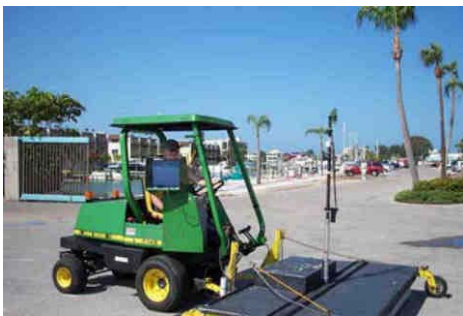
Although not designed for locating of sewer laterals, this technology can be used for their location (on a large scale) providing the surveyed area is accessible to a vehicle with a pool-table-size antennae attachment. In the system shown on Figure 3-13, a mobile array of 17 GPR antennae¹⁸ and a robotic laser tracking system is pulled over the area at speed of 2.0 mph. Large quantities of 2-D, multiple-angle imagery are collected and subsequently processed via patented software into 3-D imagery, in the form of computer video files. These “movies” can provide a virtual descent through the earth at 1” increments, showing utility lines and other features appearing at various depths. The utilities are then extracted from the movies and rendered in a CAD environment. (Lund, 2005) Tomographic GPR approaches are being pursued by manufacturers such as Witten Technologies and IDS Ingegneria Dei Sistemi S.p.A. (Italy). Information on a recent European collaborative effort on GPR research can be found at www.giga.com.

Figure 3-13. Scanning with a Mobile Array of GPR Antennae (Witten Technologies Inc).

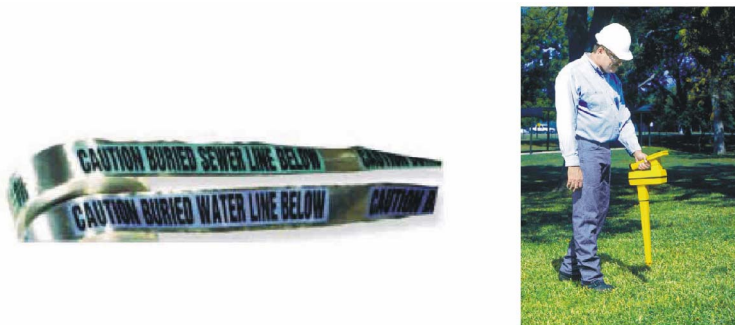
Metallic Tape. When PVC or other non-metallic pipes are being installed with an open cut, a detectable metallic underground tape can also be installed above the pipe at shallow depth (1-2’) on the entire length of the pipe. Such tape allows easy locating of pipes in the future. The magnetic tape is detected with any metallic detector (Figure 3-14) and a simple wand type detector, for example, can be used. The drawback to metallic tapes and similar conductive lines laid to mark pipe position is that they can be disturbed by future excavations resulting in loss of continuity and/or a change in position relative to the pipe beneath.

Figure 3-14. Left: Metallic Tape for Marking Laterals (USABlueBook.com). Right: Detecting the Metallic Tape Using a Wand Type Detector (www.3m.com).

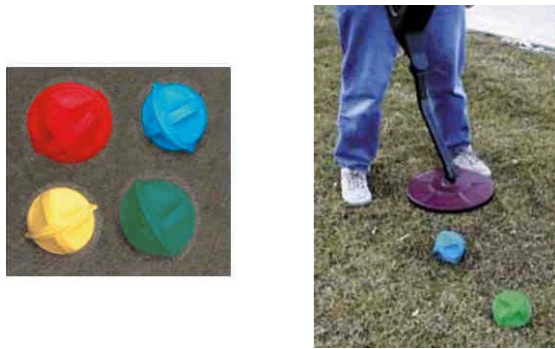
Sewer Marker Balls. Sewer marker balls (Figure 3-15—Left) can be buried next to cleanouts or at intervals along the pipe before or during backfilling. The balls have no batteries or active components, and are completely passive in the ground. However, when a signal of certain radio frequency (RF) is aimed in their direction, the balls provide a strong signal reflection. For creating the signal and detecting the signal response, special marker locators are used (Figure 3-15—Right). The peak signal response appears directly over the marker balls.

Figure 3-15. Left: Sewer Locator Balls. Right: Marker Locators for Detecting Locator Balls (USABlueBook.com).

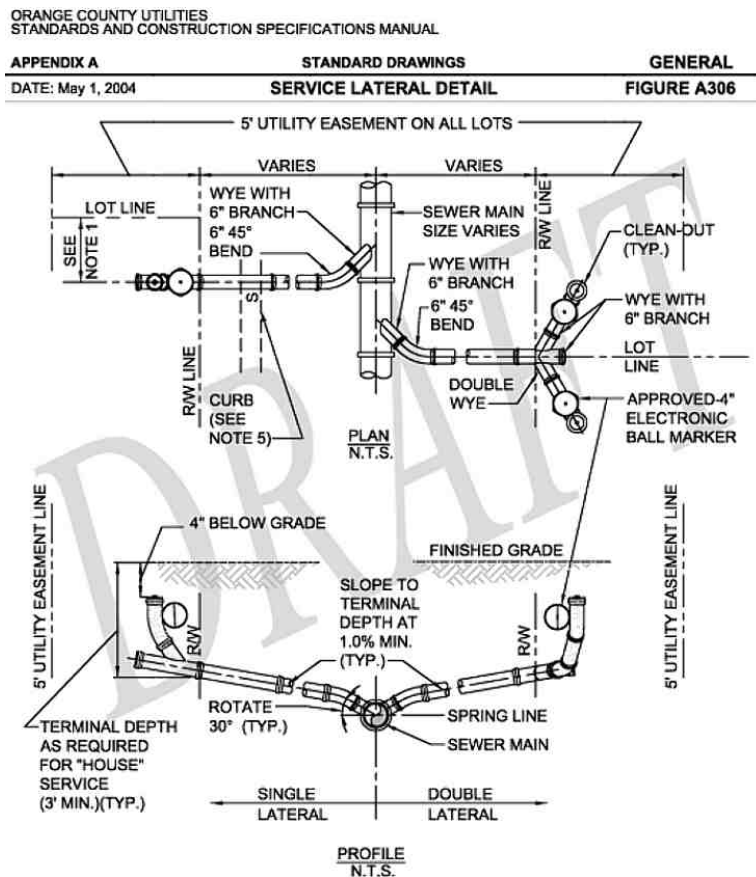
shown in Figure 3-16. The balls are positioned next to the cleanouts just below the cap. The top of cleanouts is laid 4" below the grade (Noke, 2004).

Figure 3-16. Placement of Locator Balls (Orange County, FL).

The method has been used, for example, in Orange County, FL, where a couple of other approaches were previously tried unsuccessfully. The first approach was to make a cement pad with a valve type cover over the plastic lateral cap to make it easy to locate with a metal detector and hard to destroy with a lawnmower. However, this was rejected by the community as unsightly. Next, the cleanouts were brought up to grade and an “S” cut in the curb to indicate a sewer lateral. This resulted in many calls for broken cleanout caps. The latest approach is to mark the curb with an “S” and install a locator ball at the cleanout. Positioning of the balls is

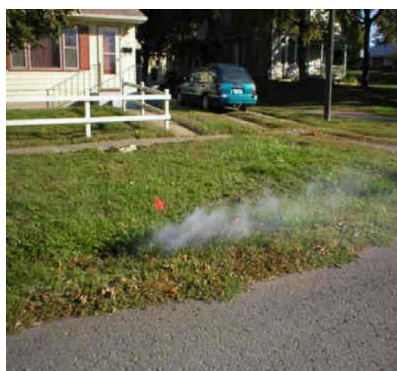
productive. The smoke surfaces through open connections and defects (Figure 3-17), and such sources are photographed and documented. An assessment of the quantity of I/I is made based on the area and type of ground cover.

Figure 3-17. Left: Smoke Testing (City of Savannah, MO).

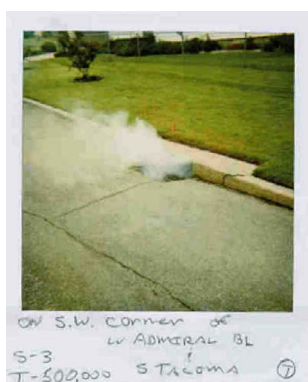
When a defect is found to be smoking, a 2"×2" orange plastic square survey flag is used to mark the defect. Each flagged defect must be photographed, whether by Polaroid camera, 35mm camera, digital camera or other device that can capture the location of the defect and the intensity of smoke so that it can be traced back at a later time for follow-up repair or removal (Figure 3-18). Photographs must show smoke coming from the defect as well as a permanent landmark such as a building, tree or power pole for reference.

Figure 3-18. Typical Field Photograph with Notations (Wade & Associates).

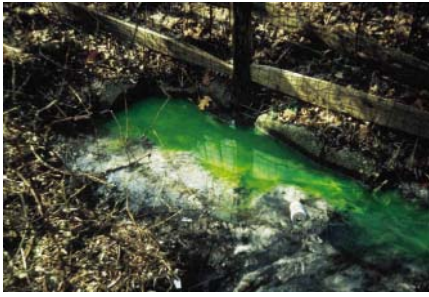
Dyed water flooding is done to determine possible sources of infiltration through the soil and lateral cracks, but can also be used to determine various inflow sources as listed in 3.2.2. The testing involves mixing a nontoxic indicator dye with water and flooding the suspect areas (Figure 3-19) or injecting the dyed water in the area of underground suspect sources. For checking suspected drain connections, the dyed water can be poured down the drain. The appearance of dye is monitored either on the CCTV camera positioned in the lateral or looking down into the cleanout. All test results should be appropriately recorded on a dye testing form. All positive dye tests should be quantified by giving consideration to the surrounding area contributing to the problem, and the amount or intensity of dye observed.

Figure 3-19. Dye Water Testing (King County, WA).

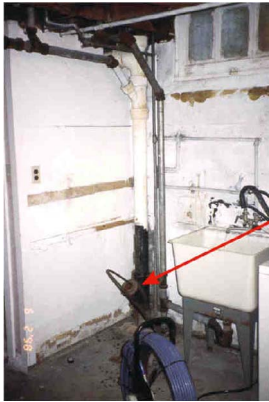
- ◆ Push-type systems mounted on a push-cable and inserted through a cleanout outside the house or a basement cleanout if the house has one (Figure 3-21). Toilet traps generally make the toilets unsuitable for insertion of the inspection equipment. If there is no suitable access point to the lateral, a small pit can be excavated, especially if rehabilitation of lateral would follow immediately after the inspection. In addition, a new cleanout is usually installed as well.

Push-type mini-CCTV camera inserted into the plumbing in the basement that leads to the lateral

Figure 3-21. Lateral CCTV Inspection from a House Basement (City of Salem, OR).

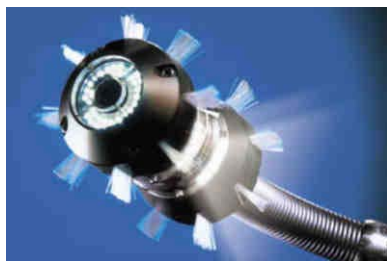
Data Collected and Output. All lateral CCTV cameras offer a forward view but some cameras also allow rotation and offer a side view (Figure 3-23).

Figure 3-23. Pearpoint's P455 Twinview Camera (Pearpoint Inc).

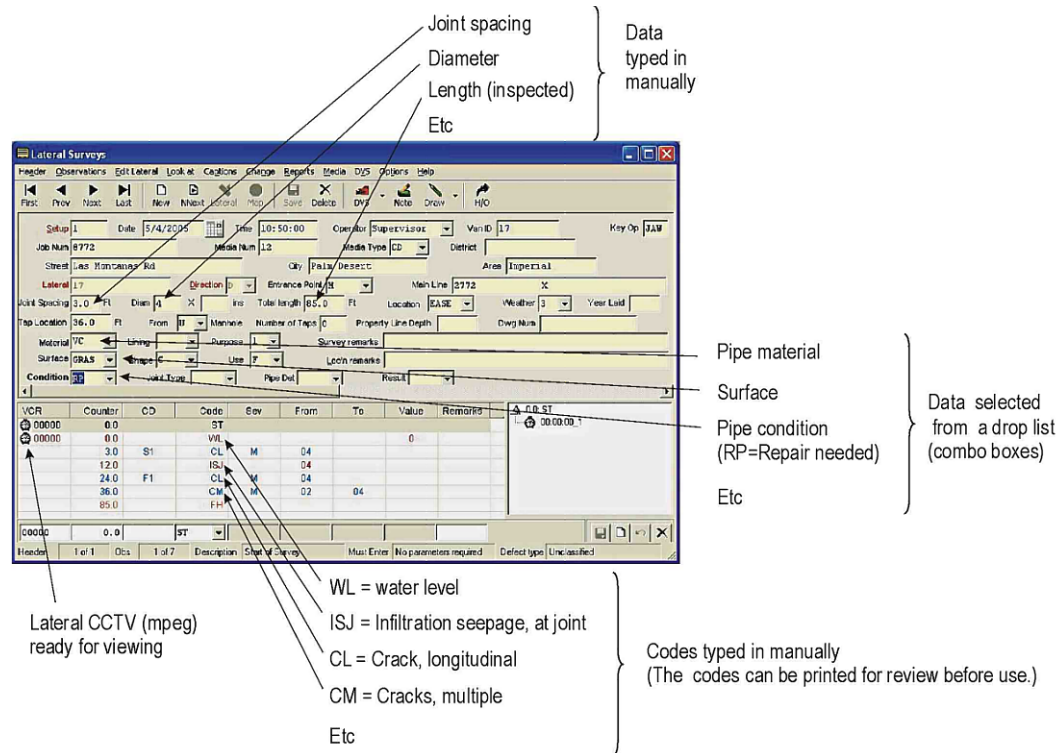
In 2004, a lateral survey form (Figure 3-25) was added to the software, as well as codes for lateral pipe inspection. The lateral survey form contains detail about a lateral survey and is available for launch from either a mainline survey form or for an individual lateral survey. The

Figure 3-25. Flexidata's Lateral Survey Form (PipeLogix Inc.).

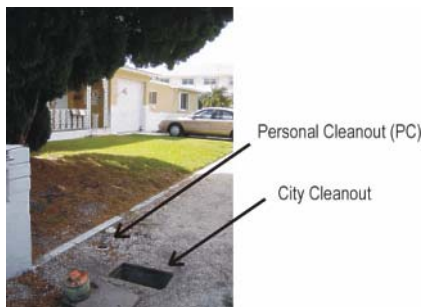
Figure 3-32. Cleanouts on the Lateral Selected for Demonstration of Water Exfiltration Testing (City of Key West, FL).

A hydrostatic pressure testing procedure to verify the leak-tightness of upper laterals developed and used in the City of Key West, FL, is described as an example. In this agency, there are usually two cleanouts on the lateral: one at the property line, also referred to as a “city cleanout” (CC) and the other, often near the house referred to as a “personal cleanout” (PC). Having both cleanouts at a very close distance apart, as shown in Figure 3-32, is a rather atypical situation. However, this lateral was selected for a demonstration of the testing procedure to avoid entering private property.

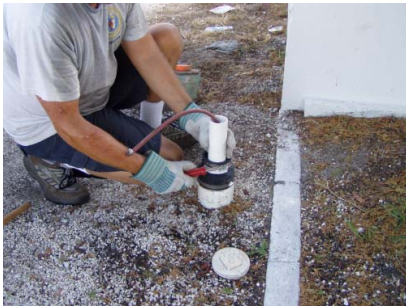
Figure 3-33. Stack over the Cleanout (City of Key West, FL).

To fill the plugged section with water and create the required hydrostatic pressure, a stack is mounted over the cleanout (Figure 3-33). For this purpose, a short PVC pipe is used, which is an extension of the cleanout to the required height. It should extend no further than to the house floor level to prevent any damage to the house. A dye is added to the water and, for the duration of filling the section with water, the city cleanout is observed for any trace of dye, which would indicate improper plugging. After the stack is completely filled, the water level in it is monitored for 30 minutes (Figure 3-34).

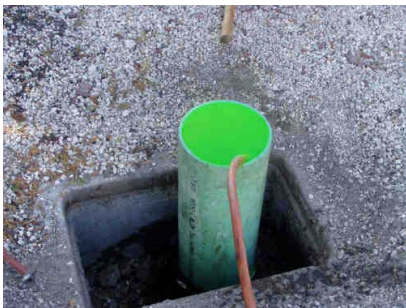
Figure 3-34. Dyed Water in the Stack Monitored for Any Level Drop (City of Key West, FL).

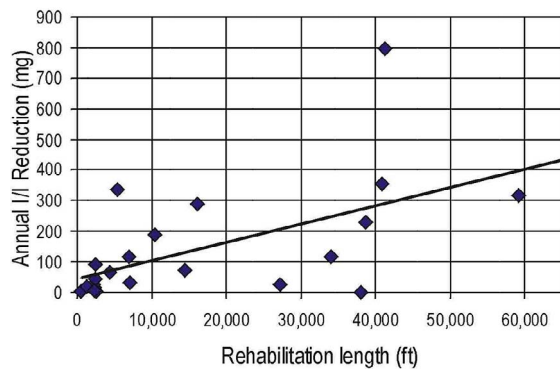
Figure 4-16. Sewer Rehabilitation Effectiveness Data and Regression Line (Nashville and Davidson County).

Sewer Rehabilitation Effectiveness Databases. Even when the rehabilitation projects involve mixed mainline and lateral rehabilitation, and the effectiveness of lateral rehabilitation can't be determined per se, it is valuable for the agency to determine the achieved effectiveness in the projects completed over time and maintain its own sewer rehabilitation effectiveness database. Such a database exposes whether the applied lateral rehabilitation design strategy works or not. For illustration, a database of completed projects created in Nashville, TN, stores the record of rehabilitated mainline length and rehabilitated number of laterals per project, and the annual reduction in RDI/I in mg (Table 4-5, Figure 4-16). The linear regression line in Figure 4-16 indicates the trend in annual I/I reduction from rehabilitation projects which is very useful for planning and decision making.

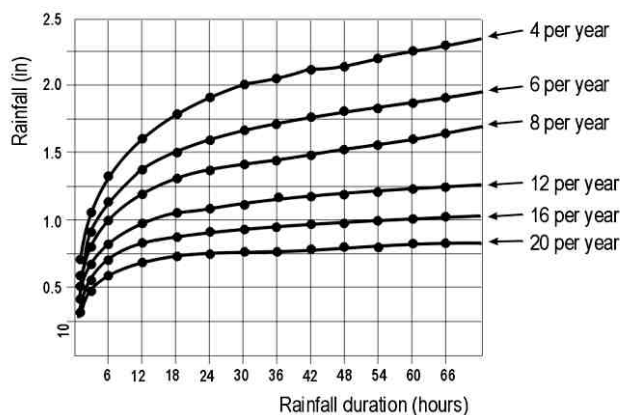
Figure 4-20. Rainfall Depth/Duration for Return Frequencies of Less Than One Year (Dillard et al., 1993).

intensity/duration/frequency curves can be obtained only for return intervals of one year or longer. The analysis determined maximum rainfall events that on average happen four times a year, eight times a year, etc. as shown in Figure 4-20 (Dillard et al., 1993).

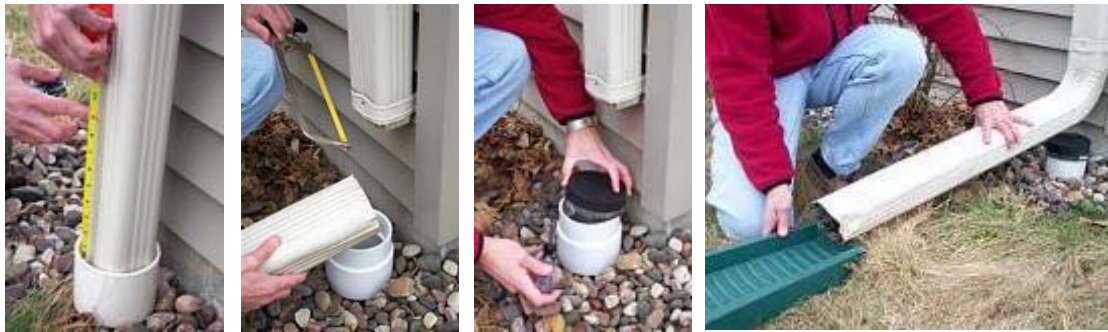
Figure 5-1. Downspout Disconnection (Milwaukee Metropolitan Sewerage District, WI).

Basic Disconnecting Procedure. A distance of 9” is measured from where the downspout enters the sewer connection and the downspout is cut with a hacksaw. The sewer standpipe is capped—a simple rubber cap secured by hose clamp can be used in most cases or a wing-nut test plug if available cap sizes don’t fit. (Figure 5-1). The downspout is next inserted into an elbow and a downspout pipe extension is attached to carry water away from the house and foundation. A splash block can be placed at the end of the downspout to prevent erosion where the water exits the pipe extension.

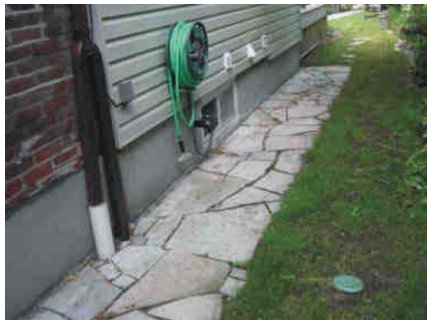
Figure 5-2. Bubbler Pot (City of Toronto, Canada).

Surface Discharge of Rainwater. The water discharged on the surface should drain away from the house foundations. Optionally, a bubbler pot can be installed to discharge the rainwater further away from the foundation. The bubbler pot is made of PVC and about 8” in diameter, and is buried in the lawn approximately 8-10’ from the foundation (Figure 5-2). As the water fills up in the pot, the lid rises up to let the water evenly overflow onto the lawn. Drainage slots in the pot let standing water filter down into the ground. The cost of a bubbler pot kit (excluding a PVC pipe and an elbow) is about \$20.

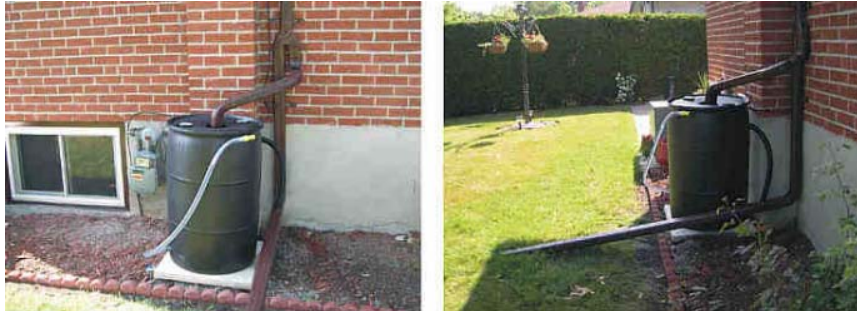
Figure 5-3. Rain Barrel Set-up for a Residential Property (City of Toronto, Canada).

One rain barrel is placed under each disconnected downspout (Figure 5-3). Optionally, a hose is attached to the spigot and/or to the overflow hole near the top of barrel, and the overflow is directed into the yard. The method is best suited for downspouts close to the plants and garden watered, where any overflow from the barrel would soak into the yard, and not a neighbor’s property. The surface on which to place the barrel would preferably be pervious (e.g. landscaped) to allow the overflow to soak into the ground. If placed on an impervious surface (e.g. a paved area), a hose is typically used to direct water to a garden area.

The most effective barrels are those that have a continuous slow discharge to a garden area. However, the performance of rain barrels in reducing runoff from a storm depends on the attention from the homeowners—who need to make sure that the barrel is drained and empty when the rain starts. For illustration purposes, a 60-gallon barrel (about 230 liters) will be filled with rainwater from 1" (2.5 mm) of rainfall on a 1,000 SF roof area. It will water about 240 SF of garden space (10'×24').

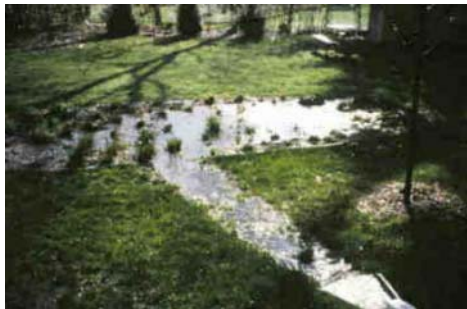
Figure 5-4. Rain Garden (Wisconsin Department of Natural Resources).

Rain Gardens. A flow from a downspout can also be directed to a rain garden³³, which is a shallow, man-made depression planted with deep-rooted native flowers and grasses and positioned in the vicinity of the downspout (Figure 5-4). Rain gardens hold the water for a short period of time and then allow the water to naturally infiltrate back into the ground.

A separate rain garden is preferably made for each downspout if there is available space on the property. The recommended size of the garden is roughly 20% of the area drained (roof area drained by the downspout) for sandy soils and 40-60% of the area drained for clays. Typically the size is between 150 SF and 400 SF. The cost of rain gardens ranges from about \$3-4/SF for “do-it-yourself” projects to about \$10-12/SF for projects completed by qualified landscapers (see, for example, Rain Garden Network, www.raingardennetwork.com). (Cubberly, 2005)

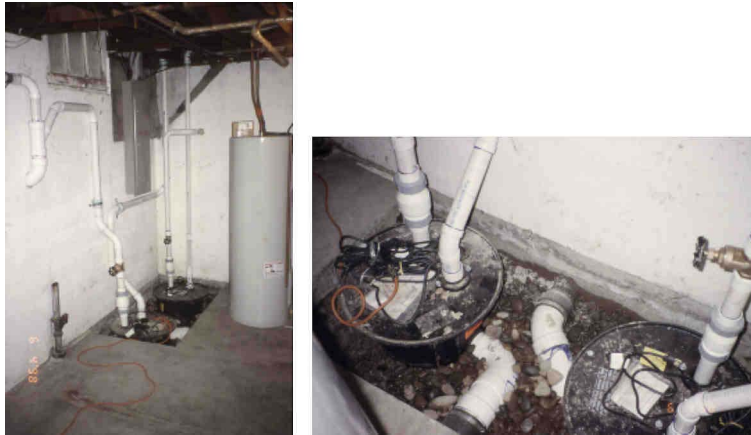
Figure 5-9. Left: Ejector Pumps Installed in the Basement. Right: A Closer View (City of Salem, OR).

Option B involves building of a new lateral and installation of a new ejector pump to pump sewage from the basement area into the new lateral (Figure 5-9). The interior plumbing is accordingly modified. Under this option, footing drains must be re-directed to a sump pump unless they can be drained by gravity to the storm drain system. If not, there is the possibility that groundwater may enter the basement. This option is more expensive than the previous one (approximately \$10,000–12,000 per home) but allows the basement to be used under any surcharging conditions and is more appropriate for homes that have a bathroom in the basement or plan to construct one in the future. The experience in Salem over the years has shown that this alternative provides a lower risk of failure. Ejector pumps have been used in thousands of installations and have proven reliability. Once the sump and ejector pump systems are installed, the homeowner is responsible for all maintenance.

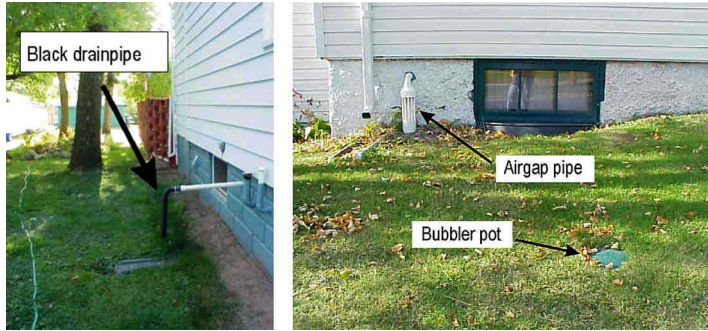
Figure 5-10. Surface Discharge of Disconnected Flow. Left: Black Drainpipe. Right: Bubbler Pot (City of Duluth, MN).

uninterrupted pumping but will not eliminate the icing issue for homes that have a lot of water to dispose of during the winter months (Figure 5-10). A bubbler pot is an alternative that allows discharge a little further away from the foundation.

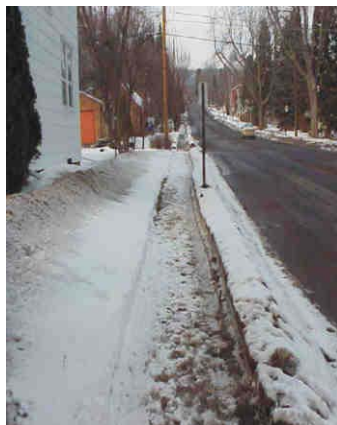
Figure 5-12. Icing behind Curb Drains (City of Duluth, MN).

A discharge pipe from the sump pump can also connect to an underground drainpipe laid from a basement wall to a catch basin in a ditch or to a curb where a hole is drilled to allow discharging the sump pump water into the drainage channel of the curb (Figure 5-11). An underground drainpipe is especially helpful in cold climates as it prevents the possible collecting and icing of water on the property (Figure 5-12).

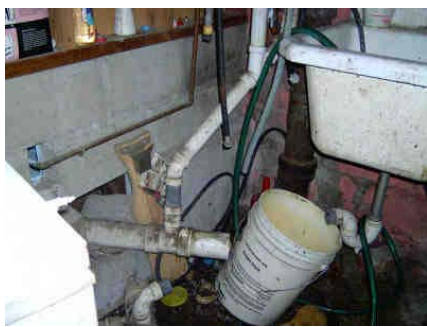
Figure 5-17. Cleanout in the Basement (City of Weymouth, MA).

Requirement for Excavation. The only time excavation is required is if a cleanout needs to be installed. Cleanouts on the laterals are basically always required even if the liner is installed remotely from the mainline, if not for insertion of liners then to prepare the pipe for relining i.e. for cleaning the pipe. The cleanouts used prior to or during CIP relining are most often located outside the house although sometimes cleanouts in basements can be used as well (Figure 5-17).

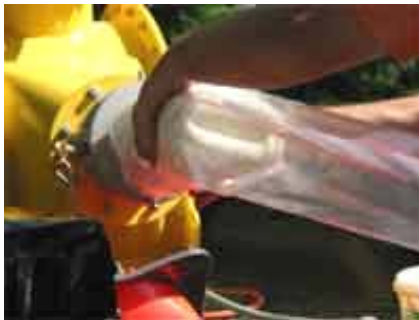
Figure 5-18. Inversion of Preliner (Link Pipe, Inc.).

If there are active leaks in the lateral before the liner inversion, many lining systems overcome them by using a preliner, which is a fiber-reinforced plastic tube that acts as a water barrier between the liner and the host pipe. The preliner is inverted into the pipe first, and the CIP liner is inverted inside the preliner next using the same inversion equipment (Figure 5-18). Thus, the preliner becomes an integral part of the CIP liner after the rehabilitation is complete. The liner is inverted into the preliner preventing water from diluting the resin in the liner material. There are other alternatives for dealing with heavy leaks as well. If the leak is under significant head pressure, it can be grouted using a packer and a chemical grout. One system recommends the use of a drain repair sleeve if the pipe is structurally damaged or infiltrating (Figure 5-19). The sleeve can be passed through three or more 90° elbows and is very easily passed through cleanouts.

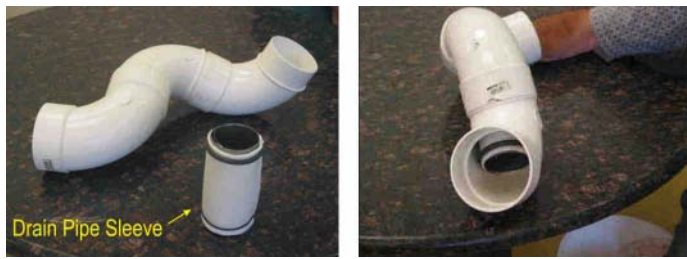
Figure 5-19. Drain Repair Sleeve Next to and Passing through 90° Elbows (Link Pipe Inc.).

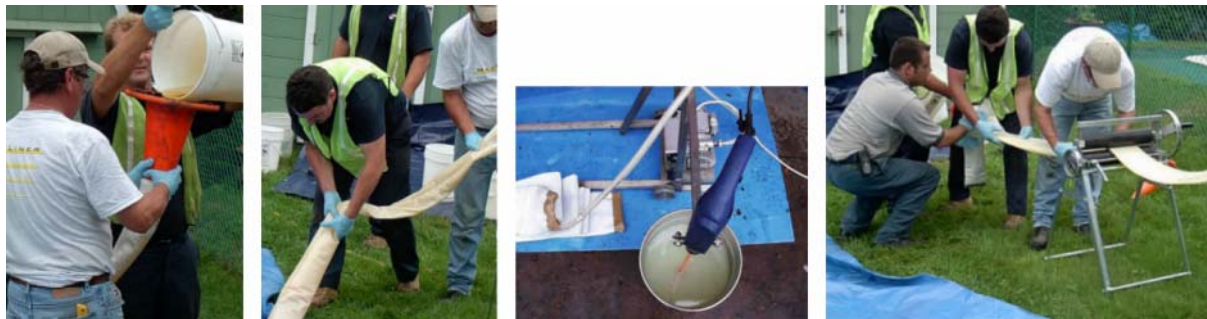
Figure 5-20. Resin Impregnating. Left to Right: Pouring the Resin into the Tube; Manual Resin Spreading Inside the Tube (MaxLiner LCC). Vacuum Impregnation (Easy Liner, Inc.); Calibration Rollers (MaxLiner LCC).

Resin mixing and impregnating—Most CIP systems have a liner that is vacuum impregnated with the resin on the site (Figure 5-20). The liner tube is cut to fit the length of the lateral and all air from the liner tube is removed with the vacuum pump. The resin is prepared by thoroughly mixing the components (a drill with a mixer attachment can be used) and the mixture poured into the liner tube. The vacuum pump is used to spread the resin along the liner tube. For even distribution of the resin in the liner tube, calibration rollers set to match the liner wall thickness are usually used. An alternative is to roll a pipe or other roller along the liner to disperse the resin as evenly as possible. During hot weather, if thermo-setting resin is used, the liner may need to be placed in cold water with ice after the wet-out is complete to slow the curing of the resin and allow the installation crew extra time before the inversion.

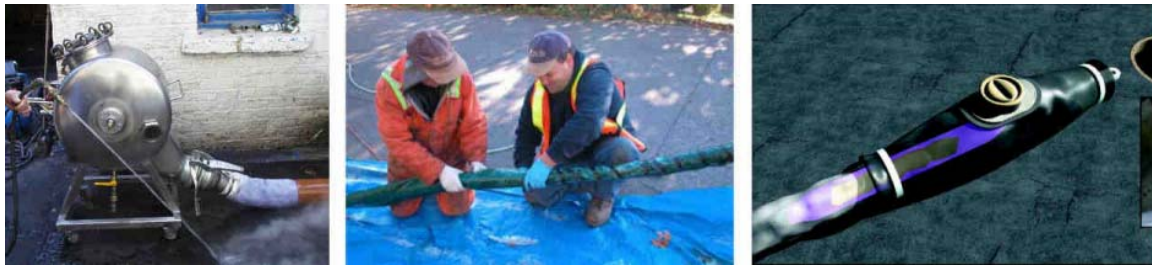
Figure 5-21. Left: Inversion Drum (Easy Liner Inc). Middle: Preparation for Insertion by Winching (Mar-Tech Underground Services Ltd). Right: Device for Inversion of Long Connection Liner (MasterLiner Inc).

Inversion/winchng of the resin-impregnated liner into the lateral pipe—For inverting the resin-saturated liner through a cleanout or a small pit, an inversion drum is usually used. The liner is loaded into the drum and from it inverted into the lateral pipe (Figure 5-21—Left). The inversion drum may have a bladder that extends out of the drum and “swallows” the liner inside the bladder, which is followed by inverting both the liner and the bladder into the pipe (Figure 5-22). However, if the liner is installed by winching, a bladder is inserted into the resin-saturated liner and the liner fixed onto the bladder firmly with tape (Figure 5-21-Middle). This creates an integral bladder/liner assembly, which is carried to the entry pit and from there pulled inside the pipe.

For inverting the resin-saturated liner remotely from a mainline, a special inversion device is used (Figure 5-21—Right). Generally speaking, the liner is loaded into the device above the ground, the device winched through the mainline and positioned at the lateral connection, and the liner is inverted from the device into the lateral. The procedure is performed in two phases, each phase involving four steps as follows (Figure 5-23):

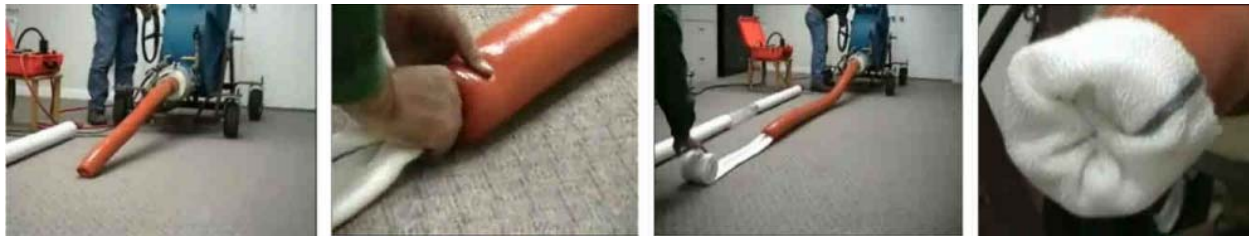
Figure 5-22. Loading of Inversion Drum with Bladder. Left: Extending the Bladder Out from the Drum. Middle Two: Feeding the Liner into the Bladder and Retrieving the Bladder inside the Drum. Right: Liner End Clamped to Invert “Inside-out” (Verline, Inc).

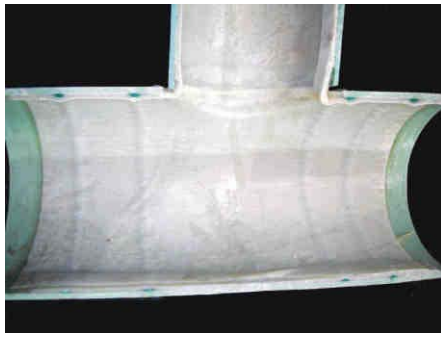
Figure 5-28. T-Liner® Installed—Cut Away Showing the 16” Mainline Seal and Hydrophilic Bands (LMK Enterprises Inc).

T-liners are intended to further protect against the infiltration at this location. They have a full-circle mainline seal factory welded to a lateral liner to become a one-piece liner. They may bond with the host pipe and/or mainline CIP liner, however they do not rely on the bonding, as the liner can stand by itself in the pipe. For sealing in the absence of a complete bond, hydrophilic rubber bands that fit between the mainline liner and the short mainline portion of the T-liner can be used (Figure 5-28). Two bands are installed on each side of the connection. These hydrophilic bands are designed to swell in the presence of water up to eight times their original thickness. This swelling action provides equal force around the entire circumference of the mainline liner. The key to water-tightness is the fact that adhesion is not a factor—the bands will make a seal to any type of material including polyethylene as well as greasy surfaces typically found in any collection system.

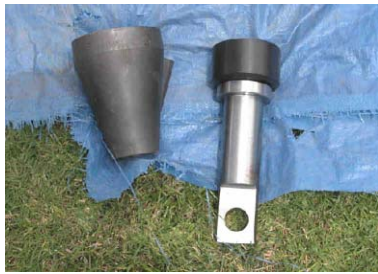
Figure 5-30. Pipe Splitting Head with Band Cutting Blade, and Clevis Head with PE End Cap (Tric Technologies Inc).

- ◆ **Static pull**—This type of bursting uses a bursting head that has no moving internal parts. The head is simply pulled through the old pipe by a heavy-duty pulling device. For replacing ductile pipes (lead, galvanized iron, cast iron, etc.), a pipe splitting head is used (Figure 5-30). This is a variation of the static pull head, with blades that slice through the pipe and split the pipe open rather than burst it into fragments as the head is pulled through the pipe.

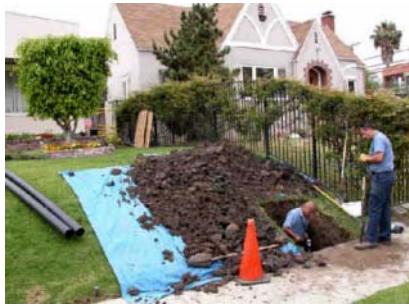
Figure 5-31. Roughly 40' under the Sloping Front Lawn—Suitable for Pipe Bursting (Tric Trenchless Inc).

Typical lengths in lateral replacement are between 20' and 200', although longer lengths can be carried out. In that sense, the length is not a limitation in applicability. However, pipe bursting is often considered unsuitable for short replacements, e.g. replacement of lower laterals only, because the pits are required at close distances (the neighborhood may look like a Swiss cheese) and it is easier to simply open-cut replace the pipe. In some situations, even a relatively short trench would produce a lot of dirt and is suitable for pipe bursting (Figure 5-31).

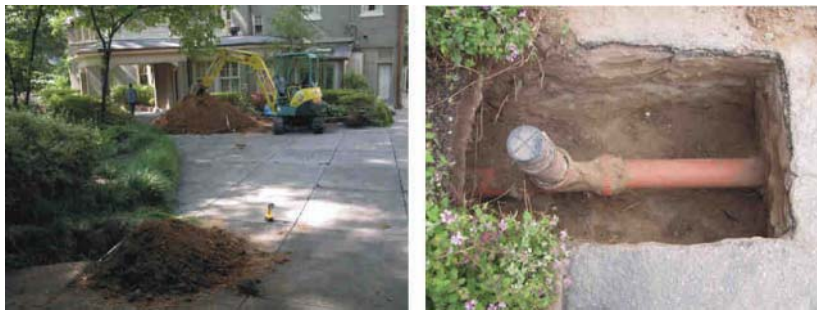
Figure 5-32. Excavating for Lateral Pipe Bursting. Left: Pits Can Be Deep (Roughly 8' Near the House). Right: Shallow Pulling Pit—Approx 2'×4' (Tric Trenchless Inc).

Requirement for Excavation. Each replacement setup requires excavation of two small pits, for example 4'×4', however the pits can be smaller or larger (Figure 5-32). The pit sizes depend mostly on depth of lateral. Depth of pits should be about 1' below the invert of the lateral. The pits are usually located outside the house but the pulling pit can also be inside the house, which allows replacement of the pipe under the foundation as well.

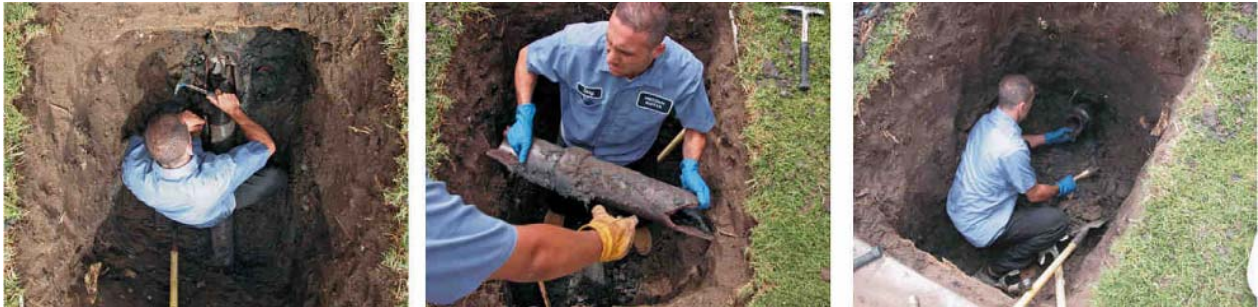
Figure 5-33. Pulling Pit Preparation. Left: Breaking Old Pipe. Middle: Clearing the Way. Right: Remove All Protruding Pipe from the Pulling Wall (Tric Trenchless Inc).

The pulling pit must have the pulling wall (the wall facing the lateral to be replaced) as vertical as possible and all protruding pipe from the wall removed (Figure 5-33). The downstream pipe can be plugged if necessary. The insertion (entry) pit must enable unobstructed entry for the replacement pipe and as even a grade as possible. Note: Most figures in this paragraph are Tric Trenchless, Inc. A case study from West Vancouver in Appendix A provides additional details of how this method can be applied using the equipment from TT Technologies.

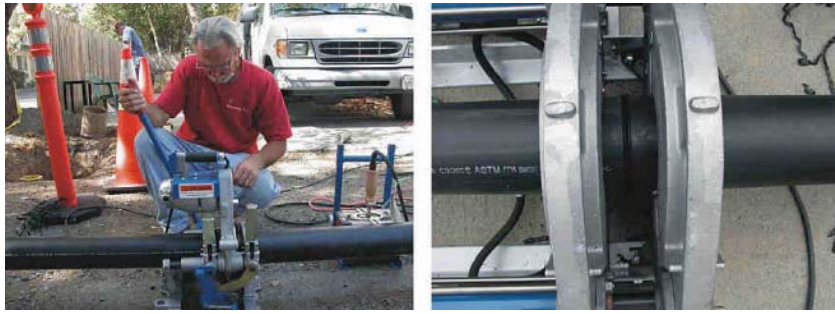
Figure 5-34. Pipe Fusing. Left: Cutting Pipe in the Jig. Right: Heated Pipe Ends Pressed Together (Tric Trenchless Inc).

While the pits are being excavated, the HDPE pipe that comes in 20' and 40' lengths is butt fused to the required length (Figure 5-34). The fusion at about 500°F takes only a short time. First the pipe ends are cut and heated until melting, then the heater is removed and pipe ends pressed together applying steady and even force until the pipe ends are fused together and the melted material rolls back to form a complete rounded “bead” on either side of the joint. The pipe is left undisturbed until just warm, or about 8–10 minutes. Bead reaming is used to clear out the pipe interior bead where the section was fused together (Figure 5-35) although not all agencies require this step.

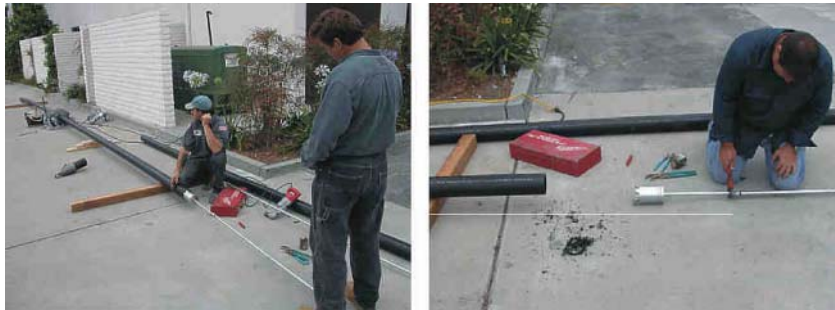
Figure 5-35. Bead Reaming. Left: Bead Reamer Aligned with the Pipe. Right: Shaved Bead Removed by Reamer Blade (Tric Trenchless Inc).

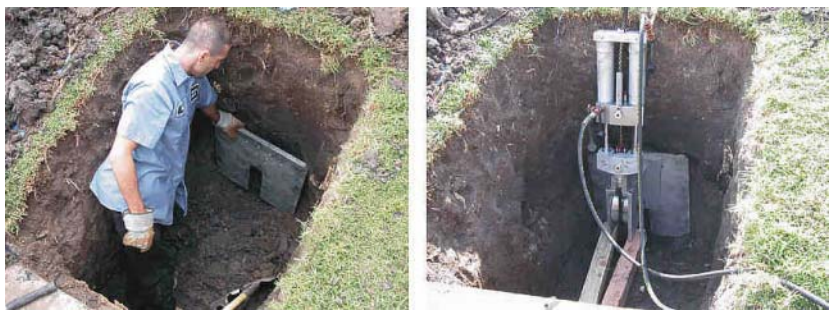
Figure 5-36. Pulling Pit. Left: Placing the Bearing Plate. Right: Pulley and Ram (Tric Trenchless Inc).

A winch (pulley) is placed inside the exit pit and braced with a vertical bearing plate behind it to spread the load on the soil (Figure 5-36). The pulling cable is strung through the lateral pipe and attached to the bursting head near the entry pit. In the case of pneumatic bursting, the head is attached to an air compressor. The head is next pulled through the lateral, pulling the replacement pipe with it (Figure 5-37). A little extra length of pipe is left to extend beyond the pit on both ends. The bursting tool is next detached and the pipe cut to the correct

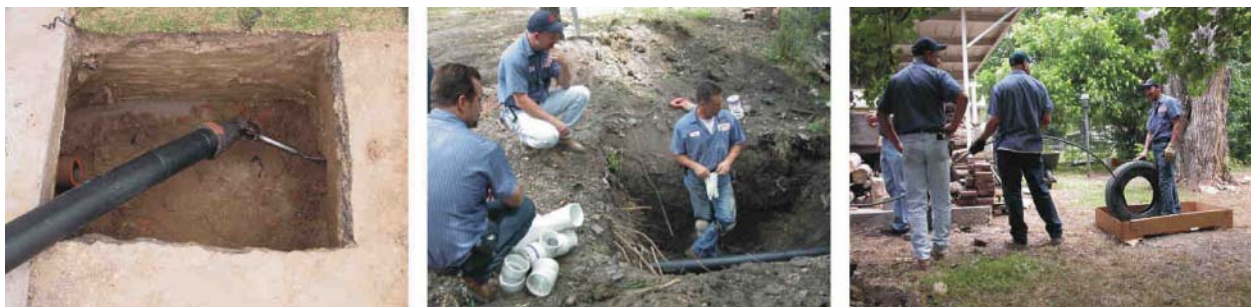
Figure 5-37. Left: Ready for the Pull. Middle: Pipe Moves Quickly. Right: Old Tire As a Container for the Cable (Tric Trenchless Inc).

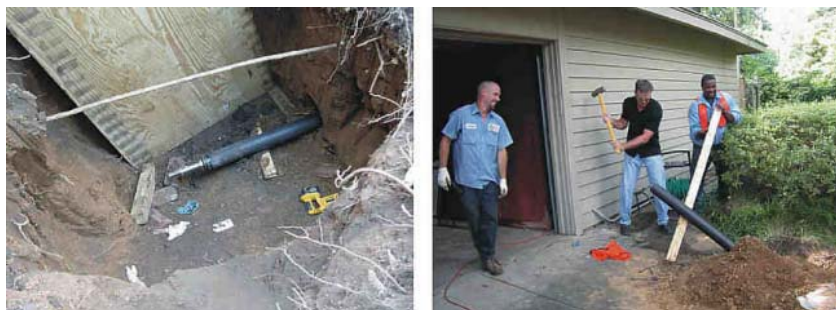
Figure 5-38. Left: Ready to Connect in the Pulling Pit. Middle: “Bumping” in the Entry Pit.

Once the replacement pipe is in place, the pipe is cut and the connections made—first at the pulling pit and then at the entry pit. This sequence allows the option of “bumping” the PE pipe with a sledge hammer in the entrance pit (where excess pipe is protruding) up to connections (Figure 5-38). The bumping is a very useful technique with the smaller pipe diameters and helps relieve any pipe stretching that may have occurred during the pull, and also assists in coupling connections (it can eliminate extra couplings). Flexible rubber couplings are usually used in combination with stainless steel shear bands (Figure 5-39). Finally, the pits are closed and the surface brought to its original state (Figure 5-40).

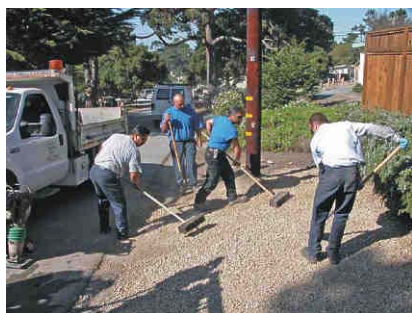
Figure 5-40. Surface Restoration (Tric Trenchless Inc).
