Water Environment Research Foundation
Collaboration. Innovation. Results.

Methods for Cost-Effective Rehabilitation of Private Lateral Sewers

02-CTS-5

2006

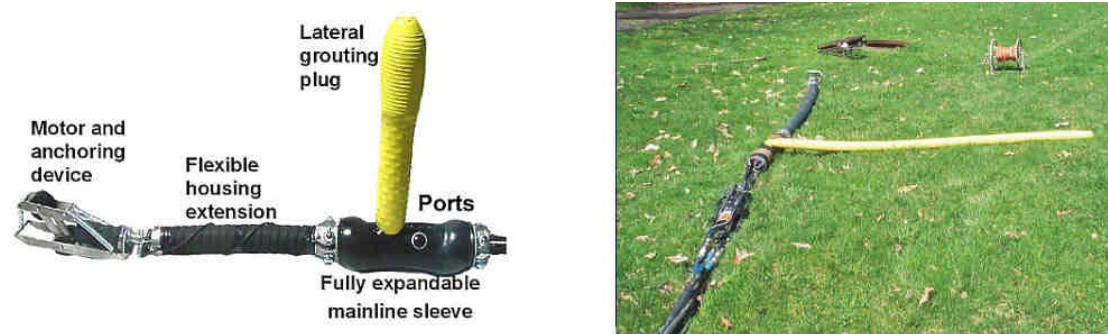
Figure 5-45. Packers Used from the Mainline. Left: Short Bladder. Right: Long Bladder—Shown Is 8' Long (American Logiball).

For test-and-seal from the mainline, special packers for this application are used (Figure 5-45). The packer is connected to a pan-and-tilt camera and a winch, and inserted into the mainline through the manhole, positioned at the lateral connection and rotated to align the lateral grouting plug with the lateral. Using air pressure, the lateral grouting plug is inverted into the lateral. Next, a mainline sleeve is inflated and the end of lateral grouting plug expanded creating an isolated T-section of the connection and the first several feet of the lateral. The air test is

performed. If the test fails, the packer remains in position and chemical grout is pressure-injected into the voids and out into the soil through the pipe or joint defects. When a satisfactory grouting pressure is obtained, the leak is sealed. After sealing, the lateral grouting plug is vacuumed back within the packer and the procedure repeated at all lateral connections along the mainline.

Bladders up to 20' long are available for grouting from the mainline, however it usually becomes rather difficult to grout lengths over 12' and this is typically the practical limit.

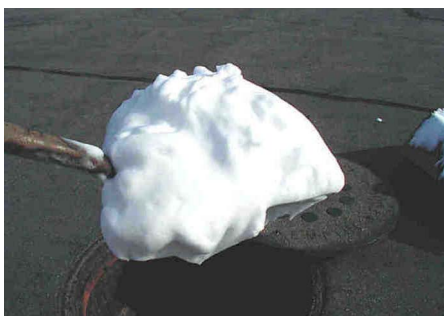
Figure 5-58. Foam Consistency (Duke’s Root Control).

Foam is the best carrying agent to deliver the root killing chemicals because foam consists of millions of small, densely compacted bubbles which trap the active ingredients in between the bubbles and hold it against the roots to provide the contact time needed for the ingredients to work effectively. The chemical with thick, shaving cream consistency (Figure 5-58) travels up the lateral completely filling the dead air space in the pipe (Figure 5-59). The sewer service is not interrupted during the treatment, and the flow will not wash the foam away for several hours. The foam will cling to the top and the sides of the pipe while the flow passes safely underneath. A minimum of one hour is needed for most successful applications, though some foams may last up to 12-15 hours. It is not always necessary to completely fill the pipe with foam to have a successful treatment. Coating the sewer with foam is reported to be enough to do the job.

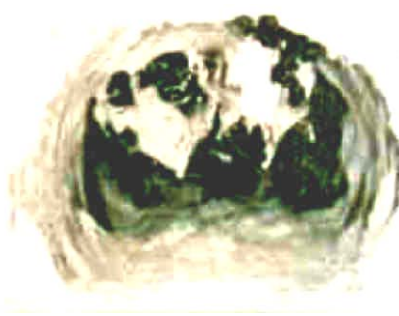
Figure 5-59. Foam in the Pipe. Left: Foam-filled Pipe. Right: Foam-coated Pipe (Duke's Root Control).

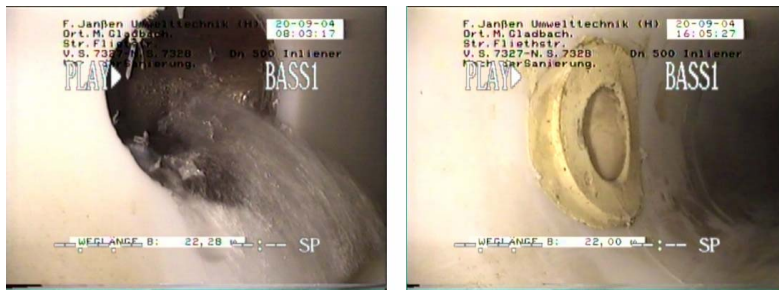
Figure 5-61. Robotic Repair Stops Infiltration. Left: Infiltration Before Repair. Right: Repaired Connection. (The Janssen Process LLC).

The method eliminates infiltration (Figure 5-61) and restores or enhances the structural integrity of pipes lost over time. Hydraulic capacity of pipes is generally not changed.

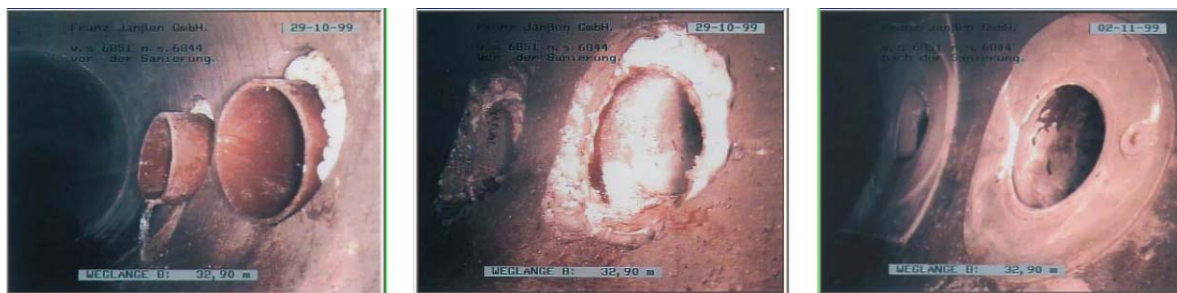
Figure 5-62. Lateral Connection Before, During and After Robotic Repair. Left: Protruding Laterals Before. Middle: The Connections After Grinding. Right: The Connection After the Resin Has Been Applied. (The Janssen Process LLC).

- ◆ Cutting off or grinding away any protruding lateral (Figure 5-62.Left)
- ◆ Grinding damaged area of pipe to cut the pipe wall thickness to a depth required to expose the virgin material of the host pipe (KA-TE grinding robot)
- ◆ Drilling holes in the pipe if the integrity of lateral-to-mainline connection is good or else grinding to completely remove the damaged piece of pipe (Janssen) (Figure 5-62.Middle)
- ◆ After completed cutting/grinding, the area is flushed with water.

Grinding/drilling is important for two reasons. With both systems, it provides a clean surface with which the subsequently applied resin can bond. Additionally, with a pressure resin injection system (e.g. Janssen), it also provides a pathway for the resin to reach the soil behind the pipe wall.

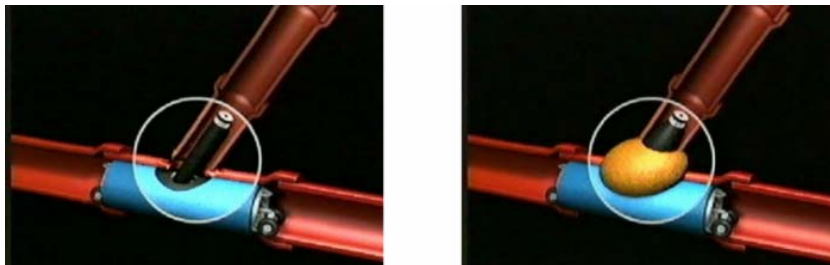
Figure 5-65. Janssen System. Left: Inflating of Bladder. Right: Resin Injection into Pipe and Surrounding Soil (The Janssen Process LLC).

The silica-based resin then is injected filling voids in the pipe and reaching further behind the pipe, where it continues filling any voids in the soil and mixing with the soil (Figure 5-65). This solidifies the soil and secures the structural integrity of the lateral and mainline pipe junction. The resin cures in about 20-30 minutes.

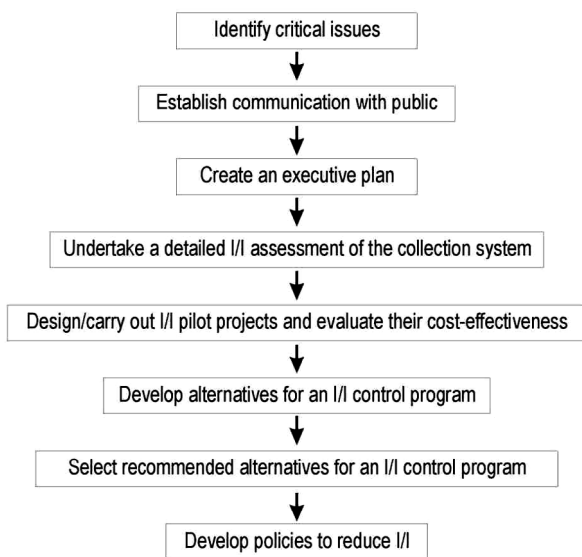
Figure 8-1. Decision Making Procedure for Developing a Long-term I/I Reduction Plan.

Rehabilitation of sewer laterals is most likely justified and necessary if laterals are responsible for significant I/I into the sewer collection systems. The agency, however, needs to make sure that the lateral rehabilitation projects are cost-beneficial and less costly than other alternatives for I/I control, and that they fit into a system-wide sanitary sewer management plan. This chapter explains the steps in a decision making procedure for developing long-term policies for reducing the I/I (Figure 8-1), in the course of which it is determined if and how the rehabilitation of sewer laterals should be carried out.

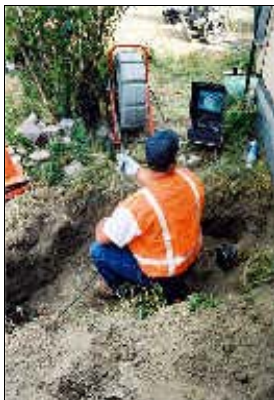
Figure A-1. Inspecting a Lateral with a CCTV Camera Prior to Lining.

After cleaning, the lateral was re-inspected with CCTV to make sure that all obstructions had been removed and the line was clean (Figure A-1). Laterals in the condition shown on Figure A-2 were often shallow.

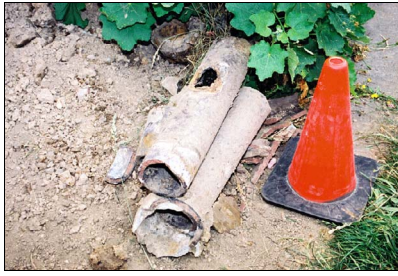
Figure A-2. Example of the Condition of Laterals that Were Relined.

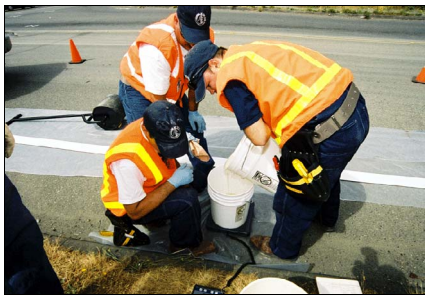
Figure A-3. Measuring the Pre-determined Amounts of Resins (Parts A and B). A Digital Scale Was Used for Accuracy.

In-Situ Liner Preparation. The two-part resin was first mixed together according to company specifications (Figure A-3). It was then poured into the precut length of liner (Figure A-4, Figure A-5) and rolled out with a 50-lb roller. (The required length had been determined during the inspection using a digital foot counter on the CCTV camera.) The liner was completely saturated with the resin and then rolled up into the air-inversion machine (Figure A-6).

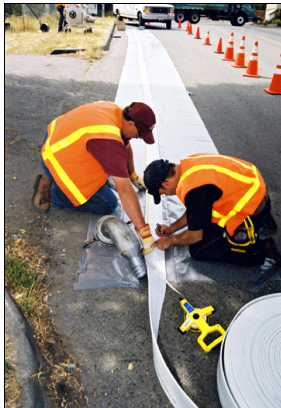
Figure A-4. Measuring the Length of Liner to Be Installed.

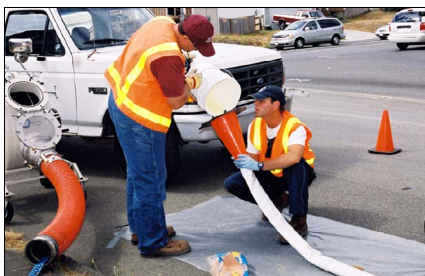
Figure A-5. Pouring the Pre-determined Amount of Resin into the Liner.

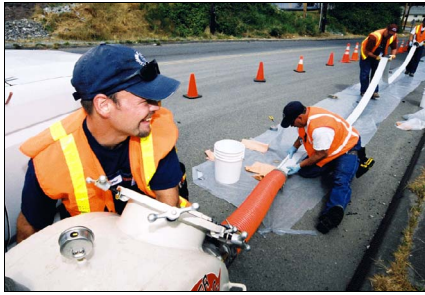
Figure A-6. The Crew Reeling the Resin-saturated Liner into the Air-inversion Machine.

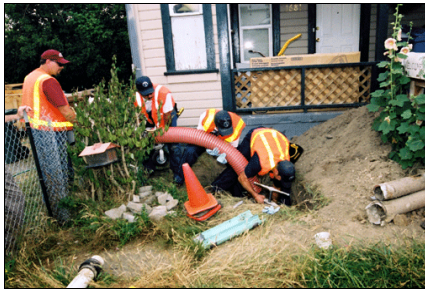
Figure A-7. The Crew Shooting the Liner into the Lateral.

Liner Inversion and Curing. The liner was inserted by air-inversion from the property line back towards the house. The air-inversion machine was lined up with the existing lateral, the air-pressure raised to 10 psi and the liner released thus unfurling into the lateral. Figure A-7 shows an “atypical” direction of relining from the house towards the property line. It was used only on a few laterals (six of 69) where the conversion point (4” to 6”) was in the street.

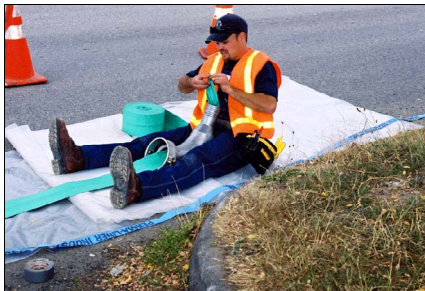
Figure A-8. Field Crew Member Preparing the Calibration Tube.

Once the liner was in the lateral, the resin curing was performed under continued air-pressure. A calibration tube (Figure A-8) was reeled into the air-inversion machine for this purpose. The air-inversion machine was again lined up with the lateral and the calibration tube shot into the lateral. Then, the calibration tube was clamped off and the air-inversion machine removed. A cap was placed on the end of the calibration tube. Next, an air-compressor was hooked up and the pressure was raised to 6 psi. Then, the clamp was released while making sure the calibration tube was holding pressure (Figure A-9). Once the pressure was holding, the crew moved to the next site. After two to three hours, the crew would return to check the liner and remove the calibration tube and reconnect the service lateral after curing.

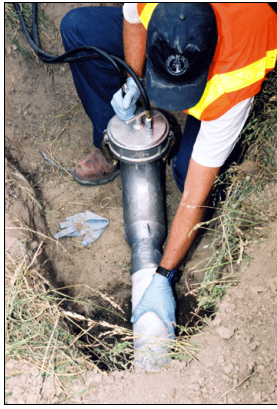
Figure A-9. Calibration Tube Being Checked for Holding the Pressure.

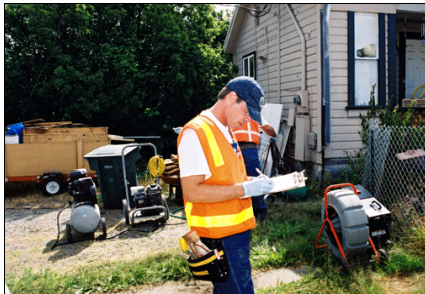
A check sheet was used to keep track of construction progress (Figure A-10). Data entered on the sheet included the liner length, the amount of resin used, and the time of installation (so that cure time could be determined).

Figure A-10. Field-crew Member Keeping Record of Construction.

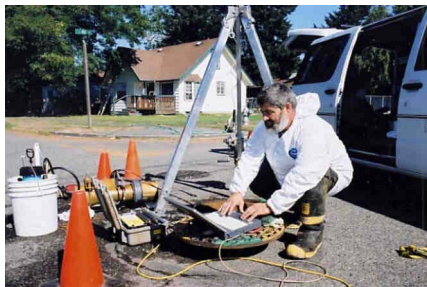
The monitor used was DataGator, which combines a modified venturi flow tube design with pressure transducers to measure flow under various conditions (open channel, full pipe, surcharged, submerged, and reverse). Flow monitoring data collection started 9/26/2002. Flow in gpm was continuously recorded every 15 min. Over the same period, rainfall data were collected at seven locations through out the city (0.01” resolution every five minutes). The nearest location was 0.5 miles away from this small basin.

Figure A-15. Flow Monitoring.

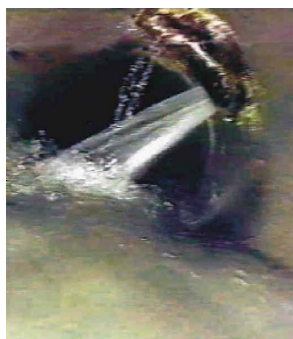
CCTV Inspection of Mainlines. The agency performed initial CCTV inspection of mainlines with typical mainline CCTV equipment (Aries). This allowed for in-house documentation of the exact location of lateral connections with the mainline. The inspection also revealed that many connections were hammer tap-ins⁸ (Figure A-16). Frequently the lateral intruded into the mainline from 1-4''.

Figure A-16. Hammer Tap-ins.

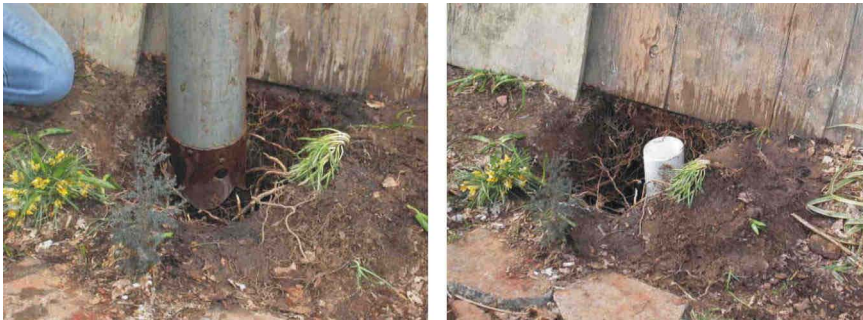
Installation of Cleanouts on Laterals Where Necessary. Hydro excavation was utilized to make excavations for new cleanouts (Figure A-17). The soil was cut with a water jet and vacuumed out with a 6" tube connected to the vacuum truck. The pit size was about 18" in diameter. Such a small excavation was adequate because a lateral saddle assembly product would be used, which snaps onto an existing lateral pipe and requires only a small foot print compared to a typical cleanout installation. It took on average 60 minutes to complete one pit.

Figure A-17. New Cleanouts. Left: Pit Hydro Excavating. Right: Installed Vac-A-Tee[®] Cleanout.

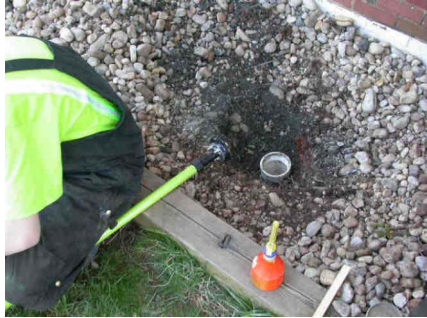
Figure A-19. Cleanout Ready for Pipe Cleaning.

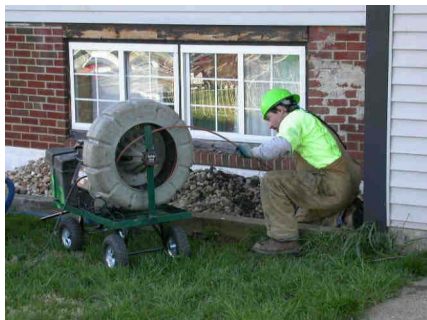
Once the lines were prepared, a small lateral CCTV camera was inserted through the cleanout near the house into the lateral (Figure A-20). The camera was pushed downstream close to the mainline. The camera would provide accurate robotic positioning of the T-liner and document the inversion process on a video recording equipment.

Figure A-20. Inserting the Lateral CCTV Camera into the Lateral.

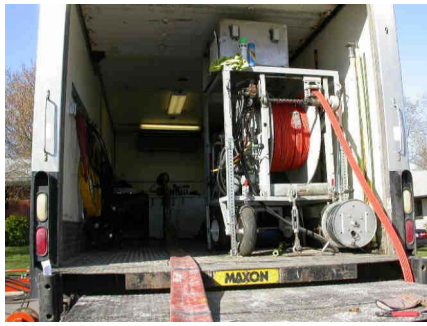
The truck was used as a mobile wet-out unit (Figure A-21). The red hose shown in the picture is the launching device. It is a flexible steam inflatable device that works in all mainline pipe sizes. The resin was mixed first, then poured into the tube and vacuum impregnated (Figure A-22). The mixed resin was poured into the tube through the end that will be installed upstream, near the house. The opposite end of the tube with a short mainline section was connected to a vacuum hose. The resin was spread inside the tube utilizing vacuum impregnation. The person in the figure on right was checking the vacuum impregnation making sure that the thickness of the saturated tube was as specified.

Figure A-21. Truck Used as a Mobile Wet-out Unit.

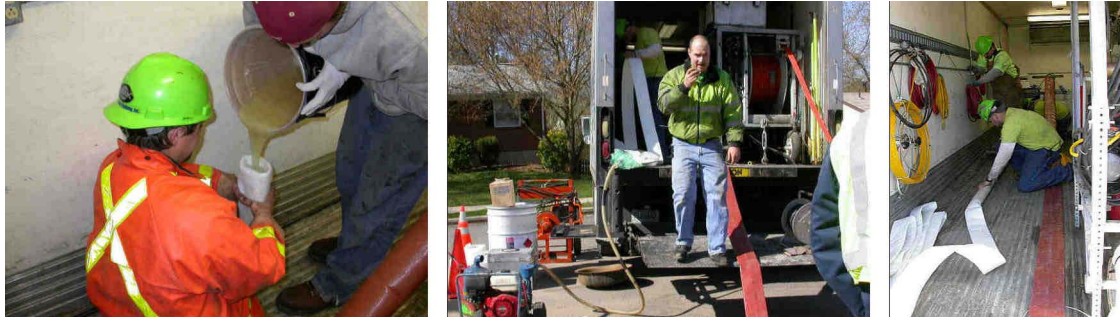
Figure A-22. Liner Impregnation with Resin. Left: Pouring the Resin into the Tube. Middle: Vacuum Hose Connected to the Tube. Right: Vacuum Impregnation.

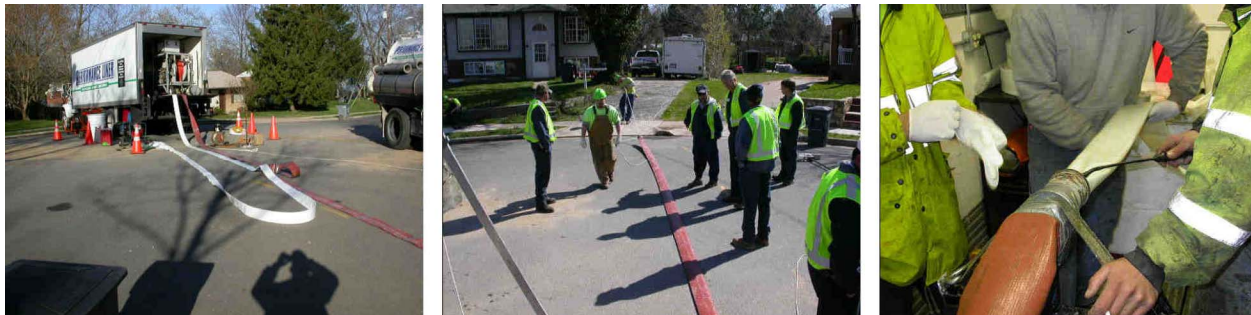
Loading of the Launcher. The liner/bladder assembly containing the resin-saturated tube was next pulled into the launcher (Figure A-23). Both tubes were laid out on the ground next to the truck. Inside the truck, one end of the launcher (through which a cable was stringed) was affixed onto a piece of pipe and the assembly connected to the cable. As the person outside was pulling the cable, the tube was entering the launcher. The loading of the launcher was completed by affixing the short mainline section onto the launcher (Figure A-24). Hydrophilic bands were added.

Figure A-23. Pulling the Liner/Bladder Assembly into the Launcher. Left: Both Tubes Laid Out on the Ground. Middle: Pulling the Cable Inside the Launcher. Right: The Assembly Entering the Launcher.

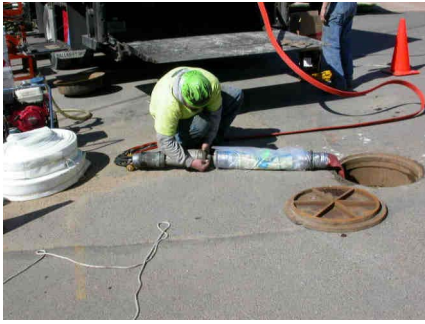
Figure A-24. Completing the Loading of the Launcher.

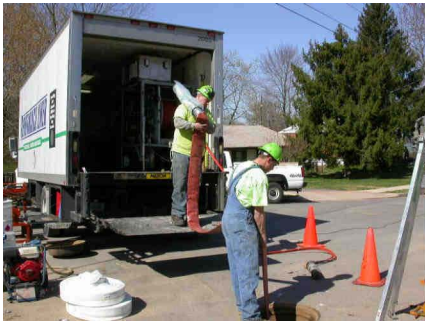
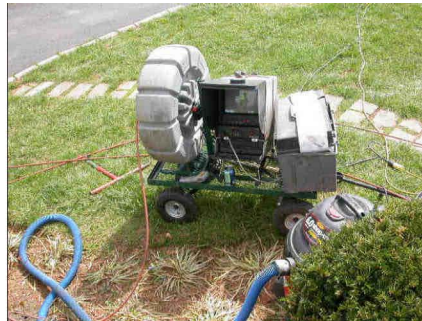
Inversion of the Liner. The loaded launcher was first positioned inside the mainline to enable inversion of the liner/bladder assembly into the lateral (Figure A-25). The end of the launcher opposite of mainline section was inserted through the manhole first. Once the launcher was completely inside the mainline, it was winched past the lateral connection until its end with the mainline section was positioned exactly at the connection. The CCTV camera inside the lateral was used to monitor the positioning of the launcher.

Figure A-25. Positioning of the Launcher. Left: Insertion through the Manhole. Right: Lateral CCTV Camera.

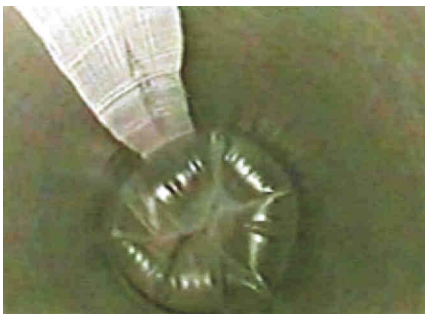
Air pressure was applied causing the liner/bladder assembly to invert up into the lateral pipe, on some laterals as far as 85 \pm (Figure A-26). Once in place, the air pressure held the bladder/liner assembly tightly against the lateral pipe.

Figure A-26. Air Inversion of the Liner/Bladder Assembly the Lateral.

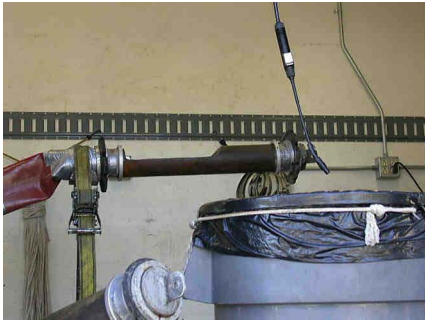
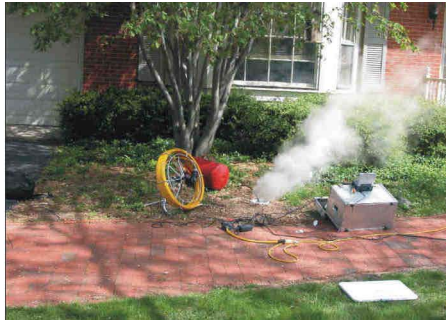
Resin Curing. Steam was used for resin curing (Figure A-27). The steam tank was connected with the bladder and steam introduced into it. The resin curing took about 30 minutes. During that time, the steam was circulating through the bladder and exiting out of the lateral at the cleanout near the house. The upstream end of the bladder was left slightly open. Once the resin curing was completed, the bladder was pulled out.

Figure A-27. Resin Cure. Left: Steam Hose Connected to the Bladder. Right: Steam Exiting at the Cleanout Near the House.

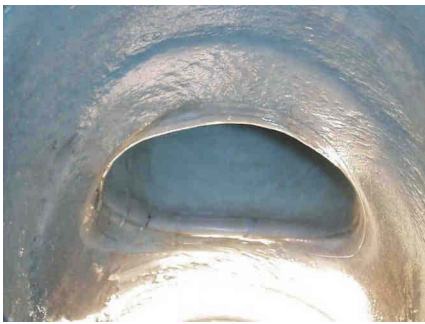
Post CCTV Inspection. The installed liner was inspected with both lateral and mainline CCTV. Figure A-28 shows the relined lateral connection viewed from inside the mainline.

Figure A-28. Installed T-liner at the Lateral-to-mainline Connection (a View from the Mainline).

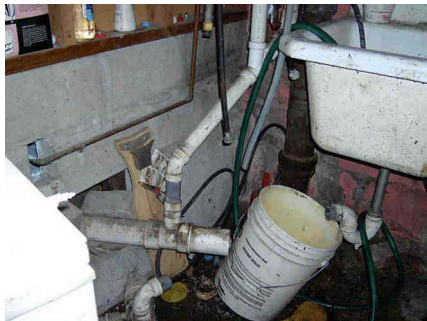
Inspection and Cleaning of Laterals. The lateral was televised using a Rigid See Snake self-leveling color camera, which was inserted through the cleanout in the basement of the home (Figure A-32) and pushed through the pipe towards the mainline in the street. The lateral was packed with roots and the camera could not reach all the way to the mainline. The lateral was cleaned with high velocity jets of water to cut the roots (Figure A-33). The equipment used was a root cutter head on a 4,000 psi jetting machine. Clearing the roots took approximately four hours.

Figure A-32. Cleanout in the House Basement.

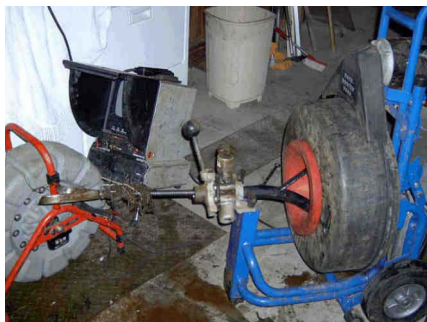
Figure A-33. Root Cutter Equipment.

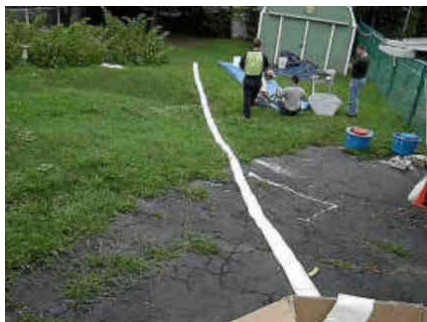
In-Situ Felt Tube Preparation and Calibration. The tube material was first laid out on the ground and cut to the required length (Figure A-35). A vacuum pump was connected to remove all of the air in the liner tube prior to wetting it out with the epoxy resin, and a two-component epoxy resin was mixed. Next, the resin was mixed and the tube filled with the resin (Figure A-36). A vacuum pump was used to spread the resin along the liner tube (Figure A-37). Precise calibration rollers set to match the liner wall thickness were used to evenly distribute the resin in the liner tube (Figure A-38). Once the inside of the liner was thoroughly wetted with the resin, the liner was placed in cold water mixed with ice to slow the curing of the epoxy and allow the installation crew extra time to get the liner installed (Figure A-39).

Figure A-35. Liner Tube Getting Ready for Wet Out.

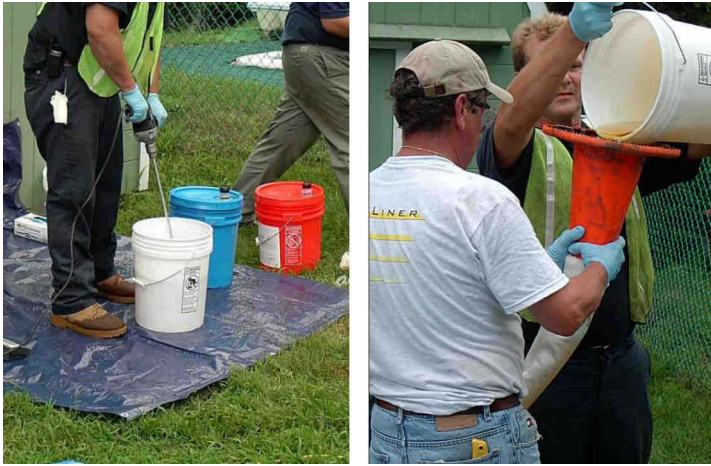
Figure A-36. Resin Mixing and Pouring into the Tube.

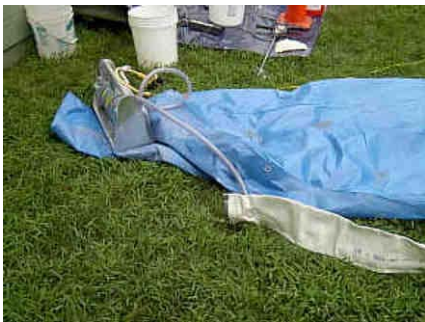
Figure A-37. Vacuum Pump Connected to the Tube.

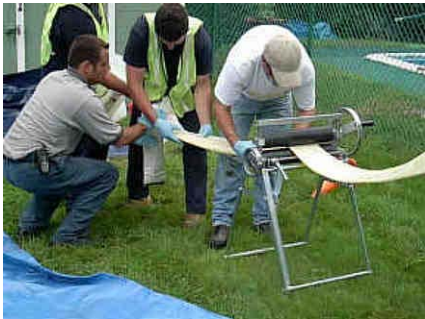
Figure A-38. Calibration Rollers for Even Wall Thickness of the Liner.

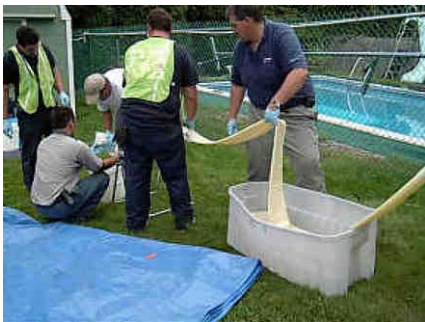
Figure A-39. Icing of the Liner to Prevent Premature Resin Curing.

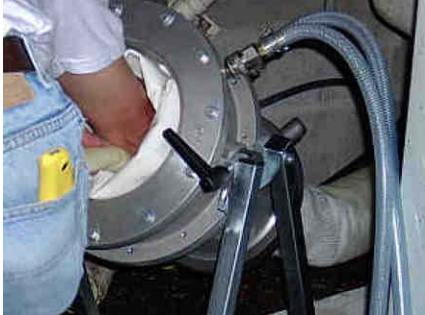
Inversion. The impregnated liner was inserted into the lateral pipe by air-inversion. A liner gun was brought into the house basement and the liner was inserted into the gun. The liner was fed into the liner gun by hand allowing the installer to positively feel the liner going into the pipe (Figure A-40). Using compressed air, the gun inverted the liner and pushed it down the pipe. It took roughly 15 minutes to invert the longer of the two liners into the pipe, and about 10 minutes to invert the other one.

Figure A-40. Feeding the Liner into Inversion Gun.

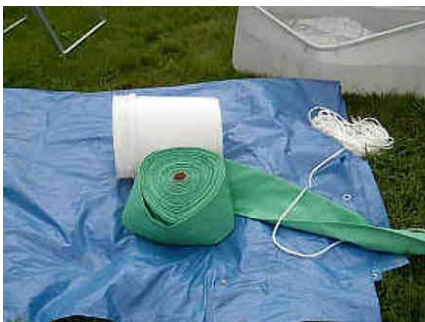
Curing. After the liner was inverted, a bladder (Figure A-41) was inflated inside the liner to hold the liner flush against the pipe during the resin cure. The bladder was air-inverted into the pipe as was previously done for the liner. The air pressure was then applied and maintained overnight until the epoxy cured. The installers checked the compressor every hour to ensure that the appropriate pressure was held. If a hot water curing process were used, the curing time would have been reduced from six hours to between two and three hours. The process is similar, the difference being that a hose is inserted into the bladder and hot water from a portable water heater (MaxLiner HotKick) circulated through the bladder.

Figure A-41. A Bladder Brought on the Site.

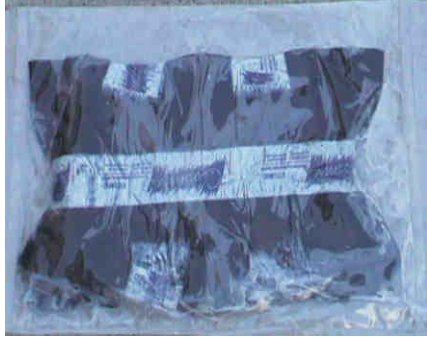
Installation of TOP HATS®. The TOP HAT® is made of ECR corrosion resistant fiberglass that is impregnated with UV-light curing resin and epoxy. The factory impregnated TOP HAT® laminate is removed from its packaging at the job site (Figure A-42) and placed onto the packer (Figure A-43). The packer is attached to a crawler that is used to maneuver the packer through the pipe. The packer is equipped with two cameras. The external camera is used for locating the lateral, then aligning the TOP HAT® with the lateral.

Figure A-42. Factory Impregnated TOP HAT® Delivered to Site.

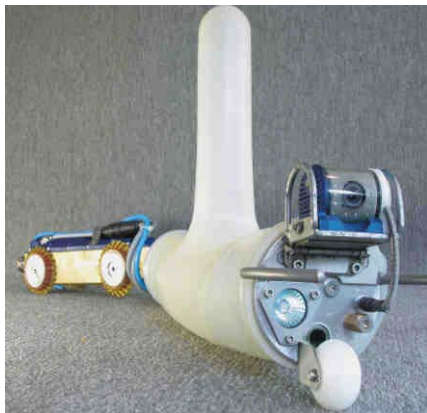
Figure A-43. Packer for Installation with Lateral Bladder Inflated.

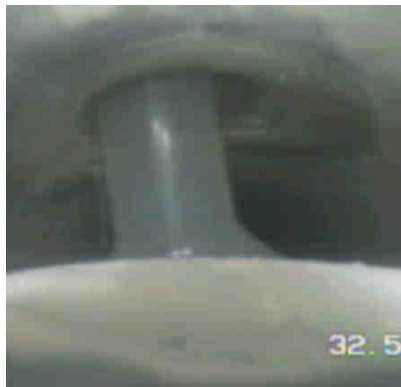
The transparent bladder allows the internal camera to see up the lateral and make sure the TOP HAT[®] has been installed correctly. The use of UV-light allows for a quick curing time that minimizes the disruption of mainline/lateral flow. If everything looks good, the UV-lights are turned on, the light is passed through the transparent bladder, and the TOP HAT[®] laminate is cured just seven minutes later. In the end, the packer is deflated and removed from the mainline (Figure A-45).

Figure A-45. Packer Deflation After Completed UV-light Resin Cure.

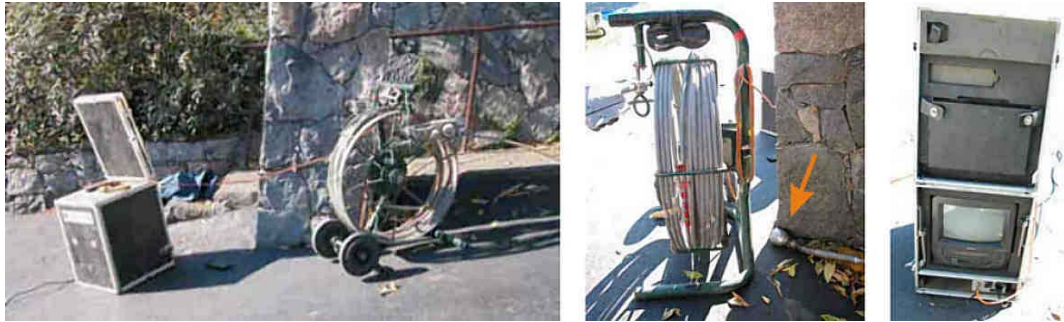
Initial Inspection and Locating of Laterals (Pre-CCTV). The locating was carried out with a CCTV camera (CUES) with a radio-wave emitting sonde (Radio Detection[®]) built into the camera's head (Figure A-46). The depth of pipes did not exceed 12-13м, which is the upper limit for application of this equipment. The camera with the sonde was inserted into the lateral through the inspection chamber and cable-pushed through the lateral. An operator walked along the path of the lateral and traversed a hand-held receiver left and right, thus identifying their layout (path and depth, and both vertical and horizontal bends). The location where the lateral entered the house was marked on the ground with orange paint (see arrow in Figure A-47).

Figure A-46. Left: Portable CCTV Inspection Equipment. Middle: Orange Arrow Pointing at the Camera. Right: Portable VCR and Monitor.

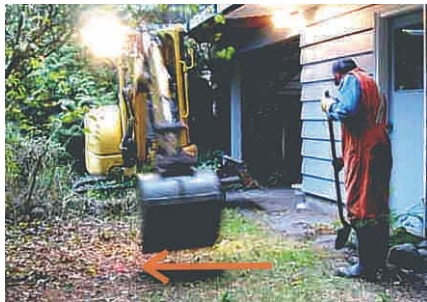
Figure A-47. Mark of Lateral Location Near the House.

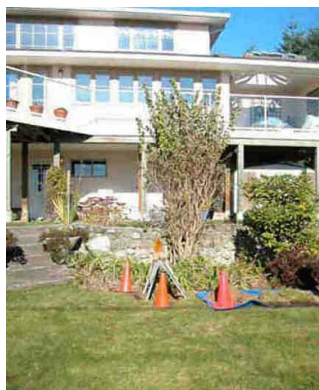
Selection of Rehabilitation Method. Most laterals in this pilot area (approx. 80%) could have been repaired by either pipe bursting or relining. Only a small percentage of laterals (approx 10%) was suitable only for pipe bursting due to offset joints in the pipe or because of collapsed pipe. About the same percentage of laterals was suitable only for CIP relining because of more than three bends on the lateral or obstacles for excavating the required pits (Figure A-48).

Figure A-48. Retaining Wall Near the Lateral Made Pipe Bursting Unsuitable.

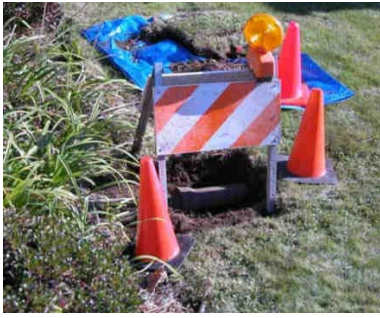
The pit size was typically 3'×3' (1.0 m×1.0 m) and the pit depth often quite shallow (Figure A-49). If the pit was on the property line, the cleanout was removed. Otherwise, once the lateral was exposed, it was cut open for access.

Figure A-49. Excavation Showing the Shallow Depth of Some Pipes.

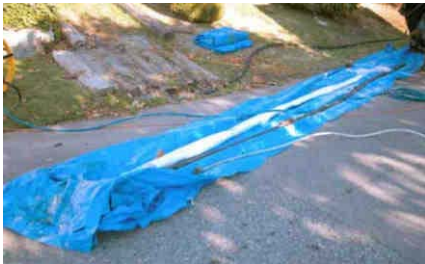
In-Situ Felt Tube Preparation and Calibration. The liner was prepared in-situ. A pre-cut felt tube (manufactured by Applied Felts, 3.0 mm thick) was laid on the ground and saturated with resin (Stypol to unsaturated polyester resin manufactured by Cook Composites and Polymer). A vacuum line for impregnation (plastic bag) and a bladder (dark hose) were laid on the tarp (Figure A-50). A tarp was used to assure a clean job site. The resin was poured into a clear plastic bag that had a felt liner placed inside. A vacuum was used to draw all air out of the clear plastic bag and ensure that the resin would penetrate the felt liner (Figure A-51). With the vacuum connected, the resin spread inside the tube. In its raw state, the resin was white, and it turned green when the green catalyst was mixed in (Figure A-52). Finally, a pipe was rolled along the liner to help evenly disperse the resin (Figure A-53). The liner was visually inspected after the wet-out to ensure that no areas were devoid of resin.

Figure A-50. Liner Tube Laid Out on the Ground.

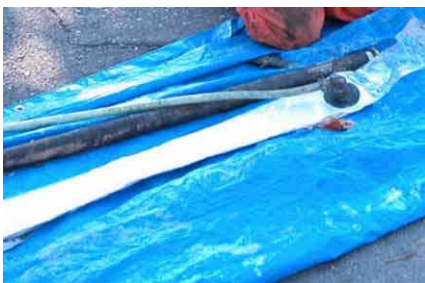
Figure A-51. Vacuum Connected to the Tube.

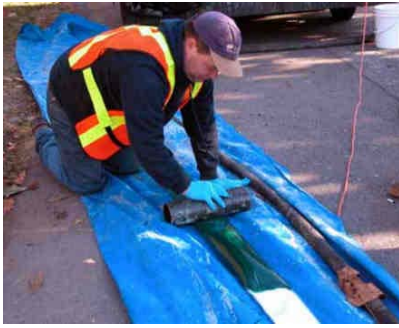
Figure A-53. Using a Roller to Spread the Resin along the Liner.

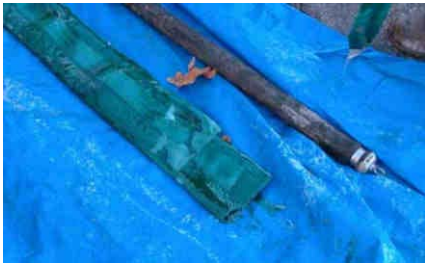
Liner Insertion and Curing. For insertion of the prepared liner into the lateral, a bladder was used (Figure A-54). The bladder also helped to hold the liner in shape during the resin cure. The bladder was inserted into the liner and then fixed onto it firmly with a tape (Figure A-55). The result was a combination bladder/liner assembly. The bladder/liner assembly was carefully carried to the excavation and typically pushed into the lateral (Figure A-56). Only rarely, if there were numerous bends in the pipe, it was attached to a string and pulled in place (less than 5% of relined laterals).

Figure A-54. The Bladder alongside the Prepared Liner.

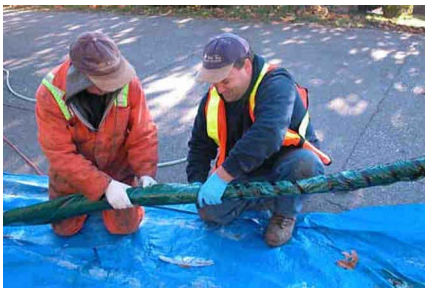
Figure A-55. Taping the Liner Tightly around the Bladder.

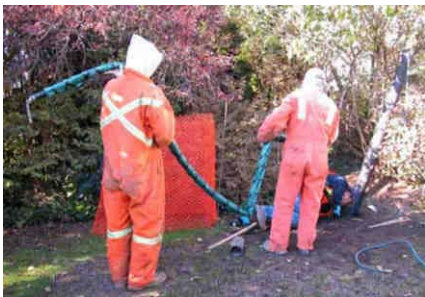
Figure A-56. Carrying the Liner/Bladder Assembly to the Excavation.

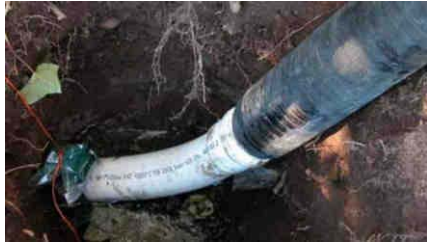
A PVC sweep bend was used in the pit to protect the bladder from being scratched on the sharp edges (Figure A-57). Pressurized air was used to inflate the bladder and press the liner tightly against the pipe (Figure A-58, Figure A-59). The resin was ambient temperature cured and the duration of curing depended on the air temperature (the colder the weather, the longer the cure). The air temperature was in 50s and 40s, and, on average, it took about 1½ hour for resin cure.

Figure A-57. Sweep Bend.

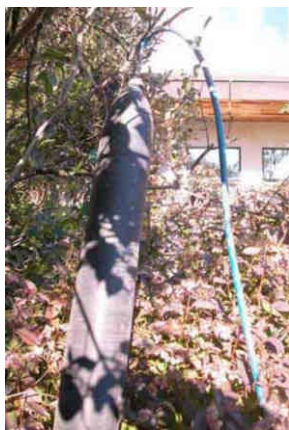
Figure A-58. Excess Bladder Extending out of the Trench with Air-pressure Hose Connected.

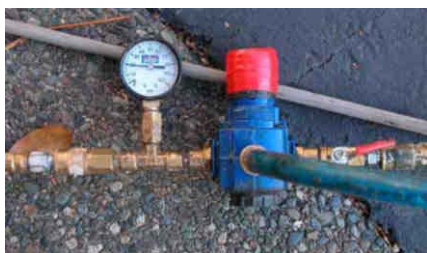
Figure A-59. The Regulator Shows the Pressure in the Bladder.

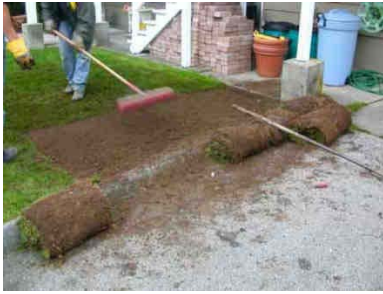
Surface Restoration and Demobilization. Once the new pipe and cleanouts were in place and all the connections completed, the pit was backfilled and any required surface restorations made (Figure A-60).

Figure A-60. Surface Restoration Underway.

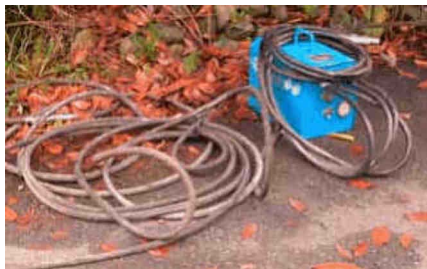
Figure A-63. Control Box and Hydraulic Lines.

Mobilization. To each site, the crew brought a backhoe and the pipe bursting equipment Grundotugger[®] by TT Technologies (Figure A-62, Figure A-63, Figure A-64).

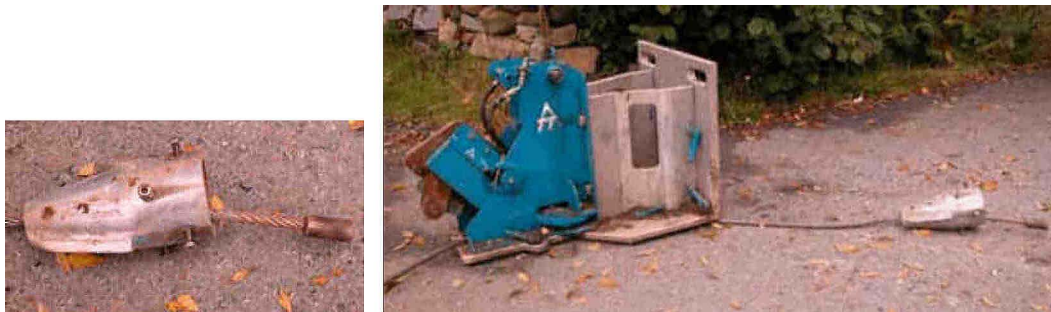
Figure A-64. Left: Nose Cone/Splitter. Right: Winch for 4" Lateral.

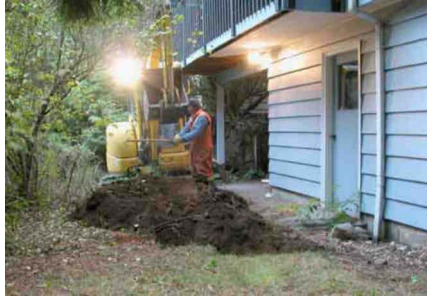
Figure A-65. Excavating of the Entry Pit Near the House.

Pit Excavation and Removal of Existing Cleanouts (If Applicable). For each lateral, two pits were excavated: one at the point where the service connection goes under the house and one at the cleanout on the property line (also called an inspection chamber³⁰).

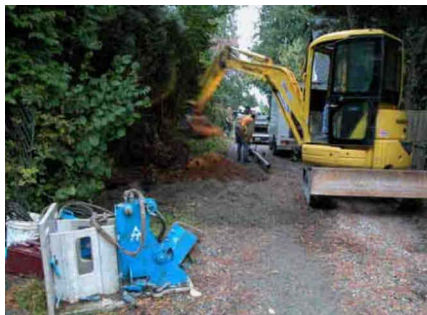
Figure A-67. Excavating of the Exit Pit at the Property Line.

excavation was rather small and the pits were typically 3 \times wide, 3-4 \times long and about 4 \times deep (Figure A-66). The pits were excavated and burst on the same day, and on average a total of two or three laterals were replaced in one day. The pits were never left open overnight. At the property line, excavating of the exit pit exposed the inspection chamber, which would be removed for the duration of pipe bursting (Figure A-67, Figure A-68).

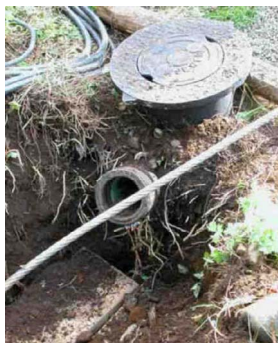
Figure A-68. Exposed Inspection Chamber.

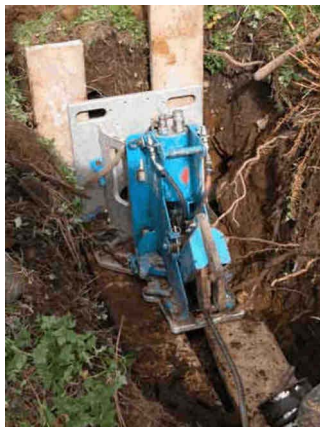
Pipe Bursting. Once the excavations were made and the cleanout removed, the exposed pipe in each pit was cut out. The winch was then lowered into the exit pit and braced with some timber behind it to spread the load prior to use (Figure A-70). Next, hydraulic lines were attached to the control box (Figure A-71).

Figure A-70. Winch in the Exit Pit.

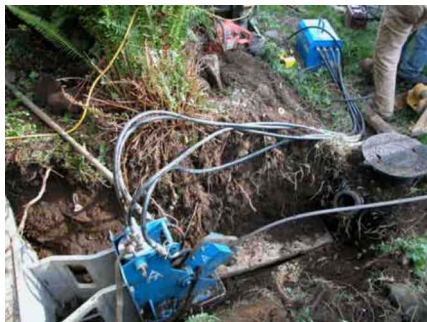
Figure A-71. Hydraulic Lines Attached to the Control Box.

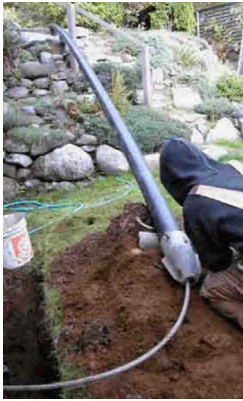
Near the entry pit, the bursting head (the nose cone-splitter) was attached on one end to the pre-cut section of HDPE pipe and on the other end to the pulling cable (Figure A-72). The cable had been strung through the existing lateral pipe thus connecting the winch and the replacement pipe (Figure A-73).

Figure A-72. Bursting Head Attached to the Replacement Pipe and the Pulling Cable Near the Entry Pit.

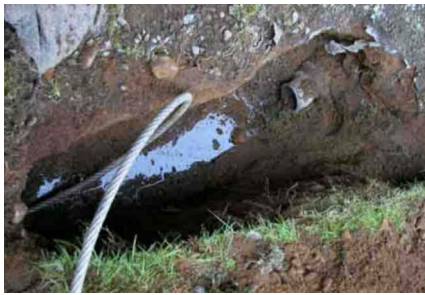
Figure A-73. Entry Pit Showing the Pulling Cable and Cut-off Section of the Lateral Near the House.

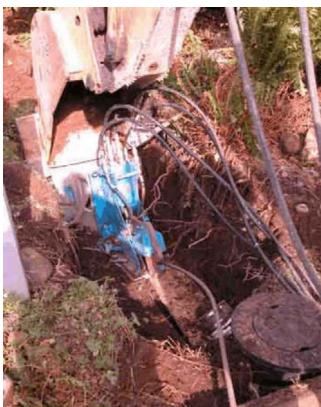
The bursting was done by pulling the bursting head through the existing lateral pipe. It was breaking the existing pipe apart into fragments, which were pushed into the surrounding soil. The backhoe was used to keep the winch from raising under the tension in the exit pit (Figure A-74). Once the replacement pipe was pulled in place (leaving a little extra pipe length to extend beyond the pit wall on both ends) (Figure A-75), the bursting tool was detached and the pipe cut to the correct length.

Figure A-74. Backhoe Assisting the Bursting in the Exit Pit.

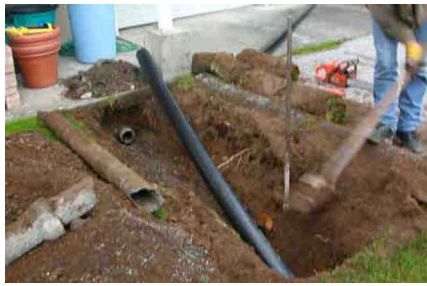
Figure A-75. Replacement Pipe Pulled in Place (Entry Pit Shown).

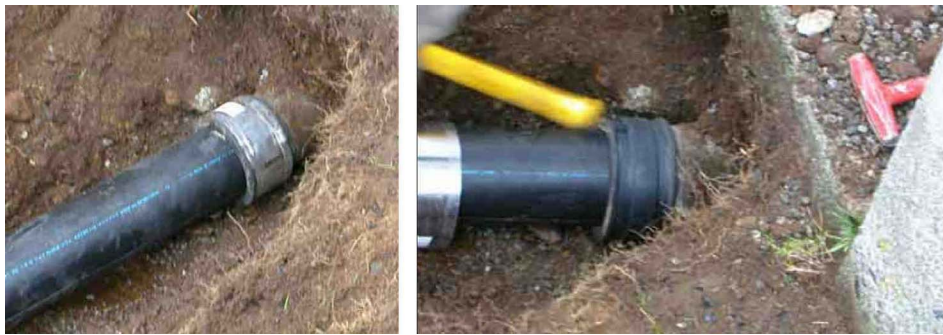
Reconnection of the New Pipe and Installation of Cleanouts. Once the replacement pipe was in place, the cleanout at the property line was reinstalled and a new cleanout installed near the house. The cleanouts were cut into the pipe and flexible rubber couplings were used to re-seal the pipe (Mission couplings with stainless steel shear bands shown in Figure A-76).

Figure A-76. Flexible Rubber Couplings with Stainless Steel Shear Bands.

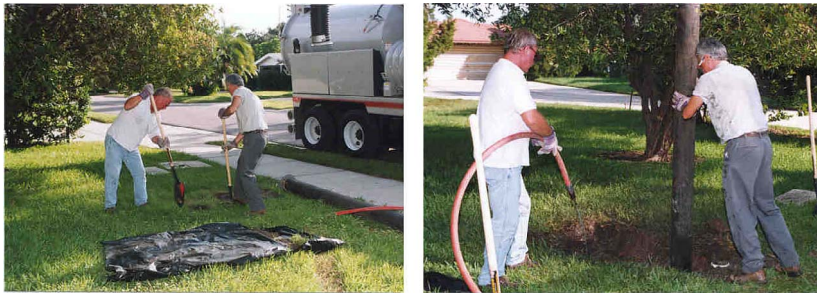
Installation of Cleanouts on the Property Line on All Laterals Located in this Phase. On 65 laterals identified with the cleaning hose/nozzle with sonde, a new cleanout was installed (Figure A-78). A stake was placed at the property line and the sod was removed at the location of the stake. Next, a hydro-vacuum excavating process was applied. The soil was cut with a water jet and vacuumed out with a 6" tube (connected to the vacuum truck). The pit size was about 2x3. It took on average 60 minutes to complete one pit. While the pit was open, a mini CCTV camera, which was mounted on a rod, was hand pushed through both the upper lateral and the lower lateral (Figure A-79). After inspection, a cleanout (4" Inserta Tee[®]) was installed in each pit and the surface was restored (Figure A-80).

Figure A-78. Installation of Cleanouts at the Property Line. Left: Sod Removal. Right: Pit Hydro Excavating.

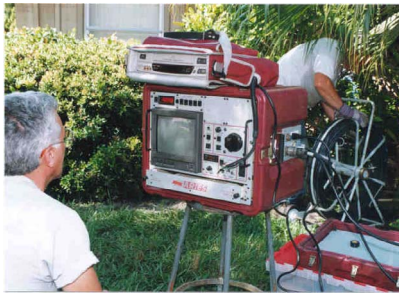
Figure A-79. CCTV Inspection of Laterals from the Pit at the Property Line.

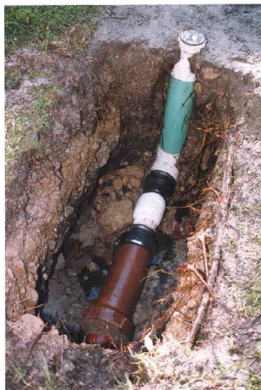
Figure A-80. Cleanout Installed in the Pit.

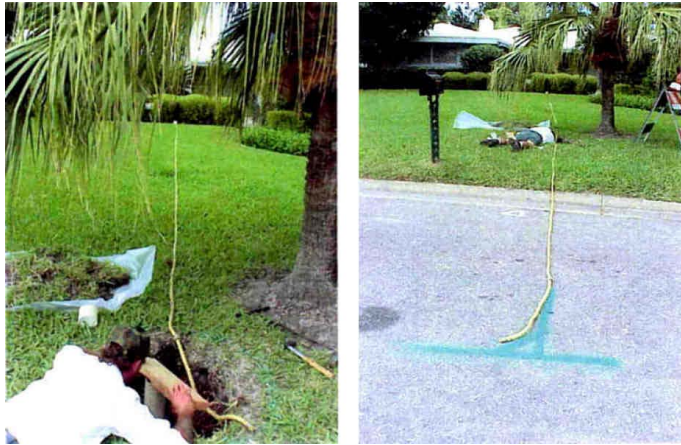
The recording technique was improved from what had been practiced three years earlier (Figure A-81) and a more accurate and complete set of records was made (Figure A-82). A 3/4" rope was laid on the ground following the path of the lateral as determined by the sonde during the video operation. The rope was digitally photographed as an additional record of the path of the sewer lateral. The lateral layout was recorded from the mainline to the building roof drip line (2-3' from the building foundation). Also, exact measurements were made of the property corners, trees and other objects on the property.

Figure A-81. Improved Recording Technique During Locating of Laterals. Left: Lateral Marking Rope Laid on the Ground. Right: Rope Extending from the Mainline.

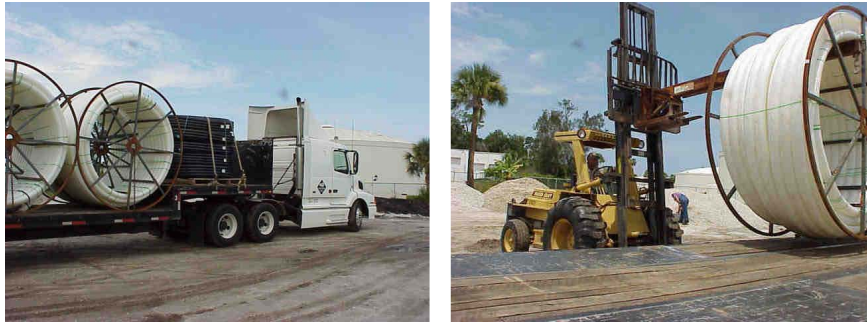
Replacement Pipe. The replacement pipe was a white 4" SDR 17 HDPE pipe supplied on 800± reels (Figure A-83). The white color would enhance future video inspections, and the length greatly reduced the need for onsite pipe fusion.

Figure A-83. Replacement Pipe. Left: Delivery to Site. Right: Handling the Pipe.

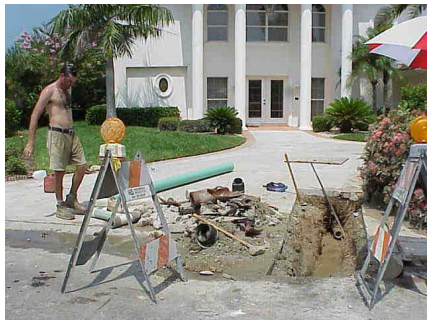
Pits. For each pipe bursting operation a small pit was excavated at the property line (Figure A-84) and another one where the sewer lateral enters the house. As explained before, vacuum excavation was used to open the pits.

Figure A-84. Excavated Pit.

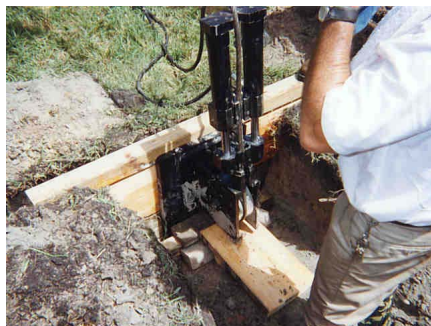
The Pull. The contractor used small, modular equipment manufactured by Tric Tools, Inc. to install the new lateral lines (Figure A-85).

Figure A-85. Small Hydraulic Puller by Tric Tools, Inc.

The small hydraulic puller was able to generate up to 60,000 pounds of pulling force. A diesel-powered Vermeer high-pressure pump supplied hydraulic power to the puller. Once the pull began, the new HDPE pipe was pulled into place at 5-10' per minute.

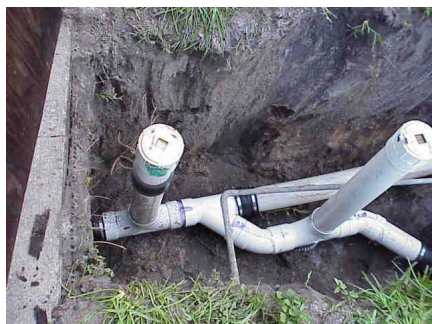
Cleanouts. During lateral replacement, cleanouts were installed every 75' to comply with city codes. For laterals over 75' long, pits were sometimes dug for extra cleanouts, and the new pipe was pulled from one pit to the next. At other times, the entire length of the new line was pulled first and the cleanouts were installed later. Cleanouts installed were 4" or 6" double-sweep Tees (Figure A-86).

Figure A-86. A Two-Way Tee and Cleanout Assembly.

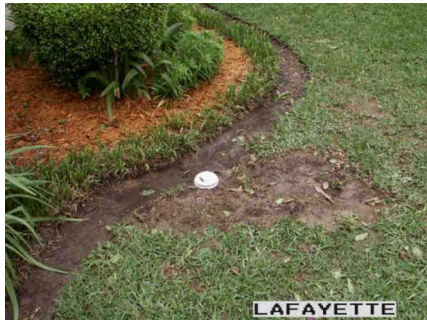
Figure A-91. Newly Installed Cleanout Close to the House.

The installed cleanouts had a two-way access to allow plug insertion downstream or upstream from the cleanout.

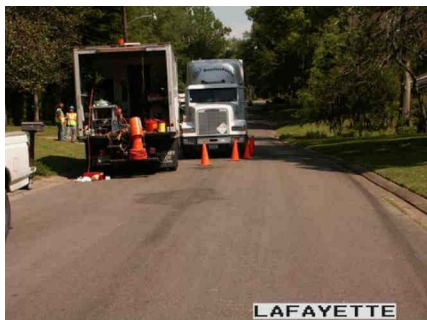
Mobilization (Site Setup). To each site, the crew brought the following equipment: a jetting truck, a CCTV truck, buckets for filling the cleanouts with water, pneumatic plugs, a three-chamber tanker with the two solutions (S-1 and S-2), two hoses, and two separate pumps. Figure A-92 shows typical site setup. At the beginning of project, the contractor did not have the proper pumps for a quick and thorough pumping out of the solutions and therefore not all the chemicals could be recovered out of the manhole, which caused serious delays.

Figure A-92. Typical Site Setup Showing Tanker in the Background and Truck with Equipment in the Front.

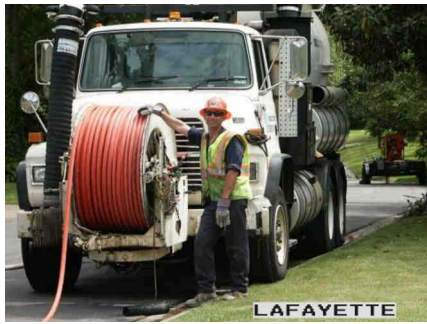
Cleaning. Manholes and pipes were again cleaned shortly before each start of Sanipor work to insure that the chemicals used for sealing would not be contaminated by the sewage. A 300-gallon trailer flusher was used for water jetting (Figure A-93).

Figure A-93. Jetting Truck.

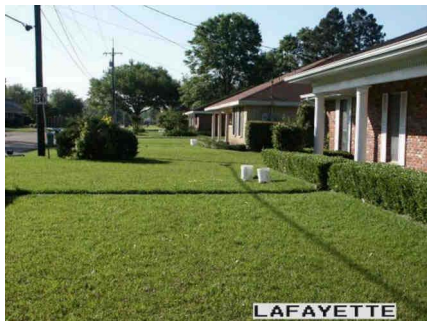
Plugging and Initial Water Exfiltration Test. For plugging the lines, 4∇ and 6∇ plugs were used in the laterals, and 8∇ plugs in the mainlines. For the water exfiltration test, the plugged sections were completely flooded to the top of manholes, and the loss of water in 5-minute intervals was measured in the manholes.

Figure A-94. Buckets Were Used for Adding the Water from a Nearby Hydrant Through the Cleanouts⁴⁷.

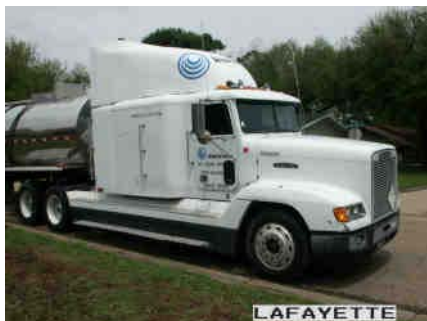
A three-chamber tanker was used to transport S-1 and S-2 to site (Figure A-96). Each chemical component had its own hose in order to avoid mixing and polluting S-1 and S-2 with each other (Figure A-97).

Figure A-96. Three-chamber Tanker for Transporting the Chemicals.

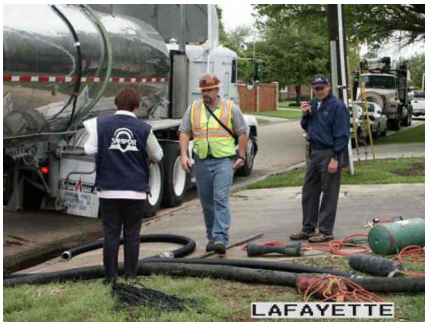
Figure A-97. Hoses for Pumping the Chemicals.

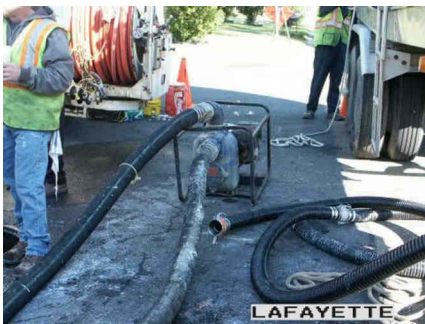
Strong and reliable pumps have a very important role in the Sanipor technology (Figure A-98). Having no vacuum pumps on the tankers, two separate pumps were used to pump out the large volumes of the sealing liquids from the sewer sections/manholes (circa 2,000-3,000 gal each).

Figure A-98. Pumps.
