Water Environment Research Foundation
Collaboration. Innovation. Results.

Methods for Cost-Effective Rehabilitation of Private Lateral Sewers

02-CTS-5

2006

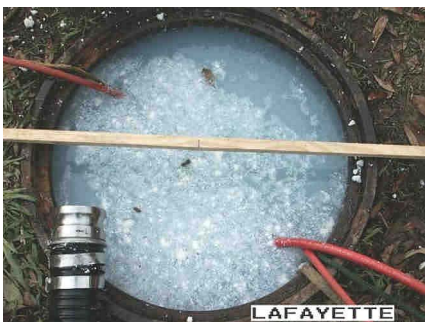
Duration of Flooding. The flooding procedure using both components was performed in cycles (one, two or three cycles, as shown in Chapter 8.0). The flooding with either solution within the cycle was typically between 25-40 minutes. During this time, the level of solution in the manhole was decreasing and the system was periodically refilled. At the end of the final cycle, the level of S-2 in the manhole stabilized, and thus the leak tightness was visually confirmed. The drop of solution S-2 level in the manhole was measured with the help of a wooden stick and a folding rule (Figure A-99).

Figure A-99. Manhole Filled with Solution to the Ground Surface.

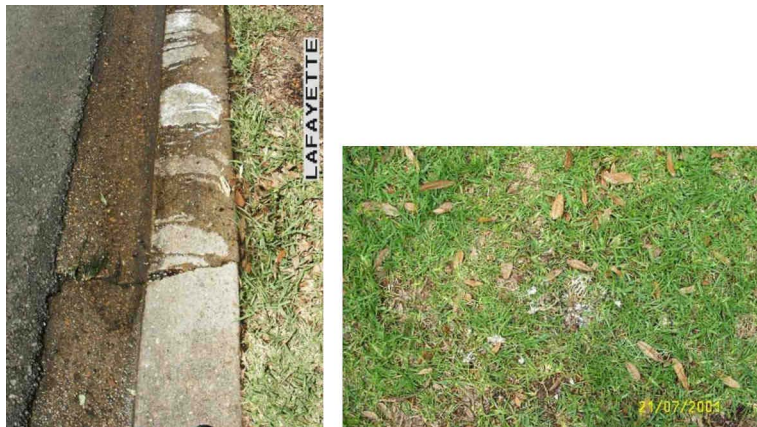
Surface Exfiltration. In several locations, the Sanipor solution reached the surface appearing on the pavement or on the grass (Figure A-100). Surface exfiltration happened because there were channels in the soil (from rainwater draining over time) that extended from rather shallow mainline pipes. These channels were filled and sealed with Sanipor as well. The white stains on the grass show where the Sanipor Silicate gel has formed.

Figure A-100. Left: Exfiltration onto the Pavement (Section #7). Right: Surface Exfiltration onto the Grass (Section #9).

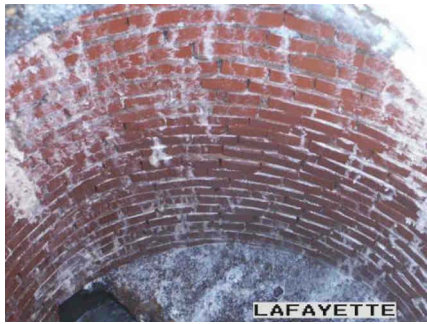
Manhole Sealing. One brick manhole (MH 1252) close to a hydrant was badly leaking whenever the hydrant was opened (section #2). The water was pouring through all gaps between the bricks into the manhole. All gaps in the manhole were successfully sealed with one cycle. White stains in Figure A-101 (MH 1252) show the product of reaction between S-1 (draining from the soil back into the manhole) and S-2 (being filled into the manhole). Five days after the Sanipor sealing, a test was made by opening the nearby hydrant and flooding the surface surrounding the manhole. No infiltration was visible in the manhole anymore.

Figure A-101. Sealed Gaps on the Manhole Wall (Section #2).

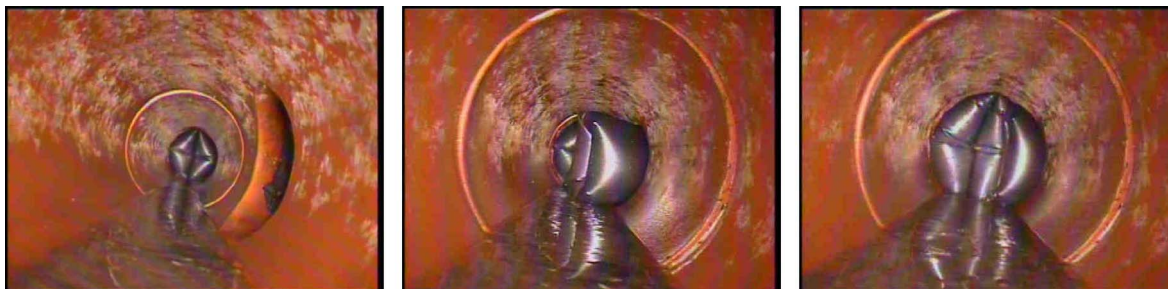
Figure A-113. Left: Lateral Bladder Retracted to Allow CCTV Camera to Pass. Middle: The Lateral Bladder Extended Again to Protrude as the Mainline Bladder was Approaching. Right: Mainline Bladder Inverting Past the Lateral Bladder.

Step 2: Inversion of first mainline bladder. The CCTV camera was moved to the upstream end of the mainline (the lateral tubes were retracted a few inches to allow the camera to pass through the mainline). The first bladder started being inverted into the mainline from the upstream manhole. The pressure of inversion was approximately 200% of the groundwater pressure above the pipe invert. As the bladder was being inverted, the CCTV camera was retracted backwards in direction of the downstream manhole.

The camera operator was telling the person controlling the bladders when the mainline bladder was approaching the lateral connection for reference. As the camera pulled past each connection (and before the mainline bladder reached the connection), the lateral bladder was extended to protrude again into the mainline (Figure A-113).

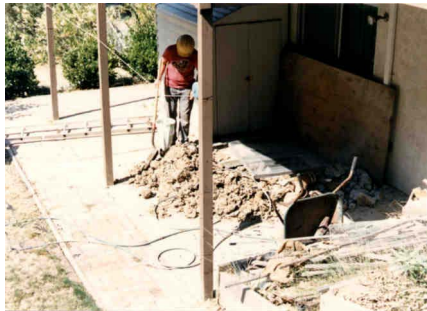
Figure A-124. Difficult Cleanout Location Near the House.

In Stege Sanitary District, the lower lateral is typically 25' in length, and the laterals in this area averaged between 60-65' in total length. None of the laterals originally had a cleanout at the property line and there often weren't cleanouts outside the building foundation. Some cleanouts near the house had difficult access (Figure A-124)

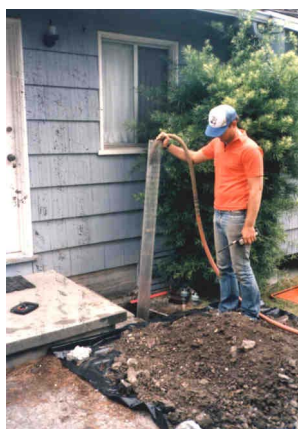
Figure A-125. Water Exfiltration Test Through Cleanout.

Water exfiltration testing (hydrostatic pressure test) was carried out on all laterals to identify the laterals that needed rehabilitation (Figure A-125). The testing was done just before the mainline sliplining, after the lateral was disconnected by inserting a plug at the lower end of the lateral. Only one of 111 laterals passed the test. It was a new cast iron lateral that was less than five years old.

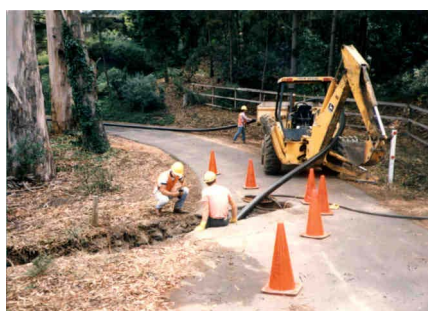
Figure A-126. Entry Pit at Lateral-to-Mainline Connection.

Pits were excavated at each lateral/mainline connection (Figure A-126). The excavations were small potholes (about 2.5'×2' near the surface). Once the excavations were made, the exposed lateral pipe in each pothole was cut out.

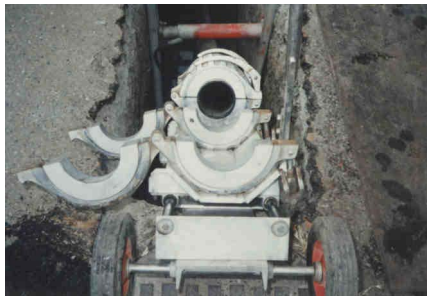
Figure A-127. Fuse Welding Machine.

The pipe was fused using normal heat fusion methods and inserted by pulling in place (using a high tension winch). Next, the HDPE pipe was left overnight to relax. The following day, the mainline was air-tested to assure mainline joint integrity⁶⁵ and holes were cut for lateral connections.

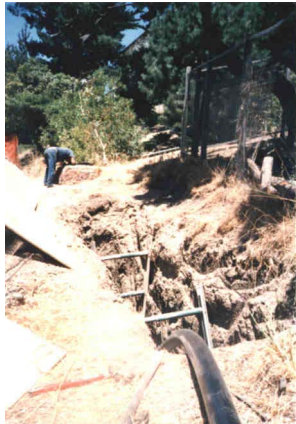
Figure A-128. One of the Additional Pits Excavated Along the Lateral.

Sliplining of Laterals. Additional pits were excavated at the property line, at any other bend in the lateral, and near the house (if the cleanout was there, it was temporarily removed). Next, the exposed pipe in each pit was cut out.

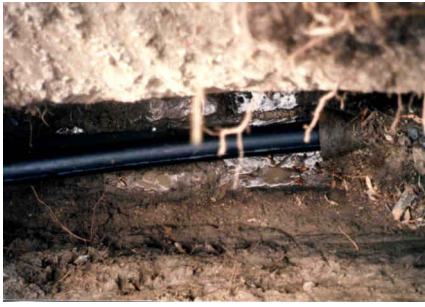
Figure A-129. New HDPE Pipe Extending Beyond Old VCP Pipe—a View from Above.

The pipe used for lateral sliplining was SDR21⁶⁶ HDPE pipe with an OD of 4". Thus, the diameter of the sliplined lateral was reduced from 4" to 3.1". Pipe segments were butt fused on site. The pipe was pushed manually into the lateral, first downstream towards the mainline and then upstream towards the house. If there were other pits along the lateral, they were used for insertion of the sliplining pipe into the adjacent lateral segments. The typical length of laterals was from 40-70', and the maximum length that the pipe was pushed was about 40'.

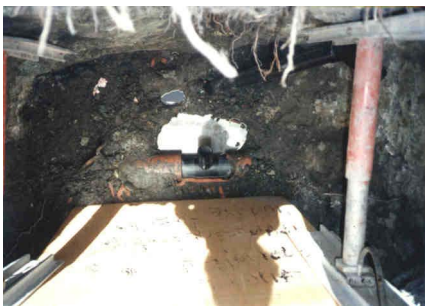
Figure A-131. Mainline Tee Ready for Lateral Connection—a View from Above.

After successful air testing, the lateral was reconnected with the mainline and the house. The laterals have been installed typically at a minimum slope of $\frac{1}{4}$ " per foot and reached the mainline-to-lateral connection point at shallower depth than the mainline. Therefore, the connection to the mainline was done using a butt-fused HDPE saddle with HDPE riser.

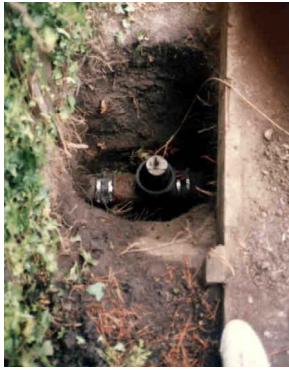
Figure A-132. Test Plug in the Lateral at the Property Line.

Point repairs were required in many locations on the laterals in order to provide the ability to slipline. A new cleanout was installed near the house and the HDPE pipe connected to it. At intermediate pits (on horizontal or vertical bends), a standard cast iron fitting with a rubber coupling and stainless steel bands was used for connection. The lateral was then air tested, after inserting plugs and taps⁶⁷ at the downstream and upstream terminus points.

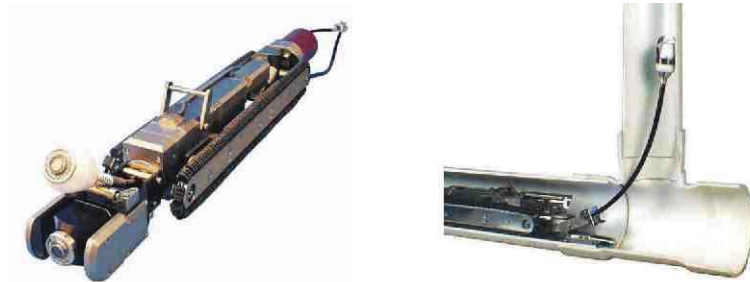
Figure B- 1. Two LETS® Models. Left: LETS® Pan & Tilt. Right: Variable Chute Launch LETS®.

Feature	Description	Comment
Lighting	Built-in hi-intensity LED lighting	48 white LED's with 10,000 hr life cycle
Camera head diameter	1.8" diameter	Stainless steel housing
Camera self-leveling	Yes	Standard
Monitor	Any make or model, color or B&W	
Resolution	570 TV lines (horizontal)	
VCR recording	Yes (4-Head)	
DVD recording	Yes	
Transfer to CD-ROM	Yes, via Inspection Software	
Sonde for locating	Yes—standard, 512 Hz	
Access point	Mainline, 8-48"	
Max. length of single run	2,000' (standard)	
Lateral pipe diameter (ID)	2-10"	
Bends in lateral pipe	Yes, multiple 90°	
Lateral-to-mainline connect.	Tee or Wye	No limitations
Vertical riser in lateral pipe	Yes	
Speed of inspection	15 ft/min	
Duration of inspection	6-7 minutes	With setup, for a 50' lateral
Daily inspection rate	Up to 50 laterals in one working day (8 hrs)	On average, assuming 50' laterals

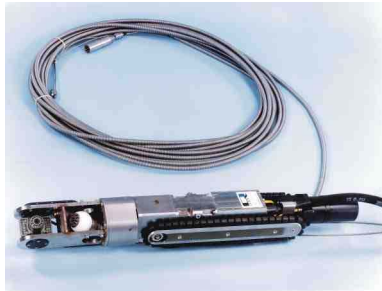
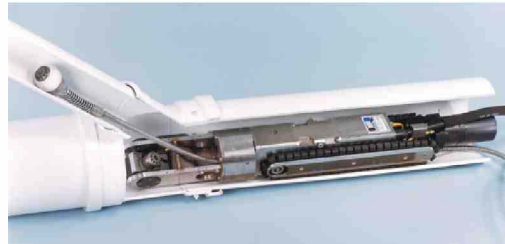
Figure B-2. Left: LAMP System (with Push Cable). Right: LAMP Launched into the Lateral.

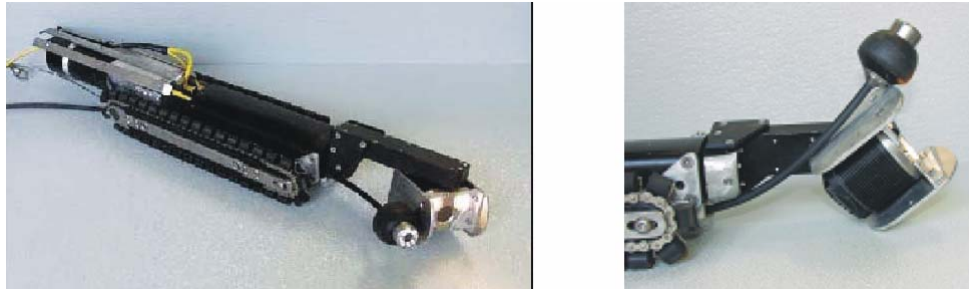
Figure B- 5. Left: RST Lateral Inspection System. Right: Close View of Lateral Camera.

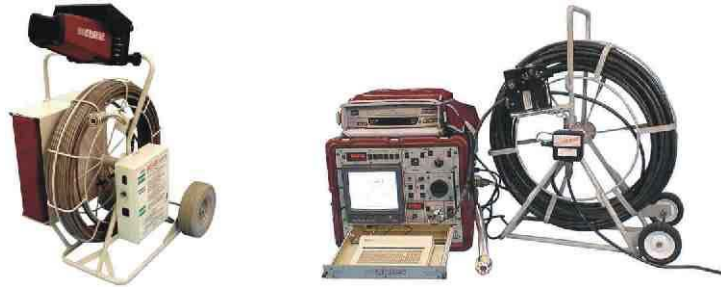
Figure B- 7. Left: Seeker®. Right: Saturn III®.

Feature	Description	Comment
Lighting	Built-in hi-intensity LED lighting	48 white LED's with 10,000 hr life cycle
Camera head diameter	1.8" diameter	Stainless steel housing
Camera self-leveling	Yes (standard)	
Monitor	6.4" LCD color 9" color (Model JVC)	Seeker® Saturn III®
Resolution	570 TV lines (horizontal)	
VCR recording	Yes	
DVD recording	Yes	
Transfer to CD-ROM	Yes, via inspection software	
Sonde for locating	Yes—Standard, 512 Hz	
Access point	Cleanout, small pit or manhole	
Max. length of single run	100' (standard), 300' (optional) 200' (standard), 400' (optional)	Seeker® Saturn III®
Lateral pipe diameter (ID)	2-15"	
Bends in lateral pipe	Up to 90°	
Vertical riser in lateral pipe	Yes	
Speed of inspection	Operator dependant	
Duration of inspection	Varies with operator	
Daily inspection rate	Varies with operator

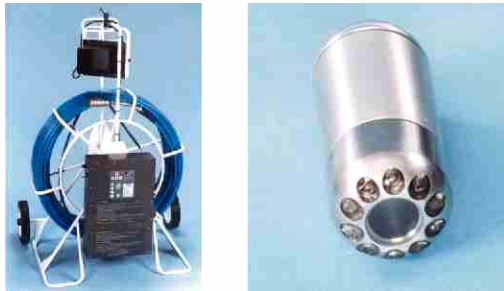
Figure B-8. Left: Mini-Push 20 20. Right: PS3 Camera.

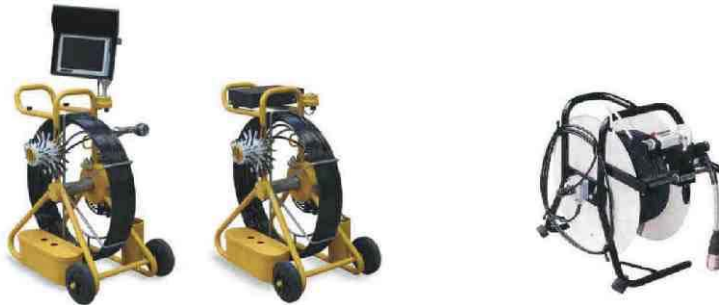
Figure B-9. Left Two: Hydrovideo Mini. Right: Evolutis.

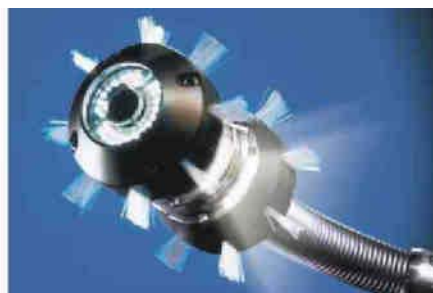
Figure B-10. Left: P571 Flexicoiler. Right: P455 Twinview Camera.

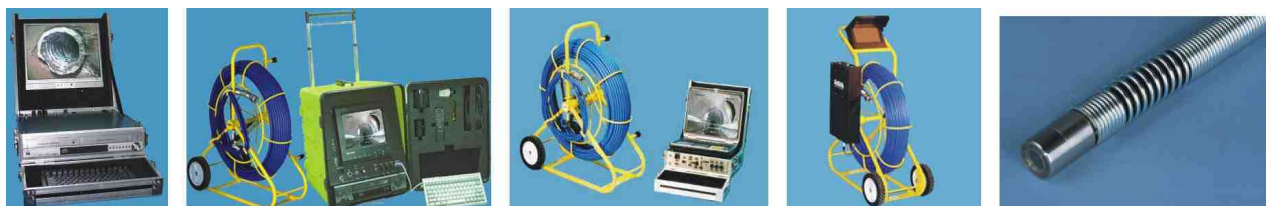
Figure B-12. From Left to Right: 1) Plumber's Elite-Duo; 2) Mate; 3) Inspector PC; 4) Fast Peek; 5) Camera Head.

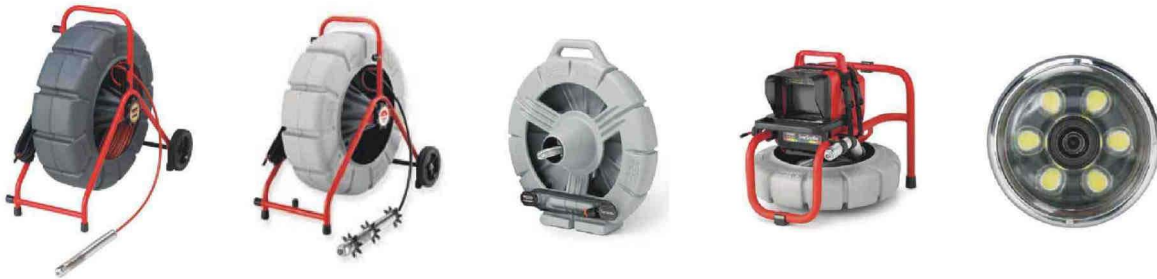
Figure B-13. From Left to Right: Ridgid SeeSnake Systems (Plus; Mini Plus; FlatPack Plus; Compact Plus), Self-Leveling Camera.

Description	Push-type lateral CCTV inspection system (four systems as shown in Figure B-13)
Internet	www.seesnake.com
History	Developed in U.S. and commercialized In 1996
Market	Used in U.S. and worldwide (Canada, South America, Europe, Asia)
Contact	Technical Service Department, P. (800) 519-3456, online email: www.ridgidtechnicalservice.com

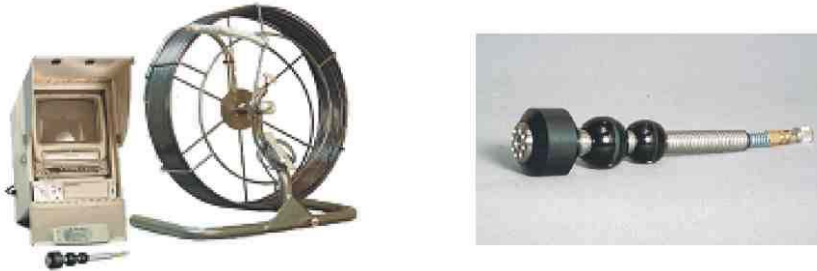
Figure B-15. Left: Complete RST 1500 System. Right: 1500 Series Ultra Mini Camera.

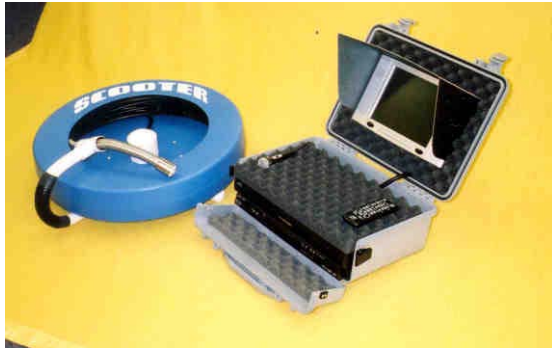
Figure B-16. Left: Scooter™ Mini Camera on the Coiler. Right: Attach'e System.

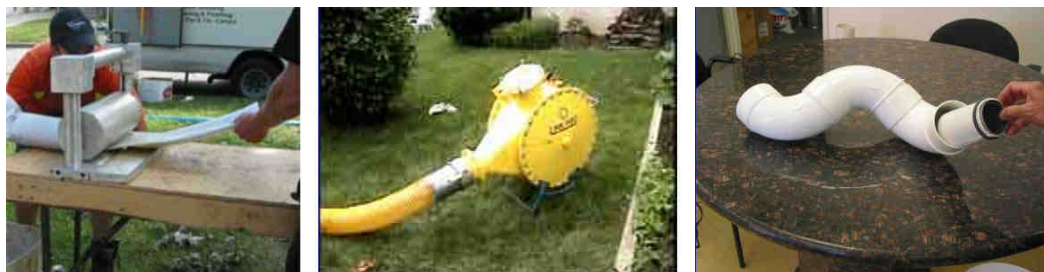
Figure C-1. Left: Roller System. Middle: Inversion Drum. Right: Drain Repair Sleeve in Elbows.

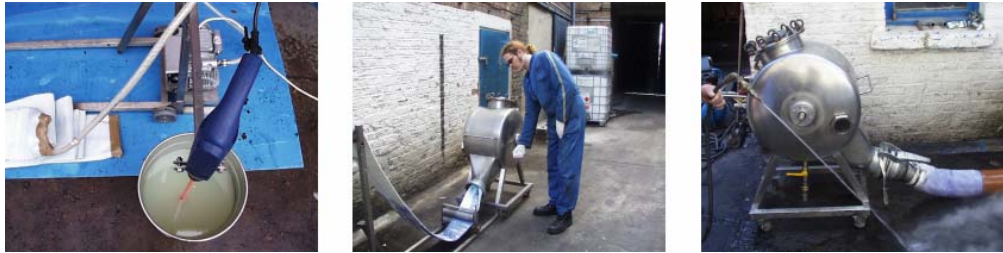
Figure C-2. Left: Vacuum Impregnation. Middle: Calibration Rollers. Right: Inversion Drum to Receive Warm Water.

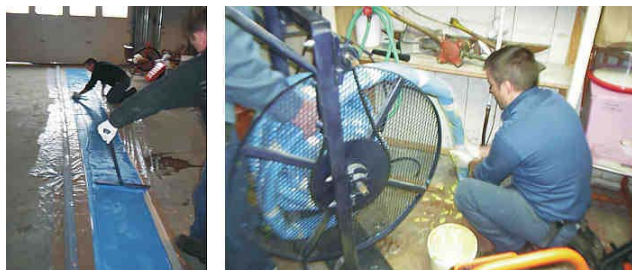
Figure C-3. Left: Liner Preparation. Right: Liner Insertion.

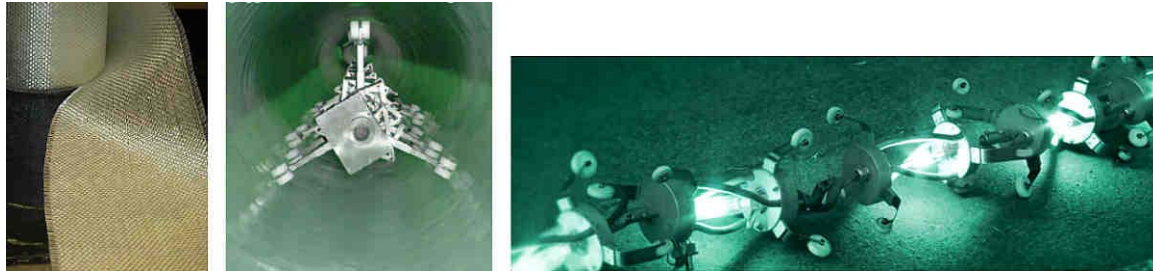
Figure C-4. Left: Tube. Middle: UV-light Source in the Pipe. Right: Several UV-lamps Used for Uniform Curing.

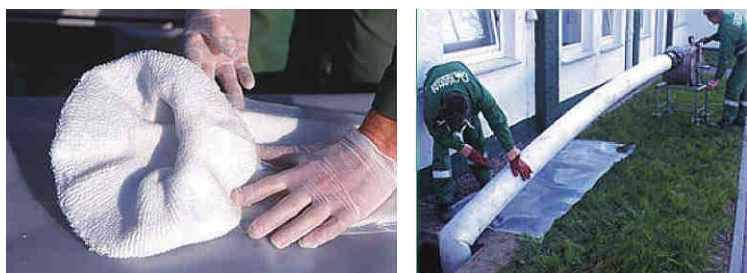
Figure C-5. InServ™. Left: Tube Material. Right: Insertion through a Small Pit.

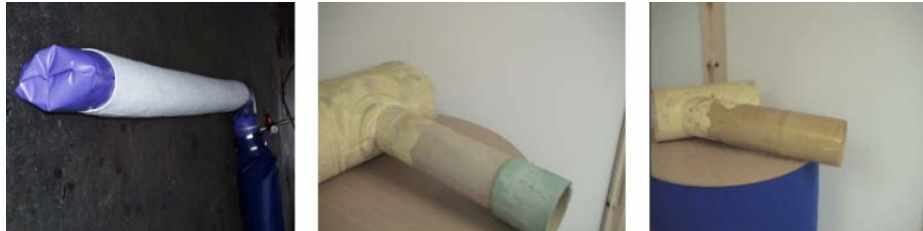
Figure C-6. Left: Liner Shown on Inverted Bladder. Middle: A 90° Junction Liner Right: A 45° Junction Liner

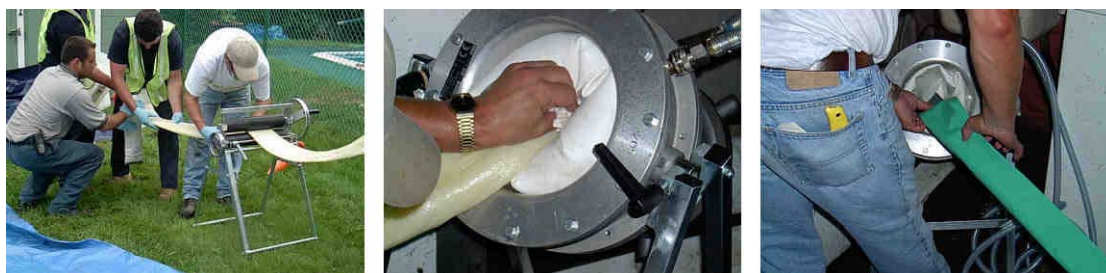
Figure C-7. MaxLiner. Left: Calibration Rollers. Middle: Liner Air Inversion with Liner Gun. Right: Bladder Inversion.

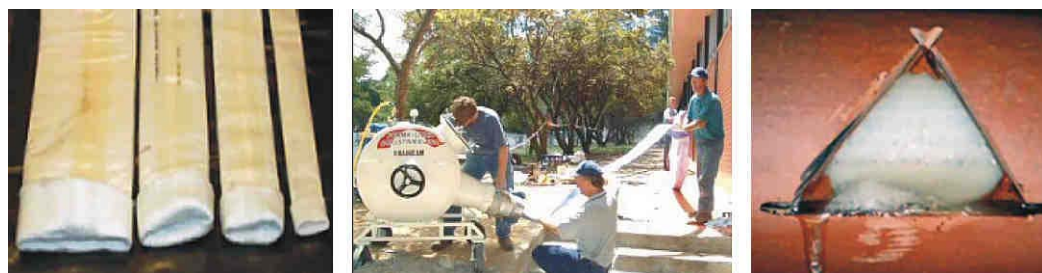
Figure C-8. Left: Liners 8" through 2". Middle: Preparation for Air Inversion. Right: Liner in Broken Pipe Sample.

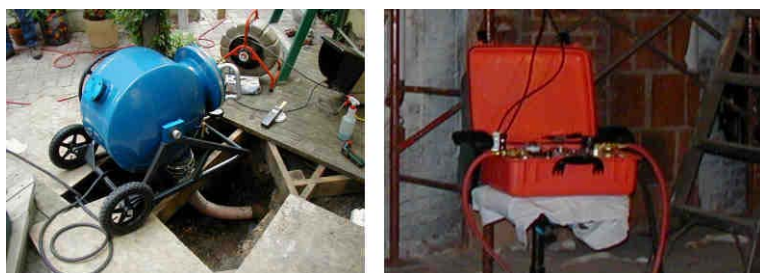
Figure C-10. Left: Inversion Drum. Right: Power Pack for Electric Curing.

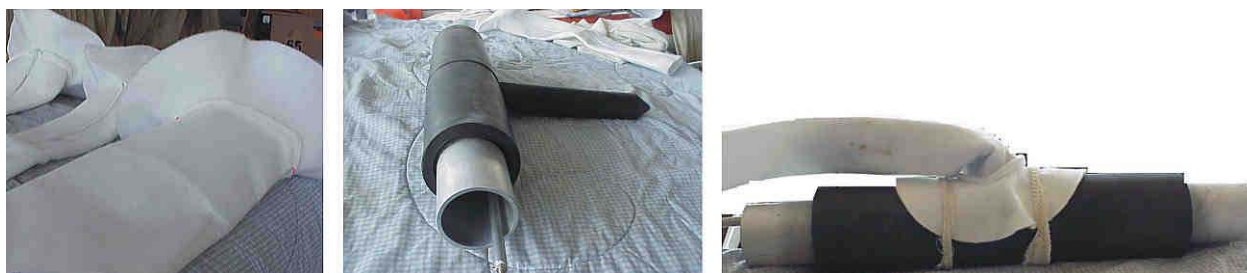
Figure C-12. Left: Material. Middle: Carrier Packer. Right: Impregnated Composite on Carrier Packer.

Feature	Description	Comment
Material	Felt (stitched)	Made in Europe
Resin type	Silicate resin	
Resin impregnation	On site (submerged in pail of mixed resin)	
Nominal liner thickness	3.0 mm	
Liner insertion	Insertion using a carrier packer	
Curing process	Ambient temperature	
Mainline pipe diameter (ID)	6-15"	
Lateral pipe diameter (ID)	3-6"	
Brim in the mainline	3-4"	
Length in the lateral	12"	
Length in mainline section (T-liners only)	12"	
Offset joints in lateral pipe		
Cracks, holes in lateral pipe	Yes	Fully structural
Active leaks	Yes	
Roots, debris in lateral pipe	Yes	Cleaning required first
Flow isolation required	No	A flow-thru packer is used
Type of flow in lateral	Gravity	
Sewage pH range		
Sewage max temperature		
Duration of repair	1.5-5 hrs	Depending on type of resin
Productivity	4-5 per day	
Average cost	\$500 –\$1,000	
Flexural modulus:		
Flexural strength		
Tensile strength		
Patents	Pending	
Product testing	Presently underway, not available as of this date.

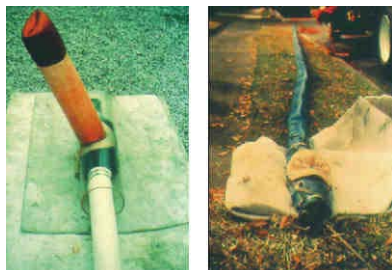
Figure C-13. Left: Loading of Inversion Device. Right: Inversion Device Ready for Installation.

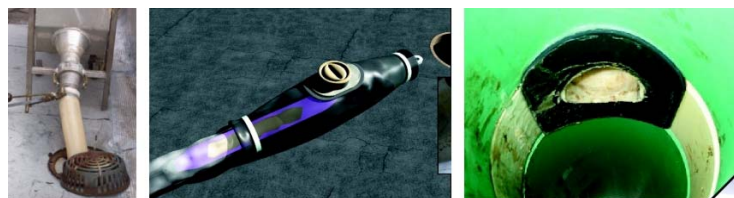
Figure C-14. Left: Inversion of MasterFlex through Cleanout. Middle: Insta T Inversion Device. Right: Insta T Installed.

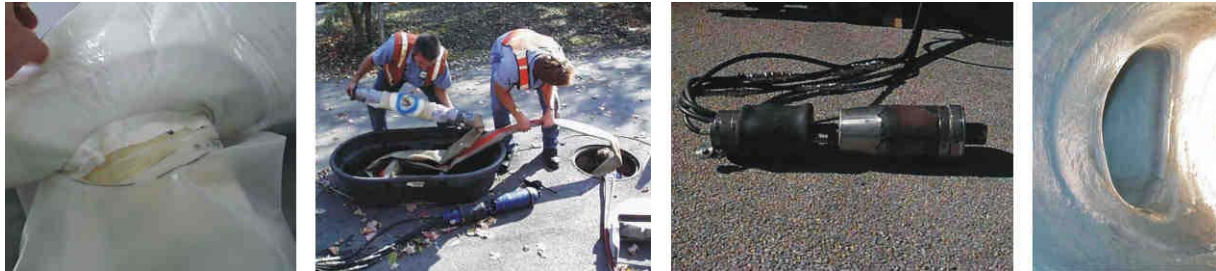
Figure C-15. Left: Liner. Middle Two: Manhole Access; Remote Positioning Device. Right: Installed Liner.

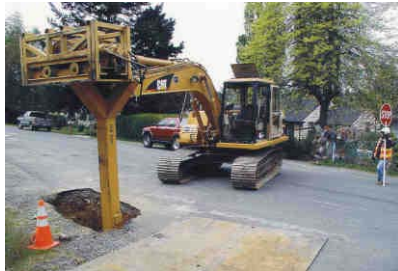
Figure C-17. Buno B-100 Pipe Bursting/Slip Lining Machine.

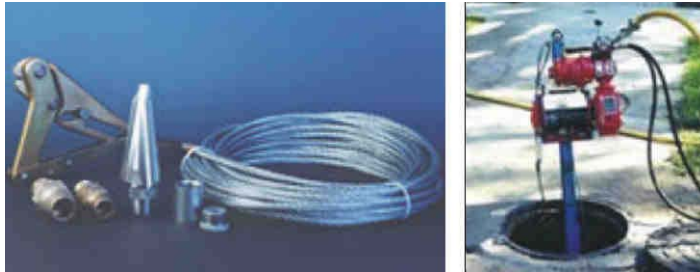
Figure C-18. Grundocrack. Left: Bursting Heads and Pulling Cable. Right: Pneumatic Winch in Manhole.

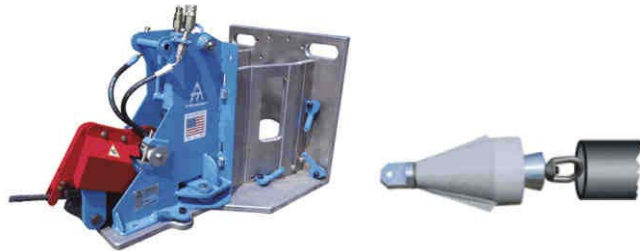
Figure C-19. Grundotugger. Left: Winch Unit. Right: Special Bursting Head (Nose Cone/Splitter).

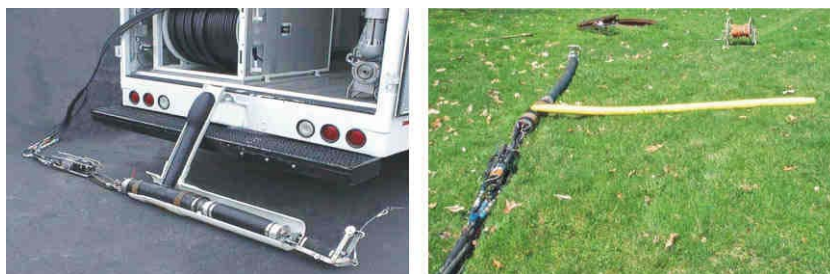
Figure C-23. Lateral Connection Packers. Left: Standard Bladder. Right: Long Bladder.

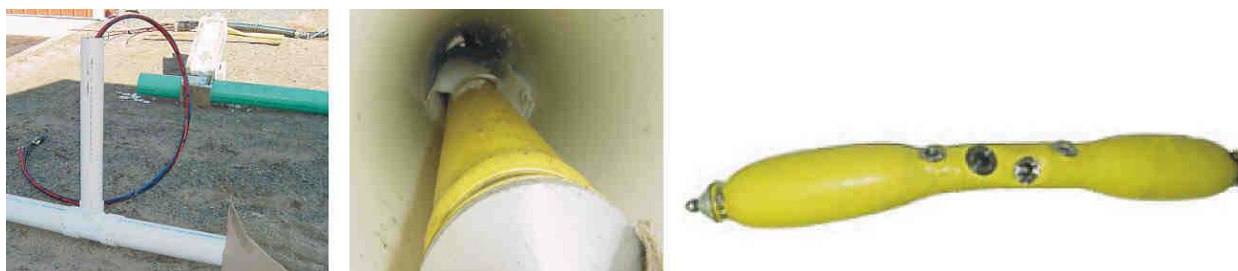
Figure C-24. Push Type Packers. Left: Fitting for Cleanout Installation. Middle: Inside the Lateral. Right: The Packer.

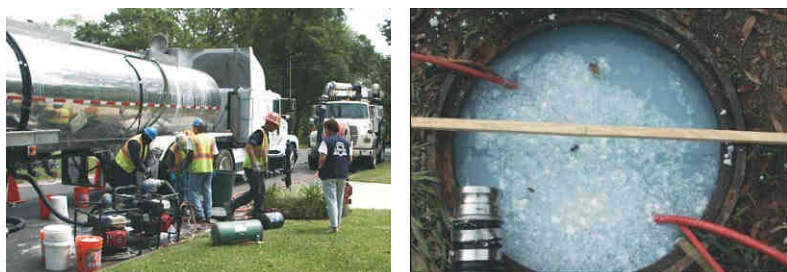
Figure C-25. Sanipor. Left: Truck with Chemicals Near a Manhole. Right: Manhole Filled with a Solution.

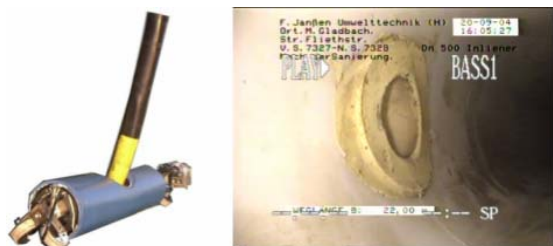
Figure C-27. Left: Packer. Right Renovated Lateral Connection (Originally a Protruding Lateral).

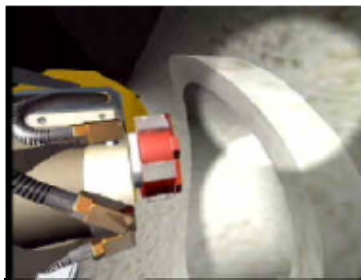
Figure C-28. Left: KA-TE Robots. Middle: Grinding Protruding Lateral. Right: Close-up of Grinding at Lateral Connection.
