The City of Naperville Department of Public Utilities (DPU) is now in the eighth year of a comprehensive sewer rehabilitation program. The goal of this program is to eliminate sewer backups by finding and fixing defects that allow rainwater and groundwater into the system.

Sanitary Sewer Service Line Rehabilitation-East Highlands

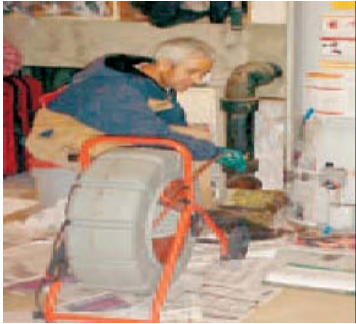
Locating the pipe

The first step in service lateral rehabilitation is locating and inspecting the pipeline. The City of Naperville uses video technology to inspect the pipe. Naperville's sewer inspection truck is

capable of launching a small camera up the service line from the city main. This method, which does not require entry into the residence, is successful in most cases. However, service lines with a series of sharp bends, tree root obstructions or other defects require the service lateral to be inspected from inside the house.

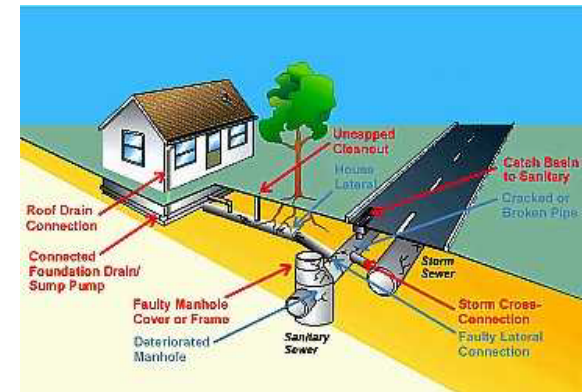
The final step in service lateral rehabilitation is the installation of the liner. Prior to lining, the contractor will thoroughly clean the lateral pipeline to remove all tree roots and other obstructions. The contractor returns later to install the lining tube, which is launched from inside the city main. To ensure a perfect fit, the contractor uses video technology to monitor the installation. When the process is complete, the resident has a leak-free service line that is maintenance-free, from the end of the liner to the city main.
