# HANOVER PARK WATER RECLAMATION PLANT FISCHER FARM MONITORING REPORT FOR FIRST QUARTER 2019

June 2019

Subject: Hanover Park Water Reclamation Plant - Illinois Environmental Protection Agency Permit No. 2016-SC-61315, Monitoring Report for January, February, and March 2019

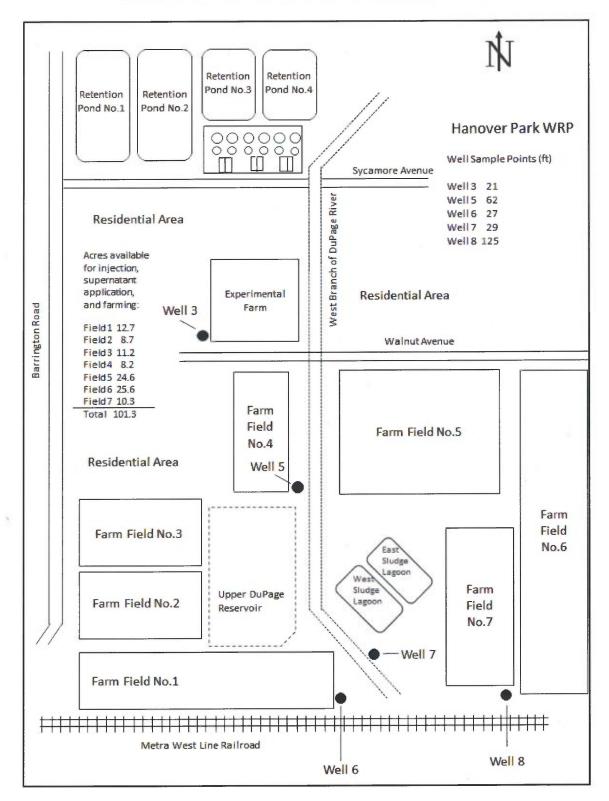
#### FIGURE 1 MAP OF FIELDS AND WELLS AT THE HANOVER PARK FISCHER FARM SITE OF THE METROPOLITAN WATER RECLAMATION DISTRICT OF GREATER CHICAGO

Drainage water (combined surface and subsurface) returned to the Hanover Park WRP from the farm fields was sampled in January, February, and March 2019, and data for these samples are presented in <u>Table 2</u>. The volumes of drainage water returned to the WRP during the first quarter were estimated as 9.4, 28, and 38 million gallons in January, February, and March, respectively. During application of the lagoon supernatant, it was erroneously sampled and could not be summarized in this report. The volume of supernatant and associated dry weight of biosolids applied are shown in <u>Table 3</u>. Field and water monitoring locations are presented in <u>Figure 1</u>.
