Subject: Hanover Park Water Reclamation Plant - Illinois Environmental Protection Agency Permit No. 2016-SC-61315, Monitoring Report for April, May, and June 2021

HANOVER PARK WATER RECLAMATION PLANT

FISCHER FARM MONITORING REPORT FOR

SECOND QUARTER 2021

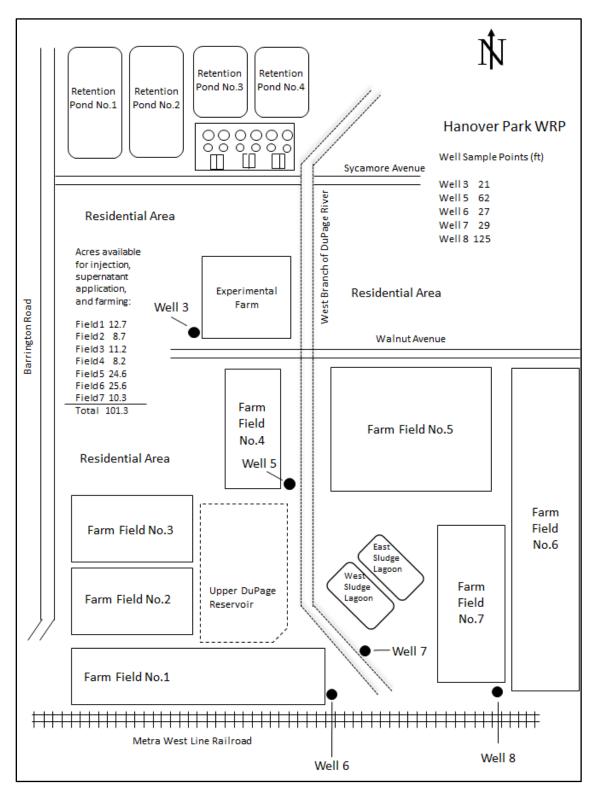
FIGURE 1: MAP OF FIELDS AND WELLS AT THE HANOVER PARK FISCHER FARM SITE OF THE METROPOLITAN WATER RECLAMATION DISTRICT OF GREATER CHICAGO

Drainage water (combined surface and subsurface) returned to the Hanover Park WRP from the farm fields was sampled in April, May, and June 2021, and data for these samples are presented in <u>Table 2</u>. The volumes of drainage water returned to the WRP during the first quarter were estimated as 1.4, 0.47, and 16 million gallons in April, May, and June, respectively. The analytical data for lagoon supernatant applied to Fischer Farm fields in June are presented in <u>Table 3</u>. The volume of lagoon supernatant and the associated dry weight of biosolids applied are shown in <u>Table 4</u>. Field and water monitoring locations are presented in <u>Figure 1</u>.
