HANOVER PARK WATER RECLAMATION

PLANT FISCHER FARM MONITORING

REPORT FOR SECOND QUARTER 2022:

SPECIAL CONDITION 2

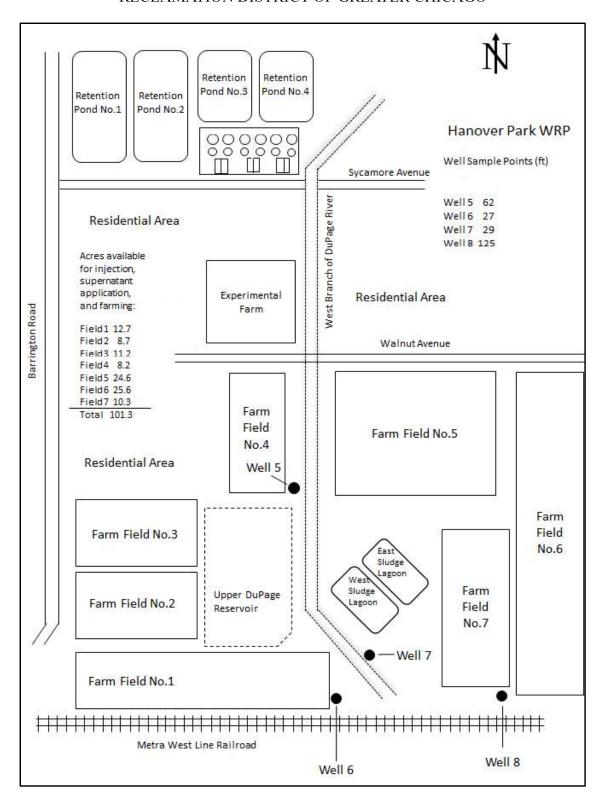
FIGURE 1: MAP OF FIELDS AND WELLS AT THE HANOVER PARK FISCHER FARM SITE OF THE METROPOLITAN WATER RECLAMATION DISTRICT OF GREATER CHICAGO

<u>Figure 1</u> Map of Fields and Wells at the Hanover Park Fischer Farm Site of the Metropolitan Water Reclamation District of Greater Chicago.
